**SAIPAN TRANSMITTING STATION  
PHOTOGRAPH LOG**

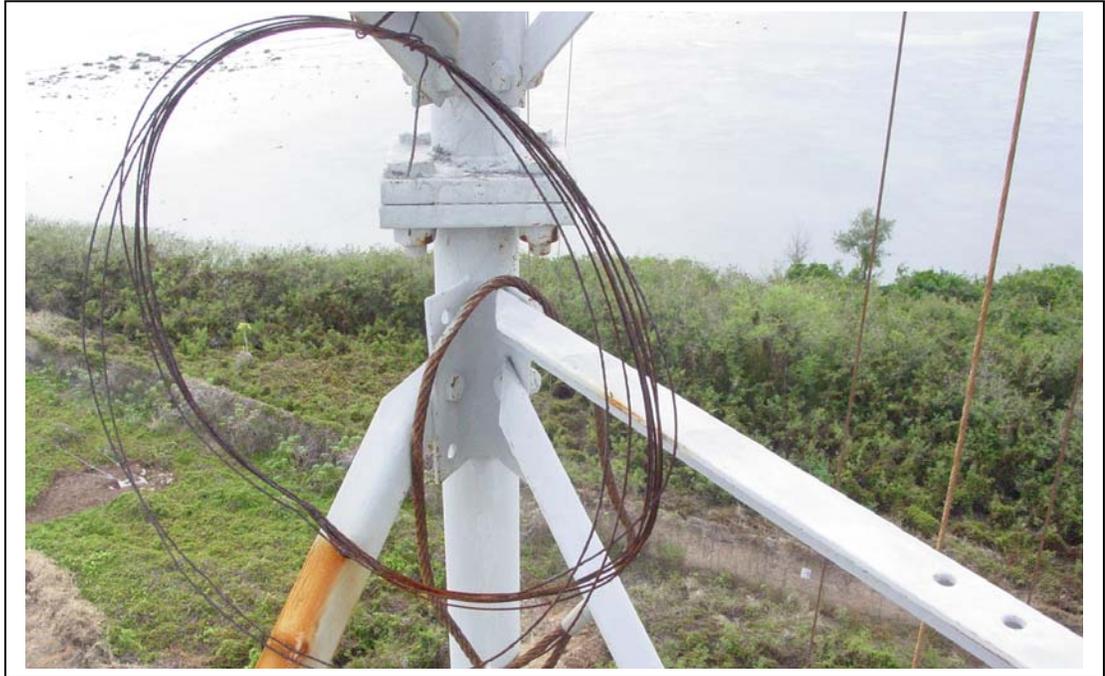
**Photo No. 15**

Photo No. 15 is a view of the leg splice at the 109.8-ft level. Note the abandoned coil of wire connected to the tower at this elevation.

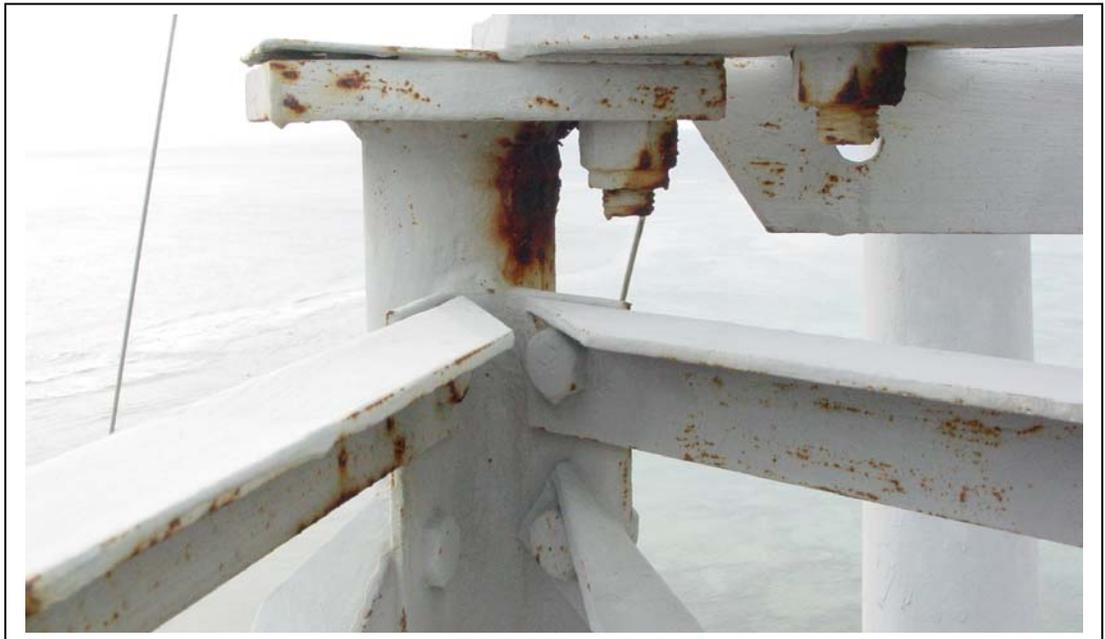
**Photo No. 16**

Photo No. 16 is a view of the top leg flange at the top of the tower. Note the rusted condition of the tower leg and connection bolts at this level.

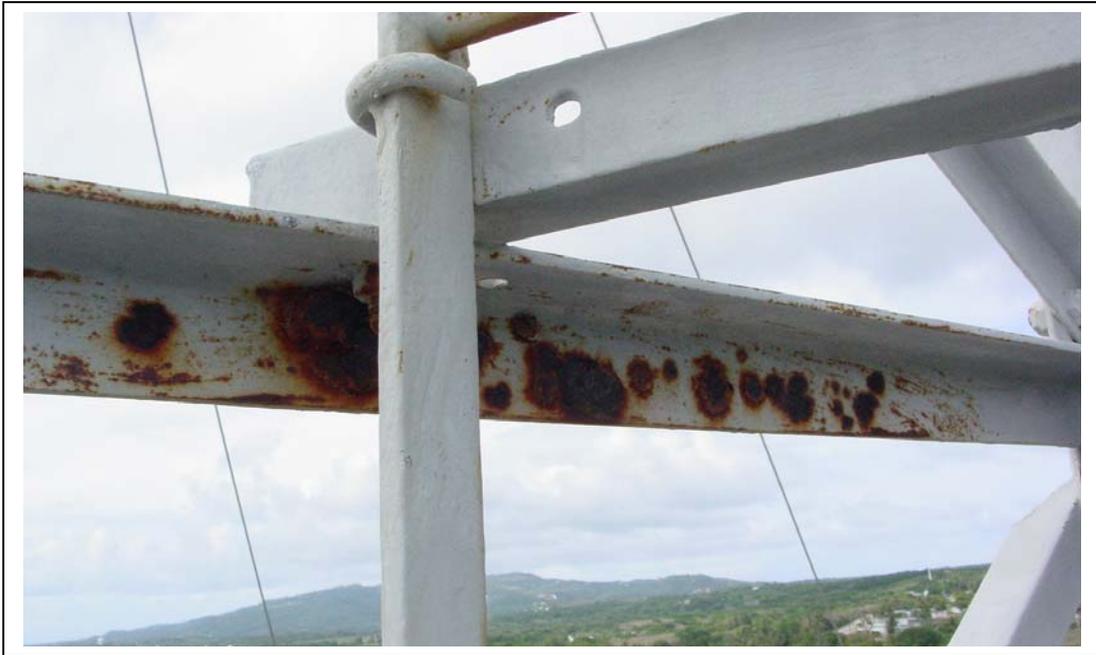
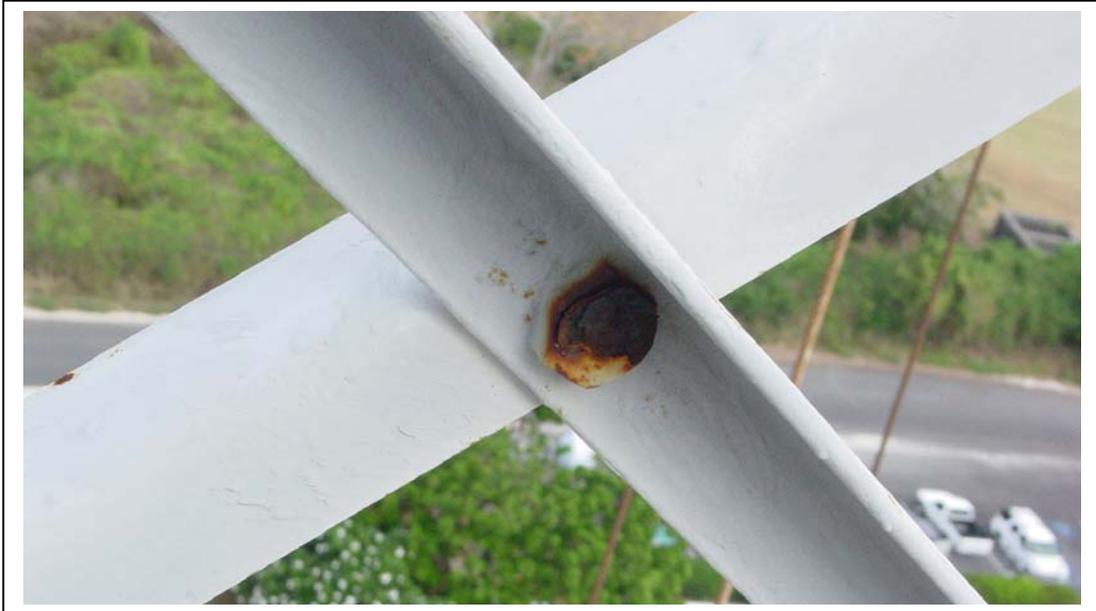
Photo Nos. 17 and 18 show the rusted condition of the tower members and connection bolts at some locations. The rusted condition is typical throughout the upper half of the tower.

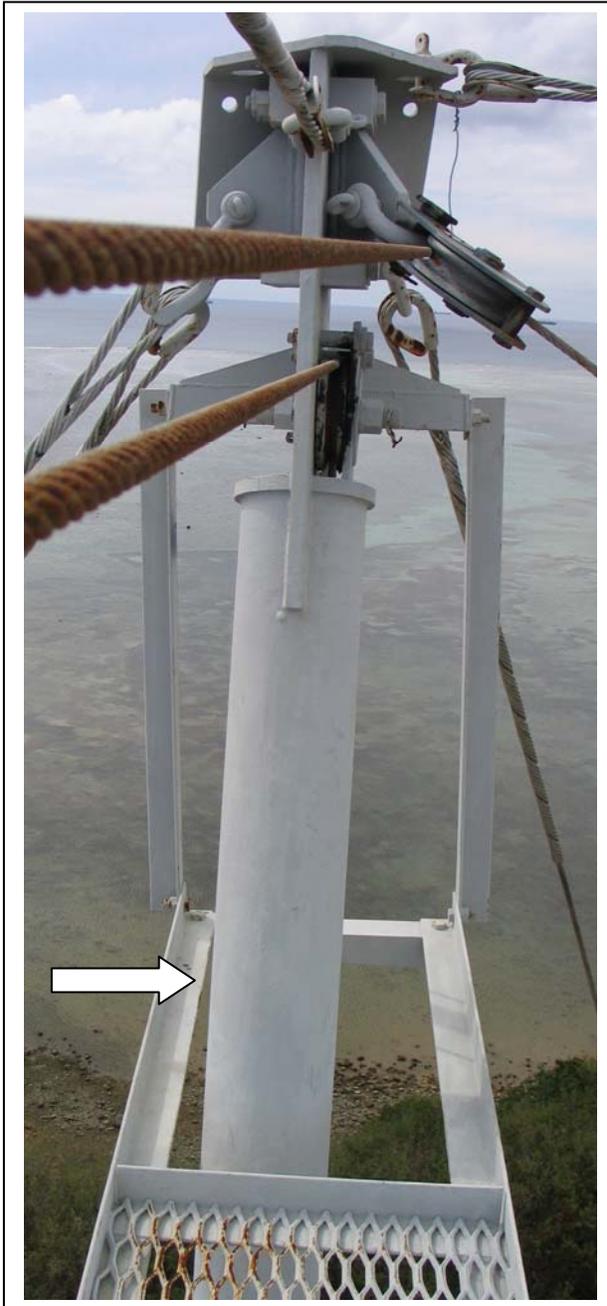
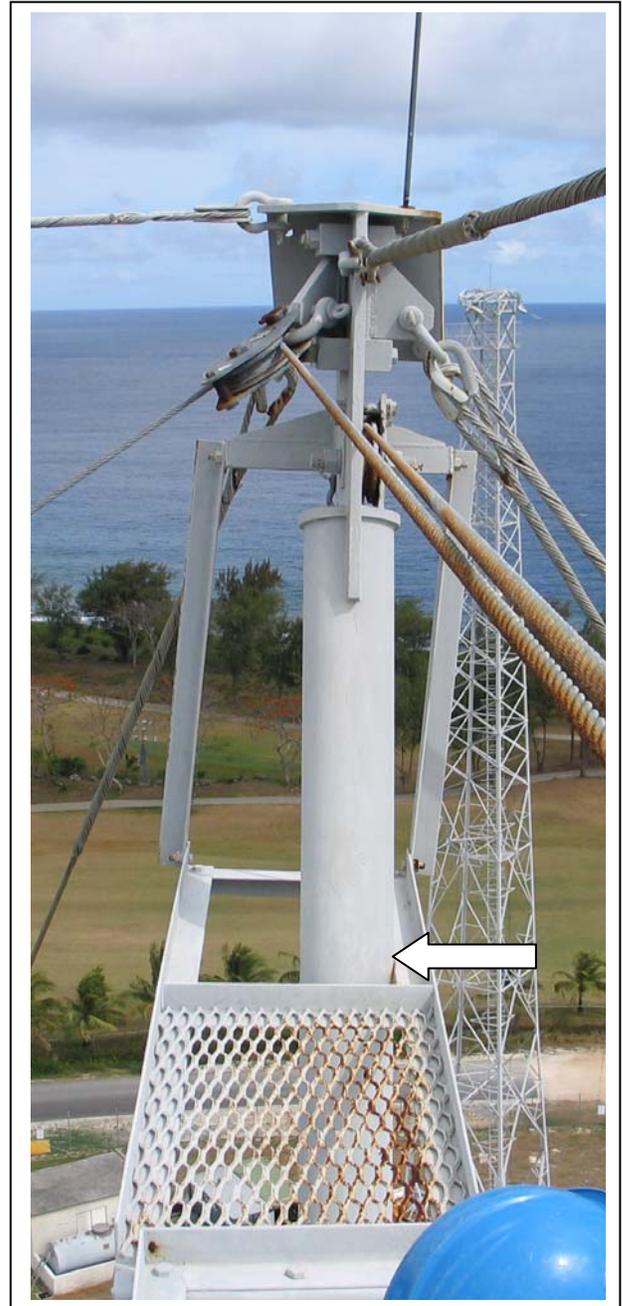
Photo Nos. 22 and 23 show the boom assembly at the top of the tower. Note that the boom assembly is shifted to one side on tower 'B'.

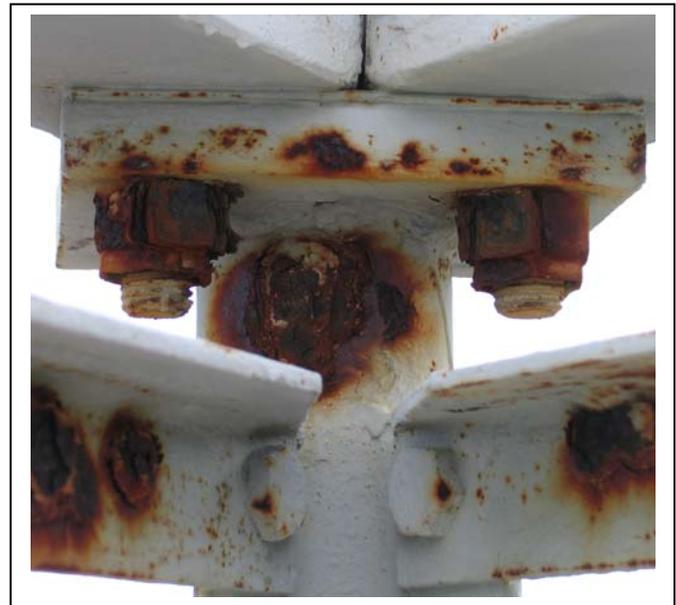
**Photo No. 37**

Photo Nos. 34-37 show the rusted condition of the tower members at some locations. Note the galvanizing is deteriorating and rust is beginning to form on the tower member surfaces, connection bolts and climbing ladder. The rusted condition is typical throughout the upper half of the towers.

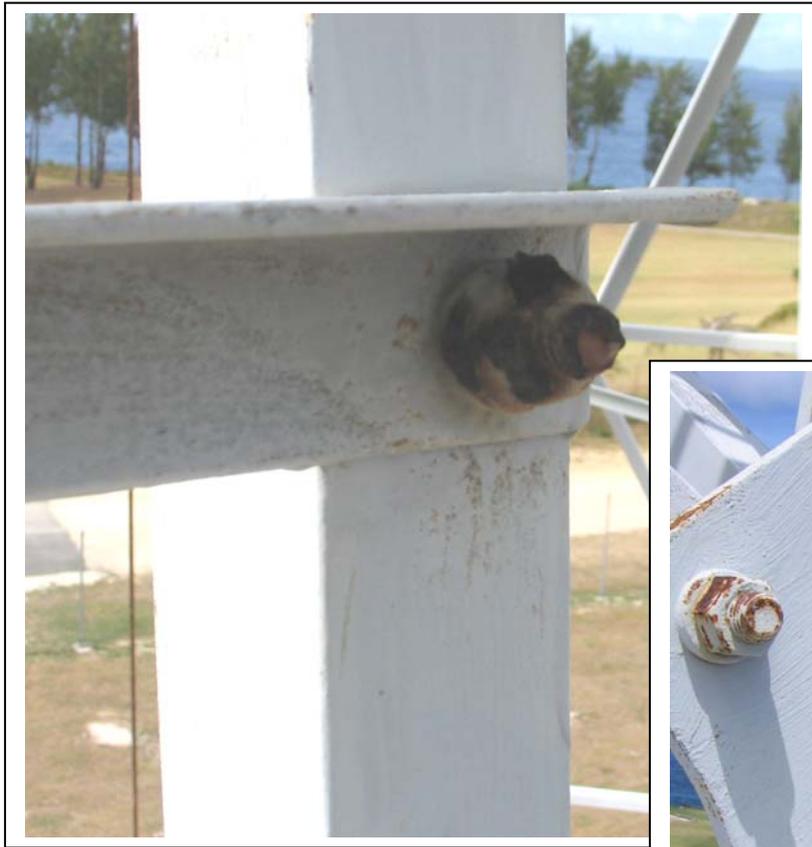
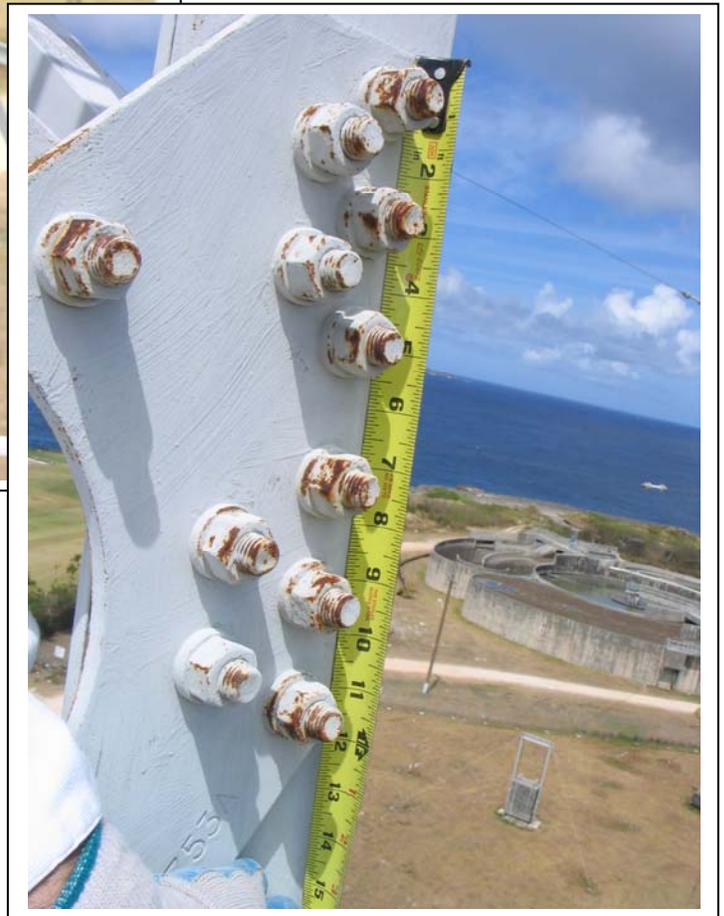
Photo Nos. 48 and 49 show the rusted condition of the tower connection bolts at some locations.

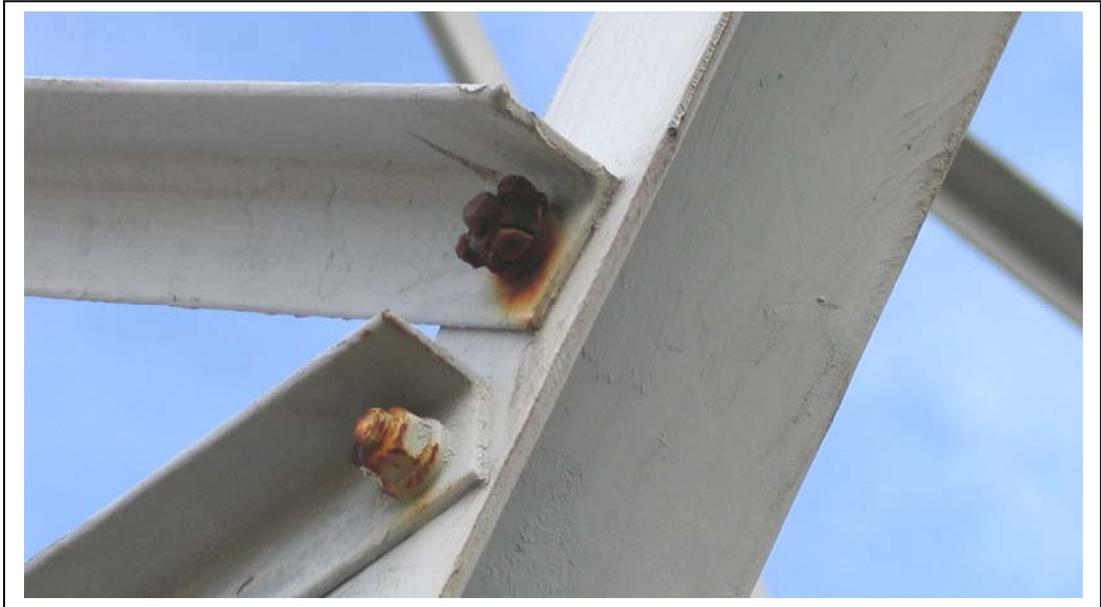
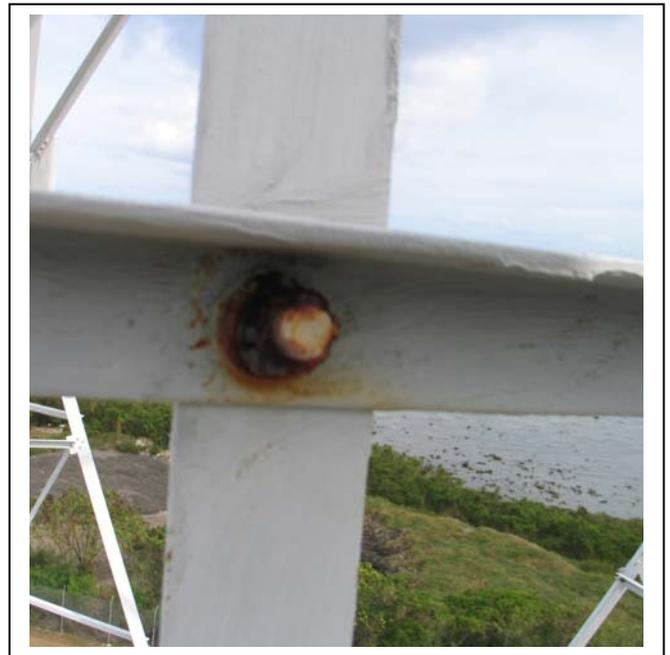
Photo Nos. 67-69 show the rusted condition of the tower connection bolts at some locations. The rusted condition of the connection bolts is typical throughout the tower.

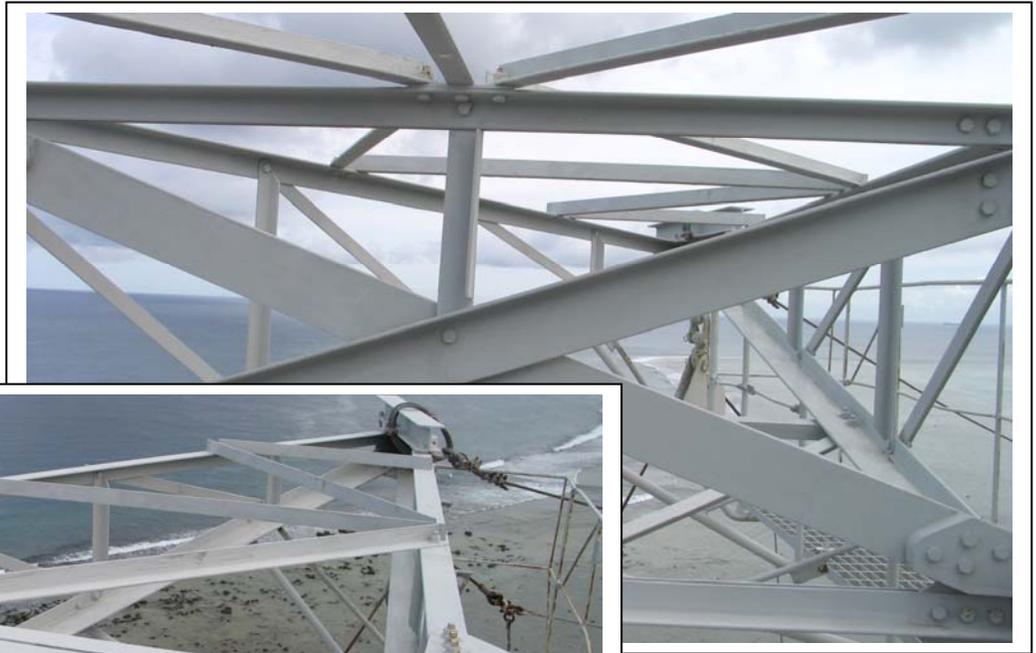
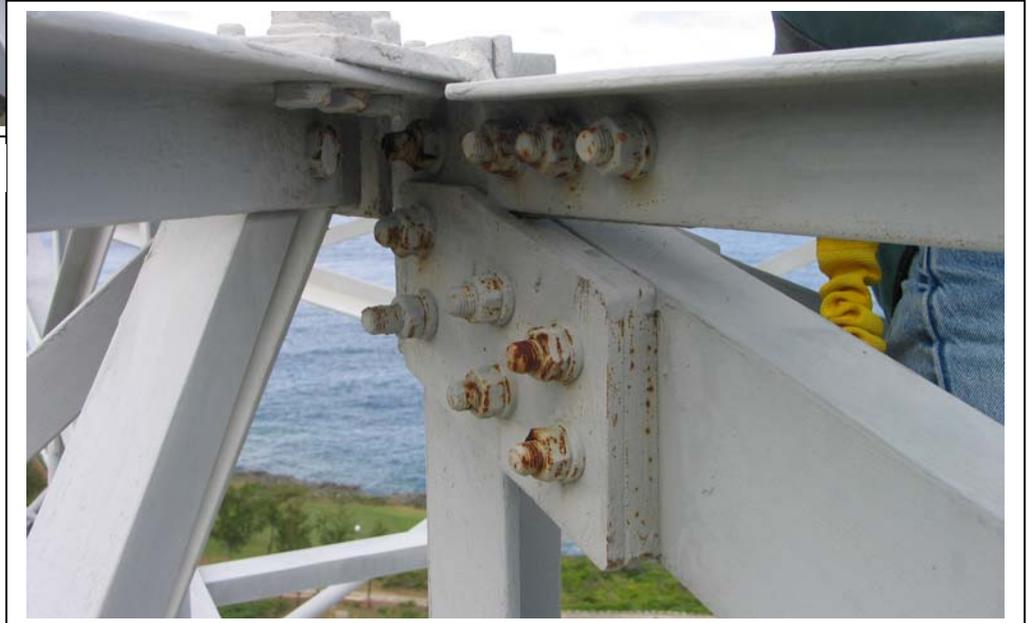
Photo Nos. 70-72 show the condition of the cross-arms at the top of tower.  
Note that some connection bolts are rusted.

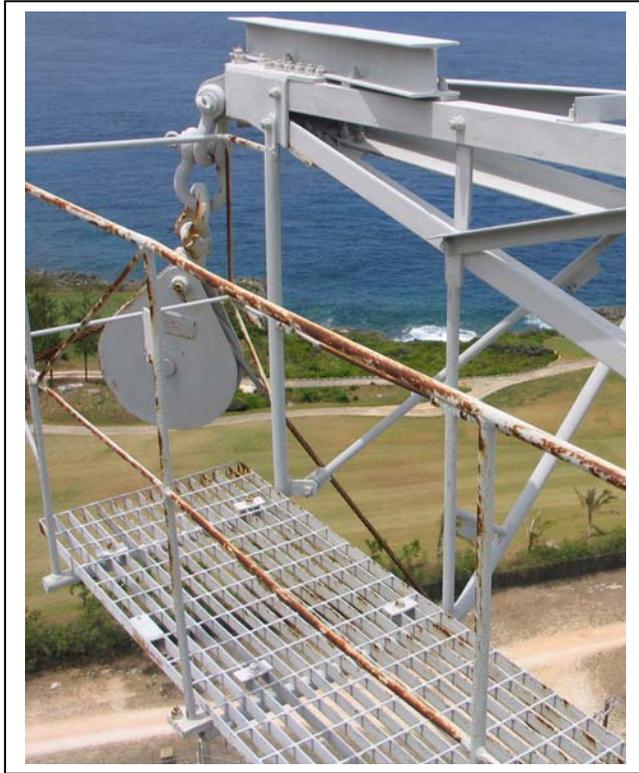
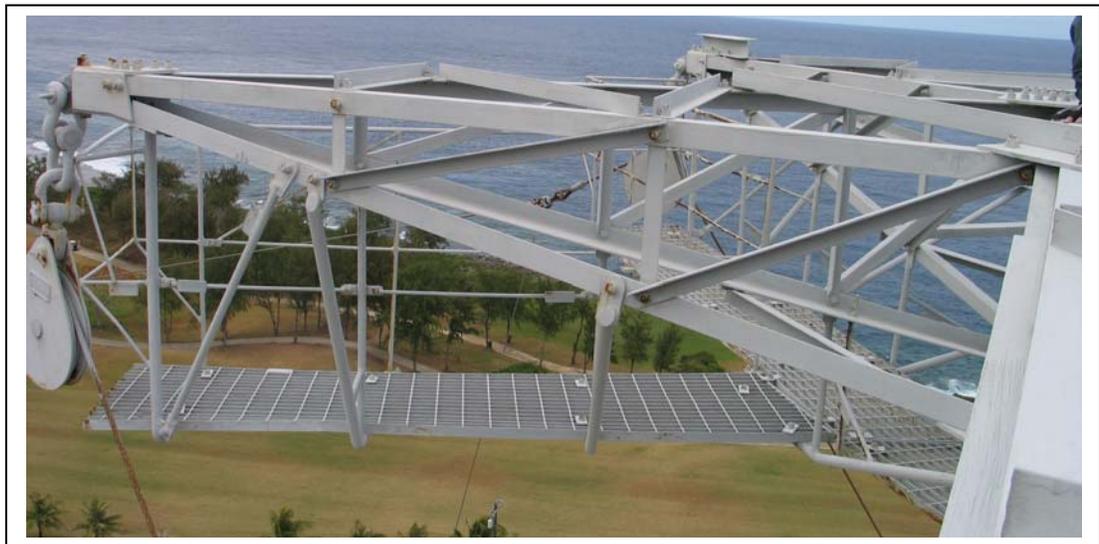
Photo Nos. 73-75 show the condition of the catwalks at the top of tower.  
Note the rusted condition of the catwalks at some locations.

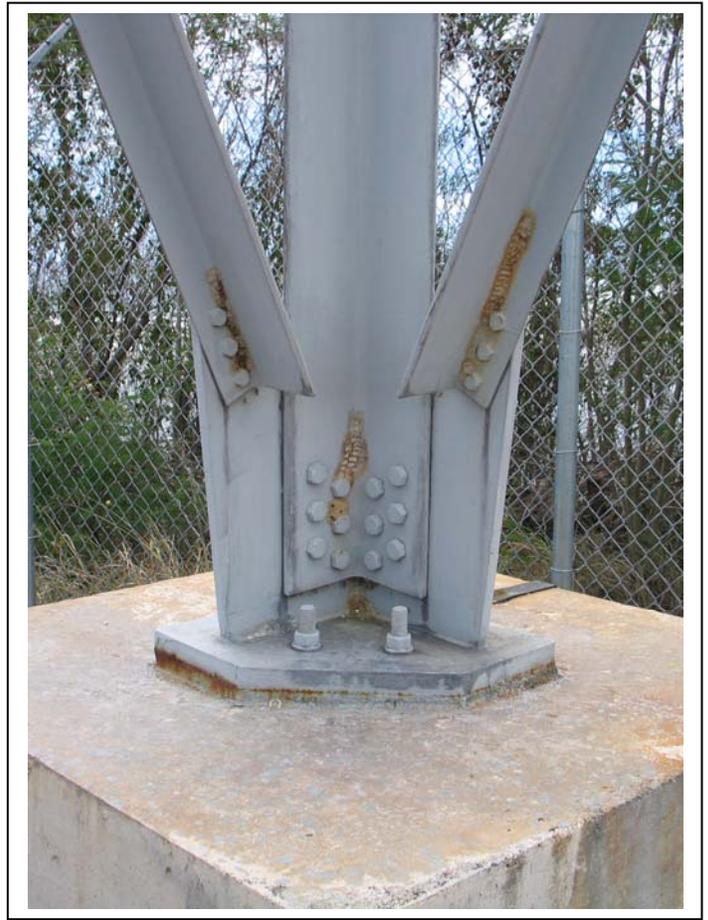
Photo No. 78

Photo Nos. 77 and 78 show a tower base.  
Note the base plate is rusted.

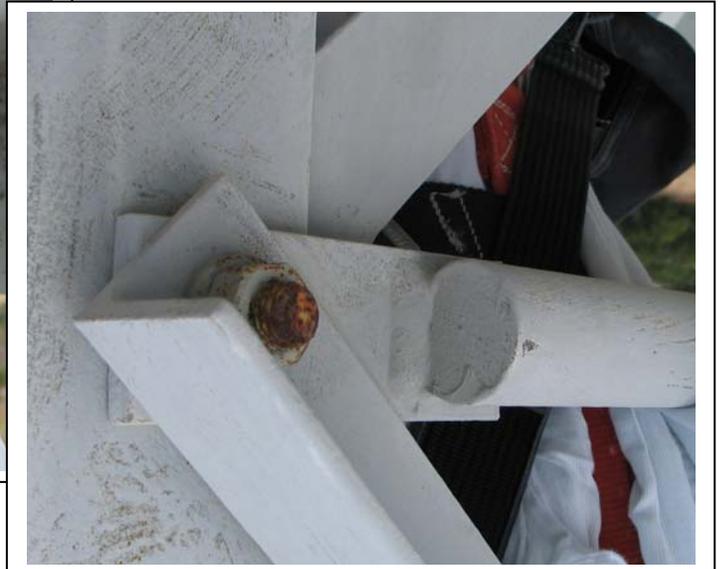
Photo No. 89

Photo No. 86 is shows the rusted condition of the tower base plate.  
Photo Nos. 87-89 show the rusted condition of the tower connection bolts at some locations.  
The rusted condition of the connection bolts is typical throughout the towers.

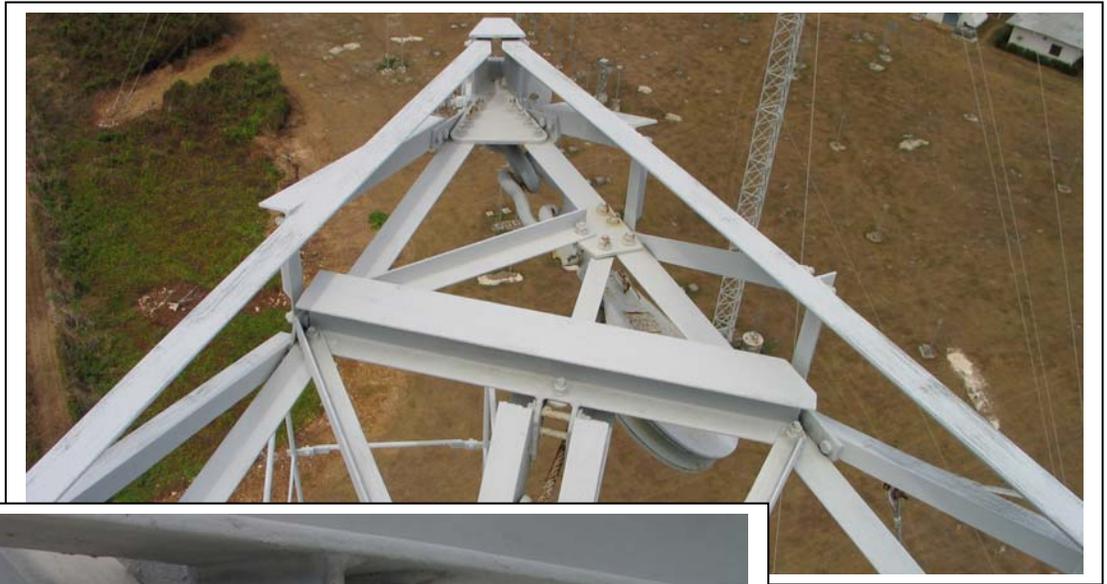
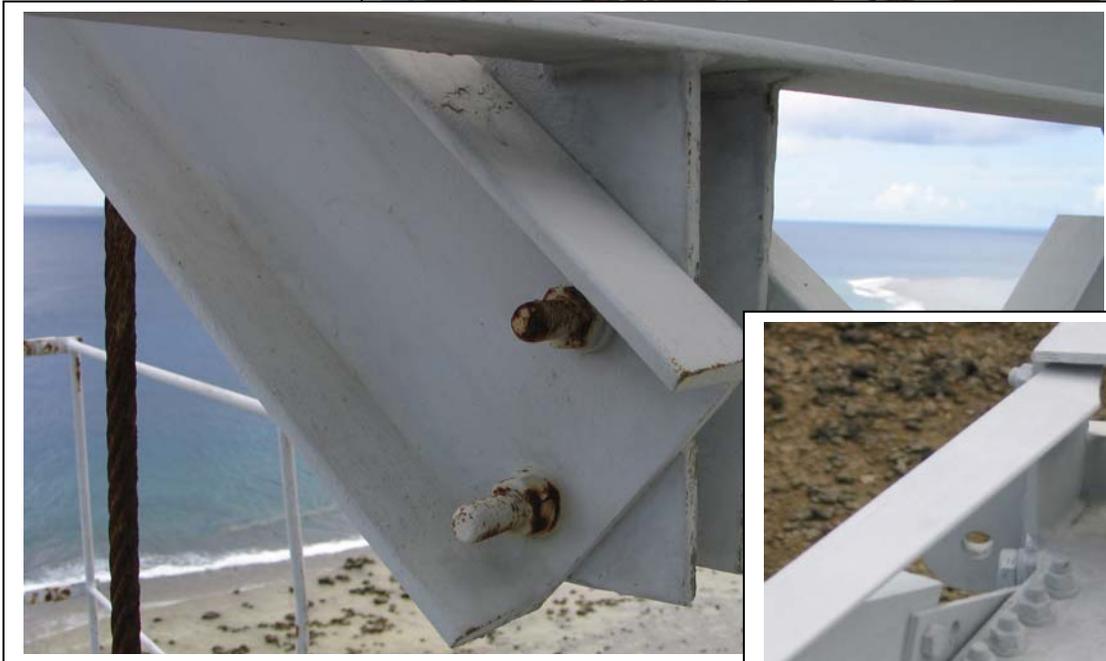
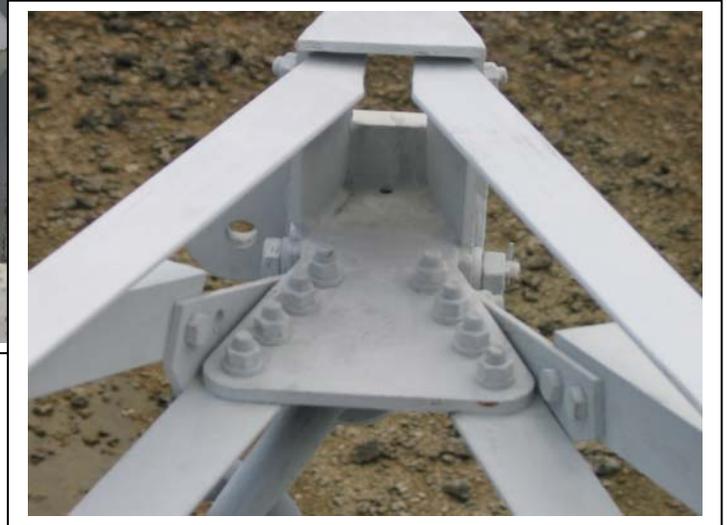
Photo Nos. 90-92 show the condition of the cross-arms at the top of tower.  
Note that some connection bolts are rusted.

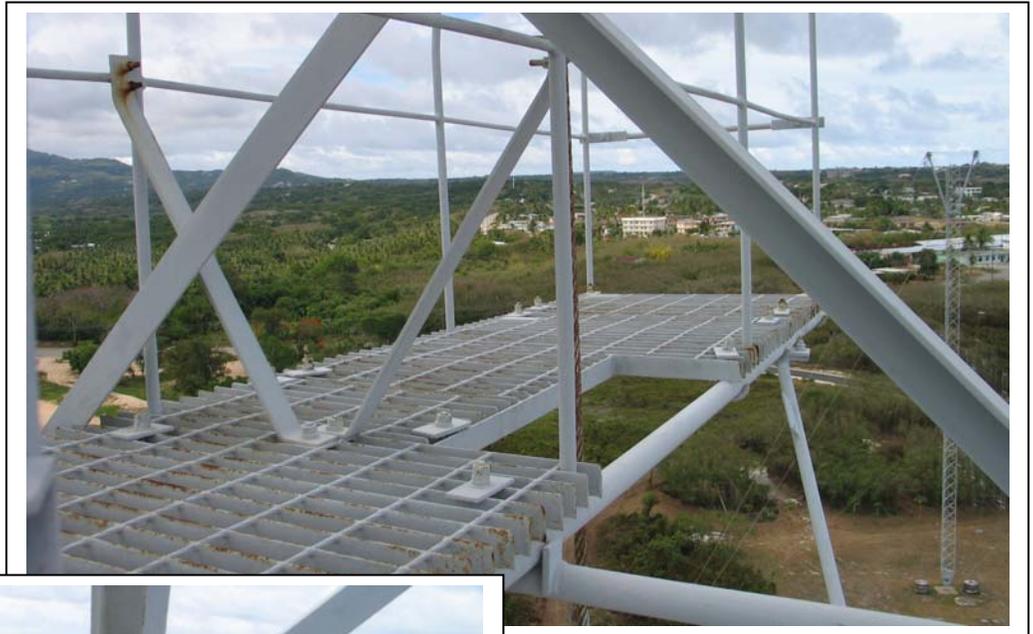
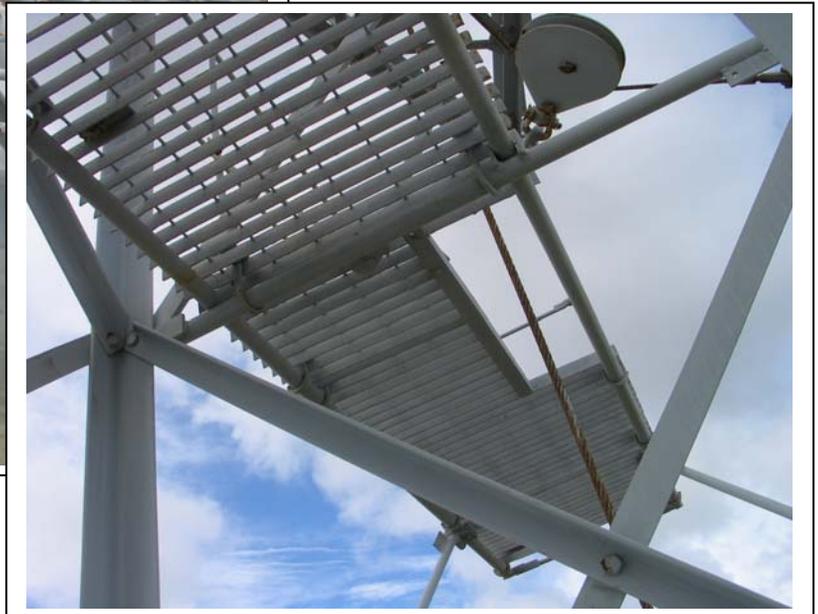
Photo Nos. 93-95 show the condition of the catwalks at the top of tower.  
Note the rusted condition of the catwalks at some locations.
