**TINIAN TRANSMITTING STATION
PHOTOGRAPH LOG**

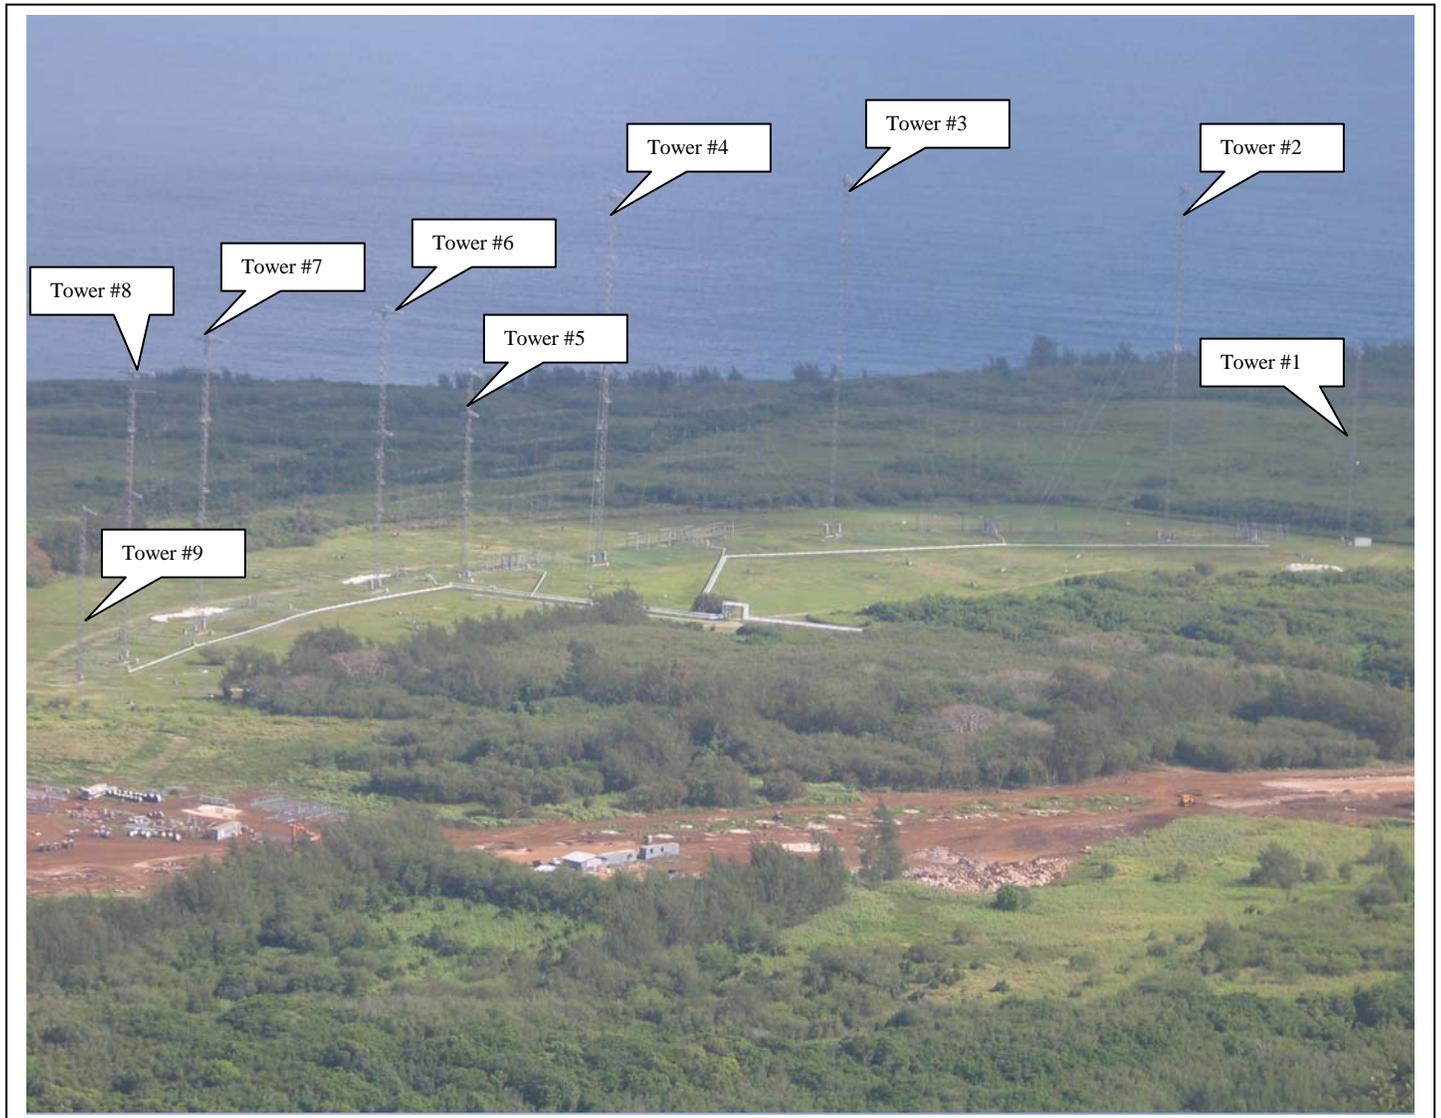
Photo No. 1 is an overall view of the Mariana Radio Relay Station located on the Island of Tinian.

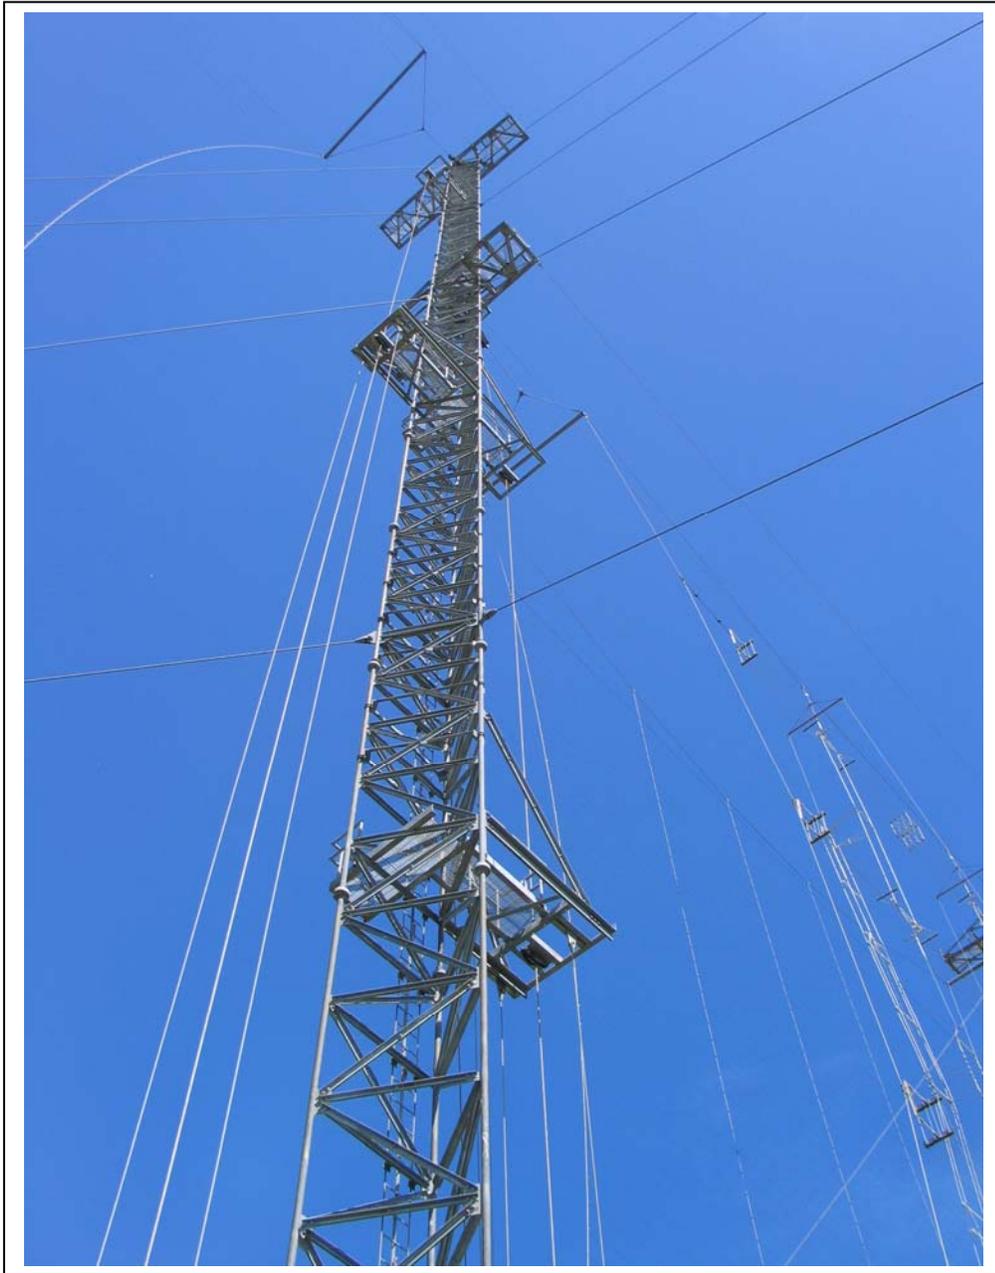
Photo No. 6 is a view looking up face of tower #8 from the northwest. The picture shows the outriggers at the 167.5-ft and 291-ft levels.

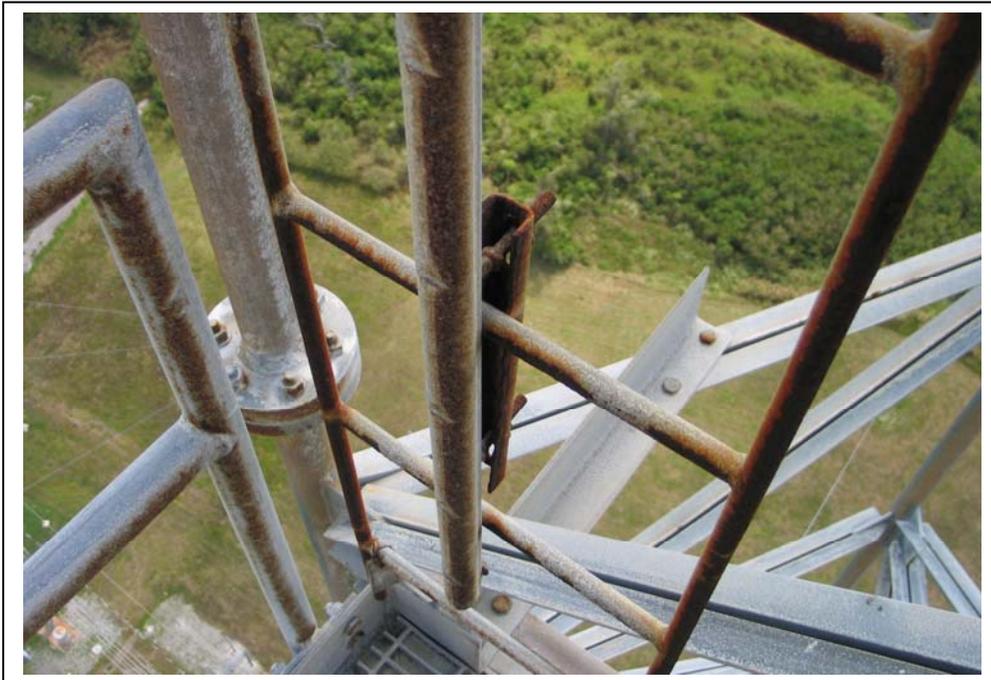
Photo No. 10

Photo Nos. 9 and 10 show the rusted condition of the tower members at some locations. Note the galvanizing is deteriorating and rust is beginning to form on the tower member surfaces and climbing ladders. The rusted condition is typical throughout the upper half of the towers.

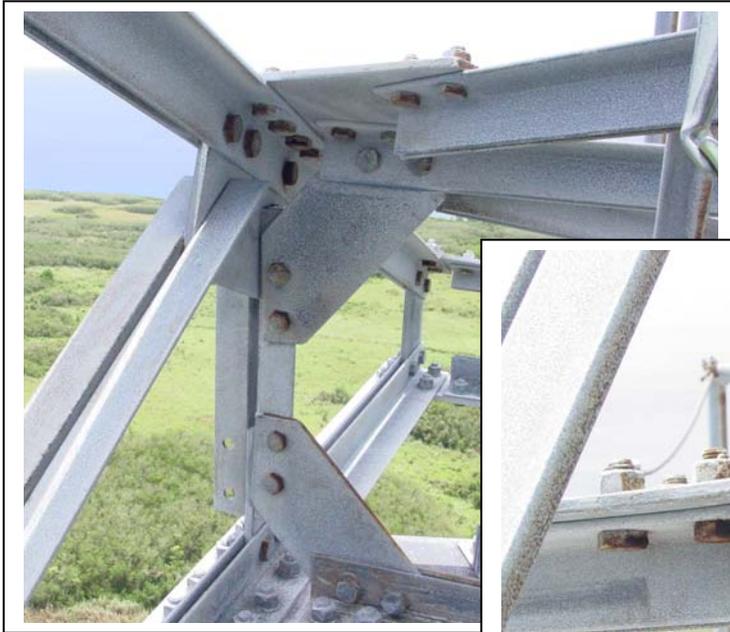
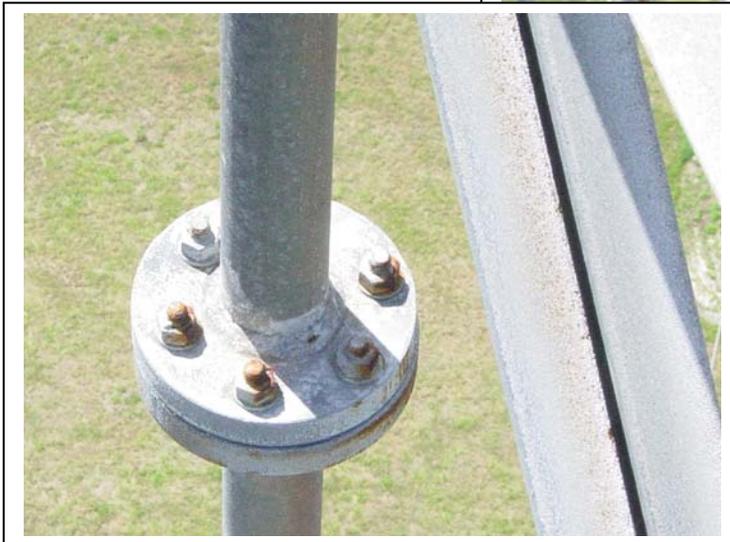
Photo Nos. 11, 12 and 13 show the rusted condition of the tower member and outrigger connection bolts. The rusted bolt condition is typical for all nine towers.

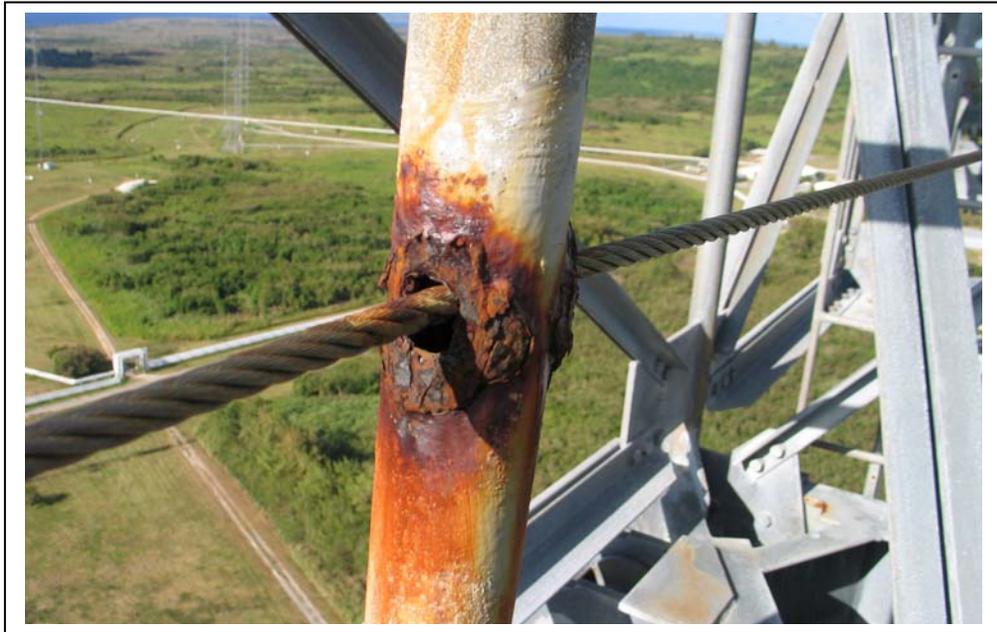
Photo No. 14

Photo No.14 shows the rusted condition of the catwalk post at the top of the tower. The rusted post condition is typical for towers #8 and #9.

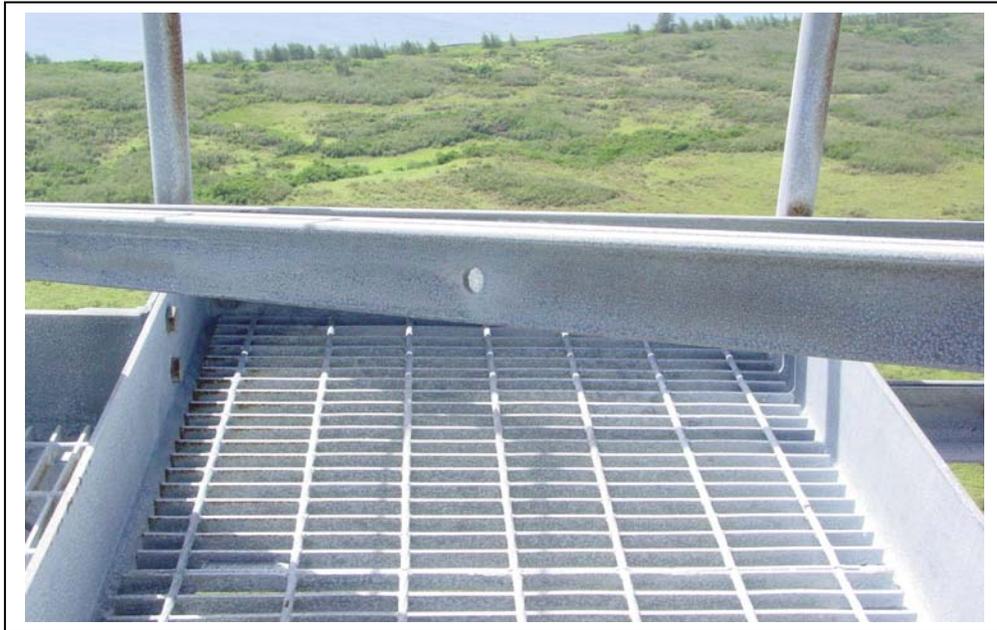
Photo No.16 shows the outrigger diagonal member at the top of the tower #2. Note the missing stitch bolt.

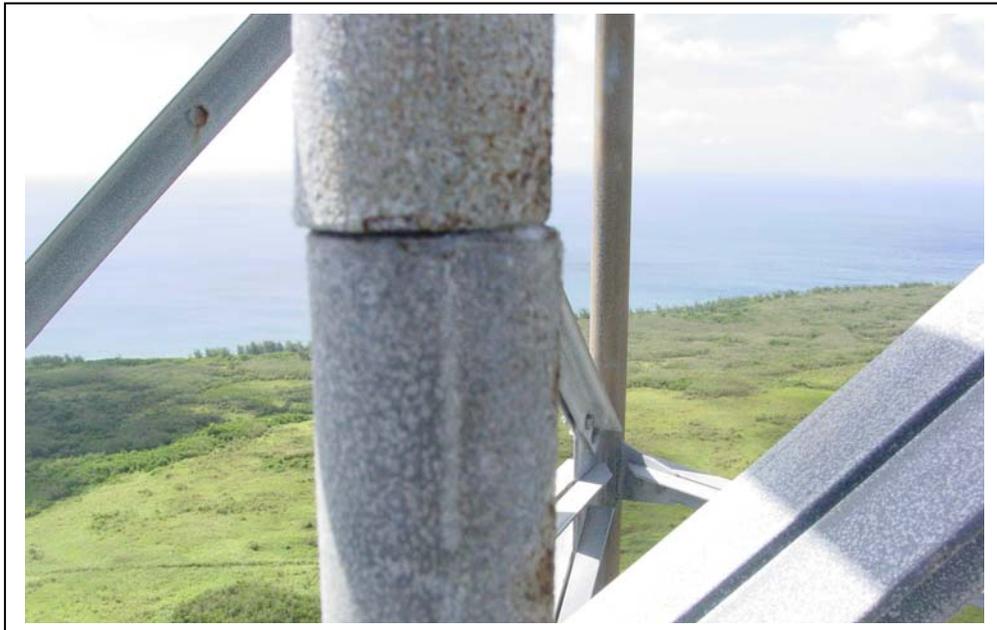
Photo No. 17

Photo No.17 is a close-up view of the safety rail on tower #2. Note that the rail sections are not lined up.

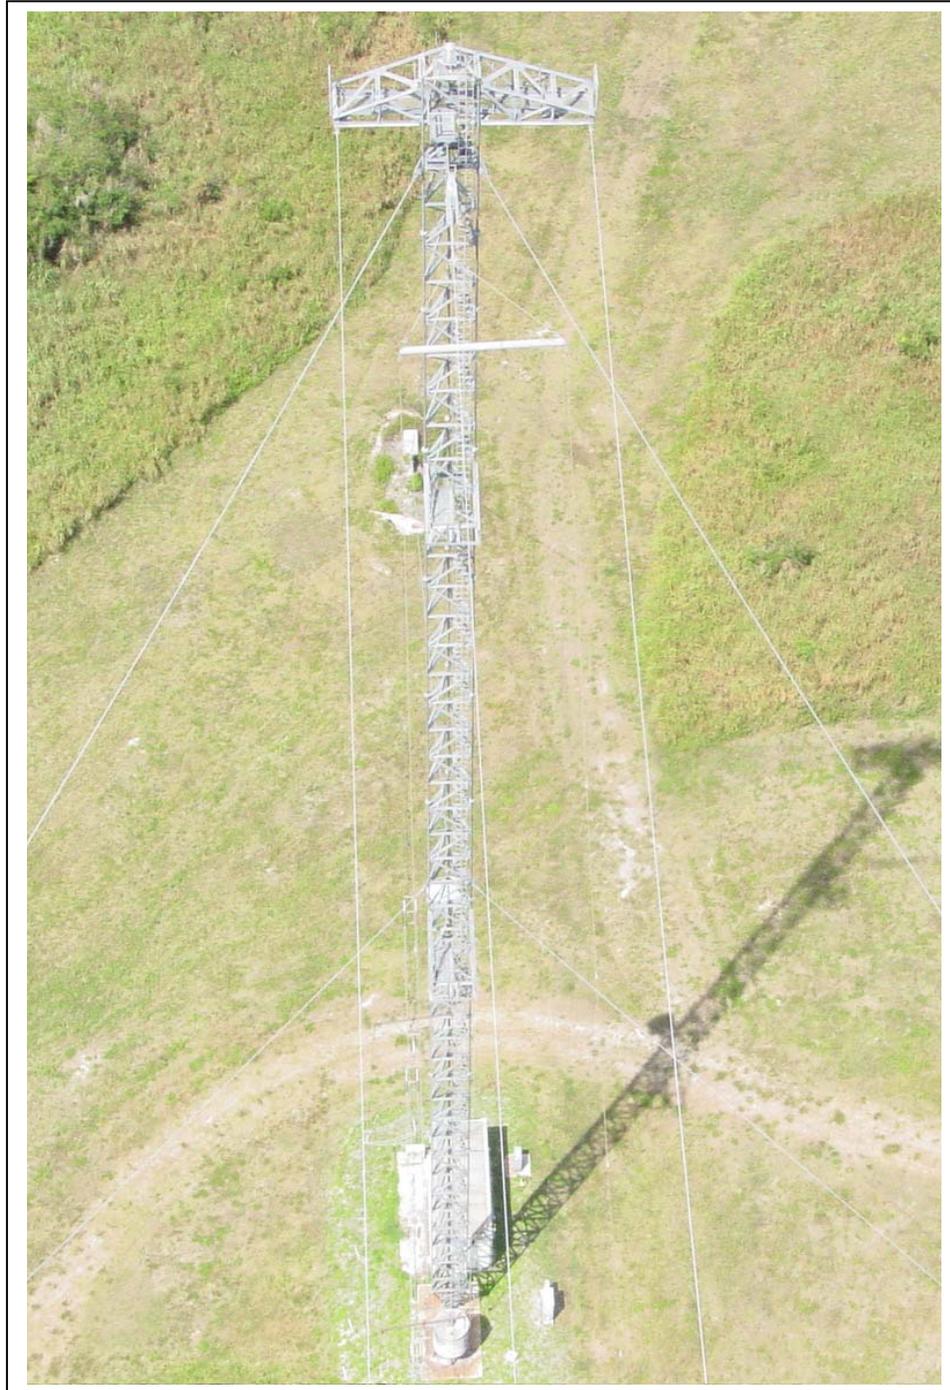
Photo No. T1.1 is a view of tower #1 from the top of tower #2.

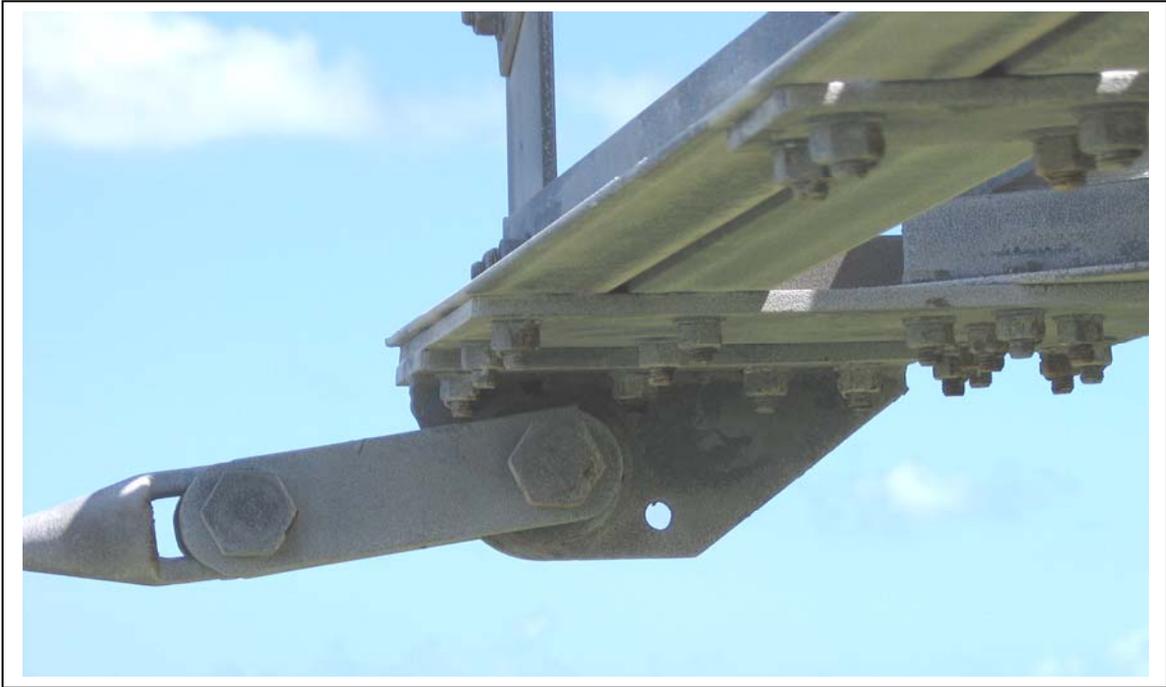
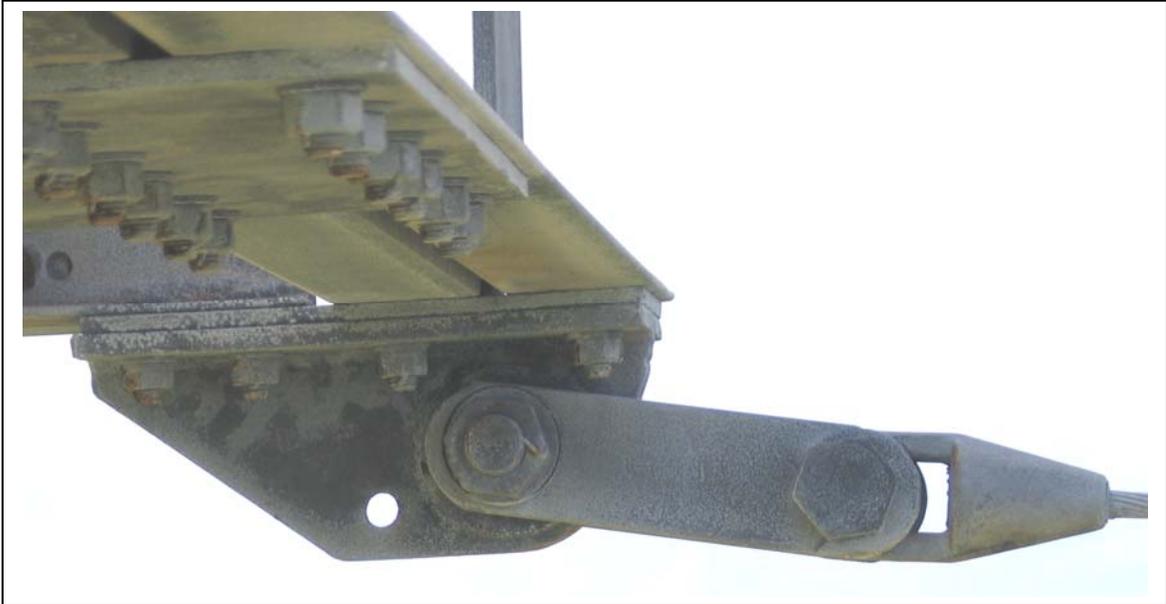
Photo No.T1.2 is a view of the catenary connection plate at the northwest side of the outrigger.
Photo No.T1.3 is a view of the catenary connection plate at the southeast side of the outrigger.

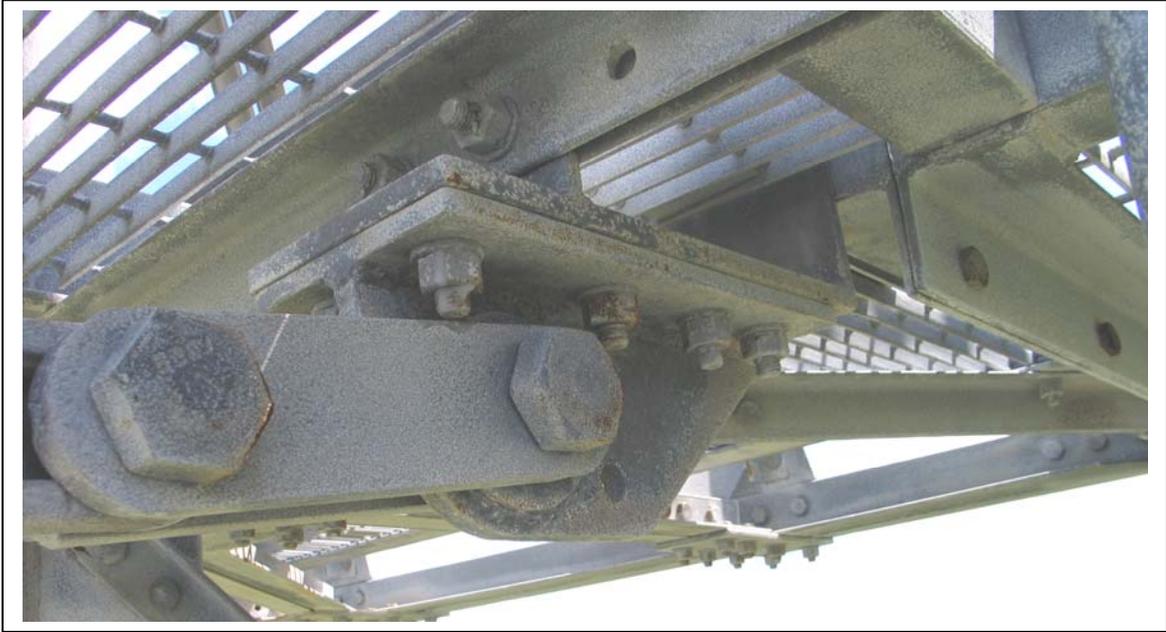
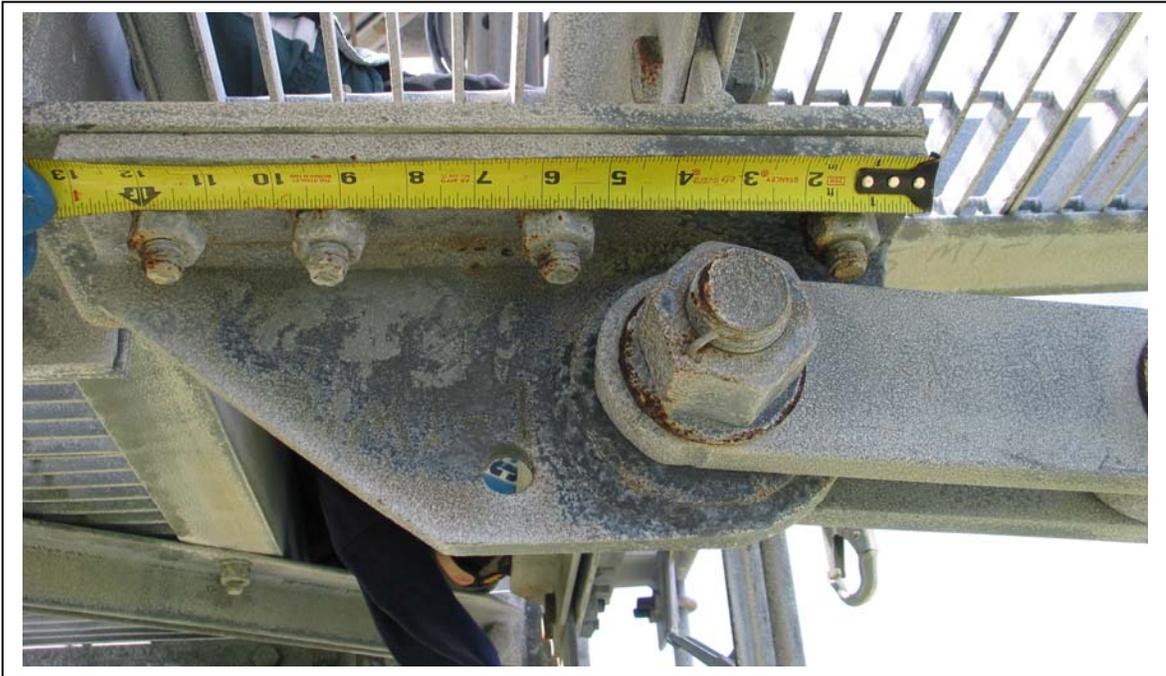
Photo Nos. T1.4 and T1.5 show the catenary connection plate at the middle of the outrigger.

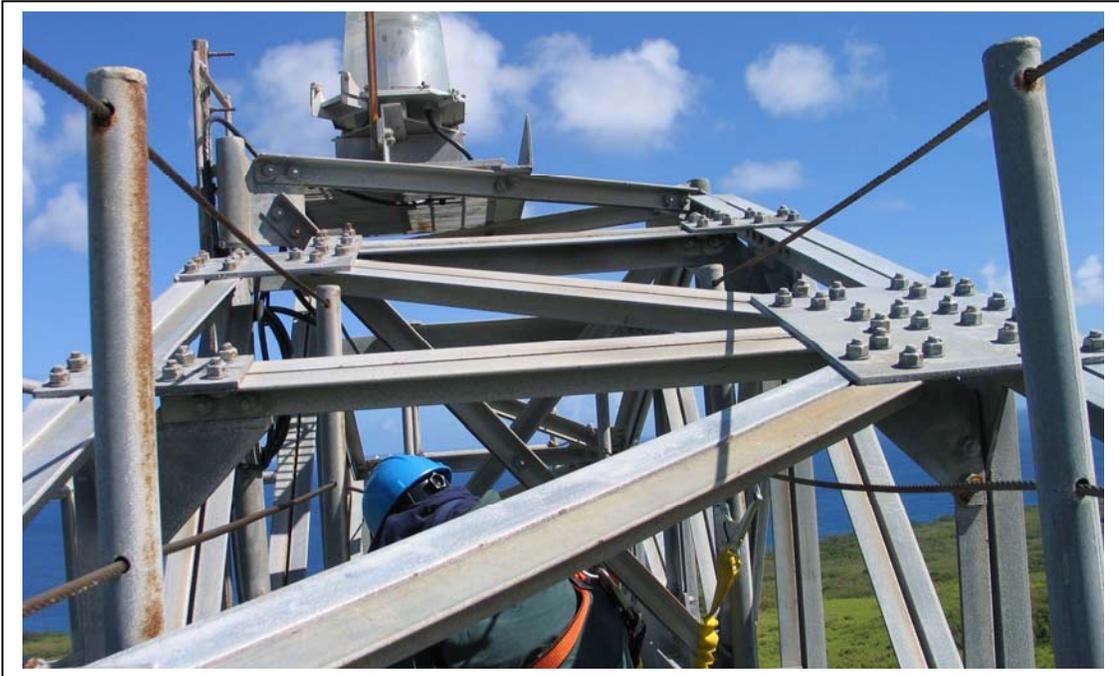
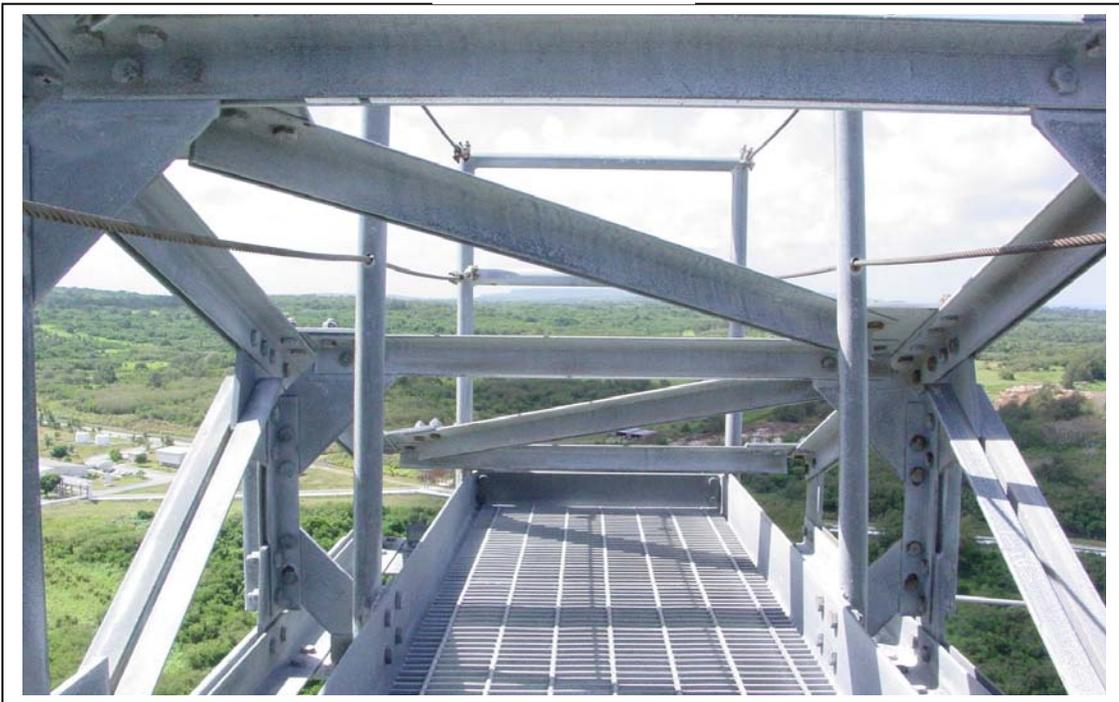
Photo Nos. T1.6 and T1.7 show the condition of the outrigger at the top of the tower.

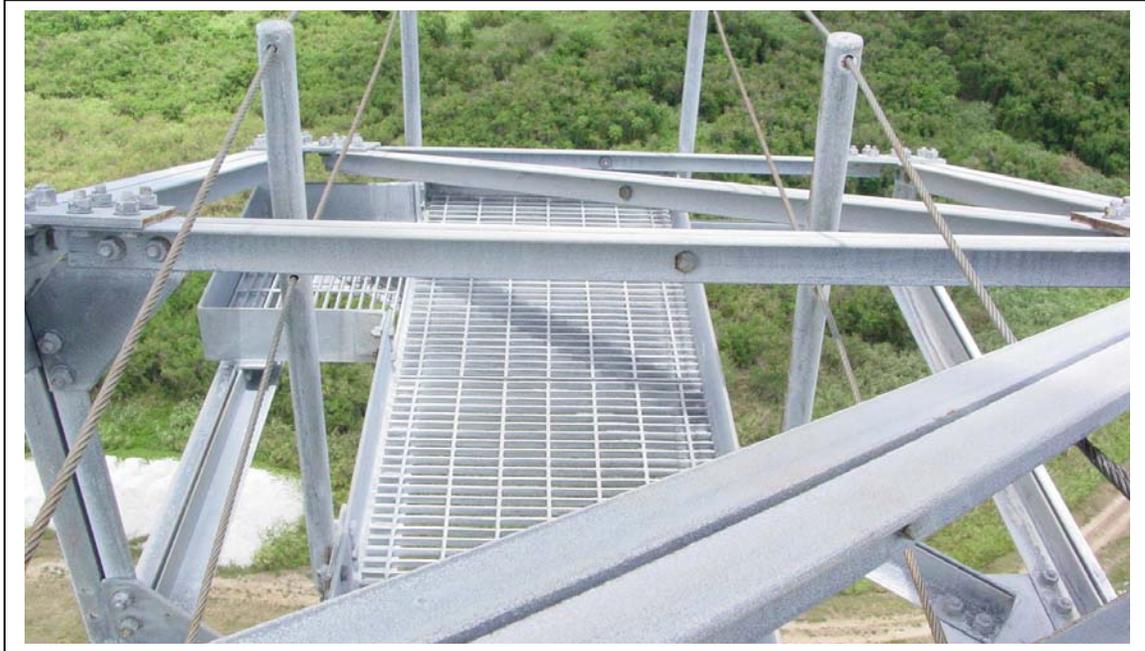
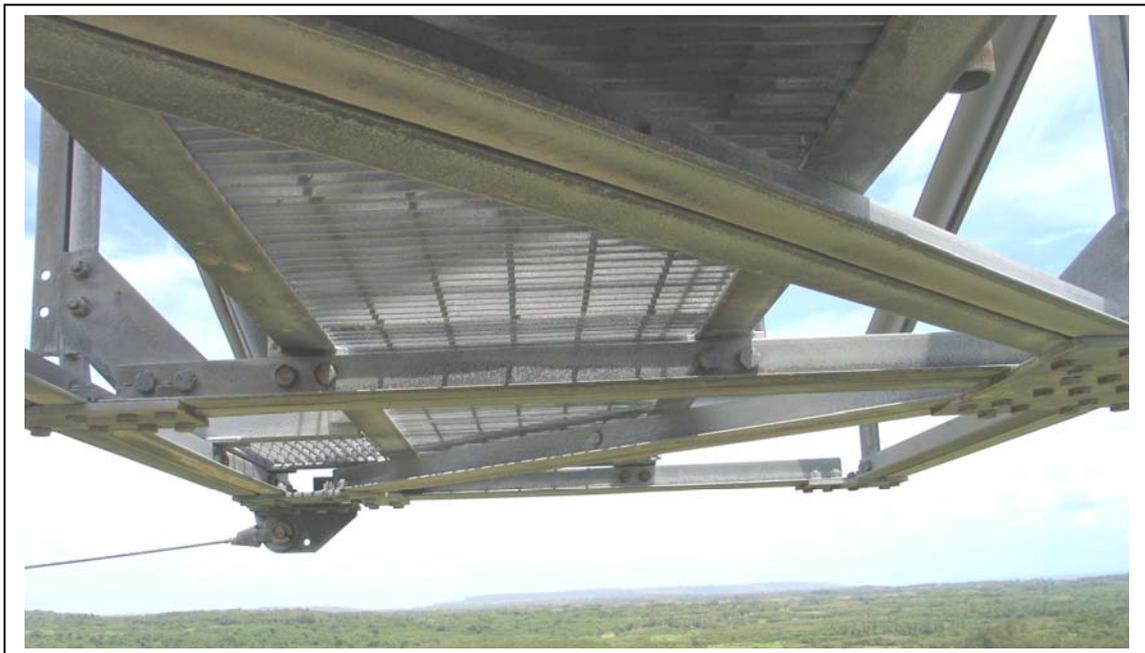
Photo Nos. T2.6 and T2.7 show the condition of the lower level outrigger at the 228-ft elevation.

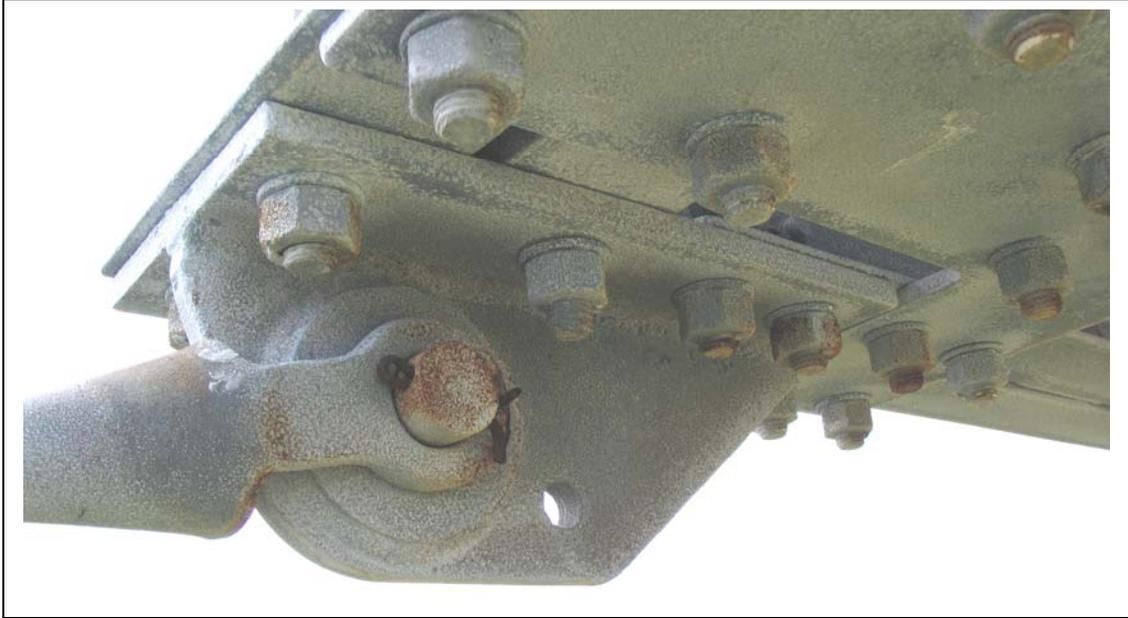
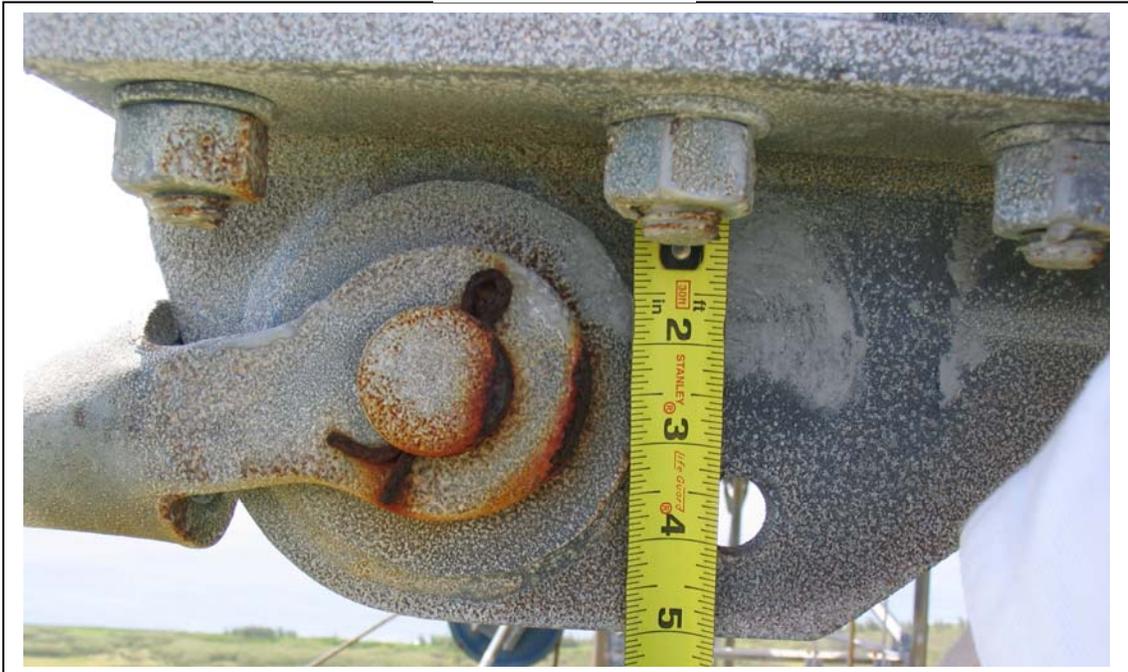
Photo No.T2.8 is a view of the catenary connection plate at the northwest side of the top level outrigger. Photo No.T2.9 is a view of the catenary connection plate at the southeast side of the top level outrigger. Note the rusted condition of the cotter pins.

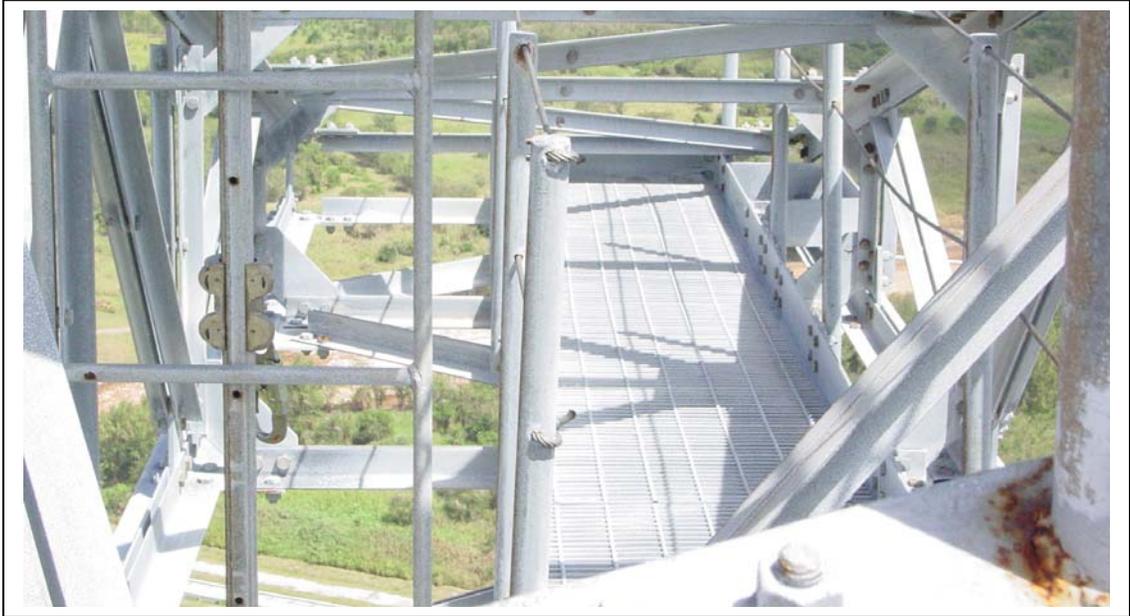
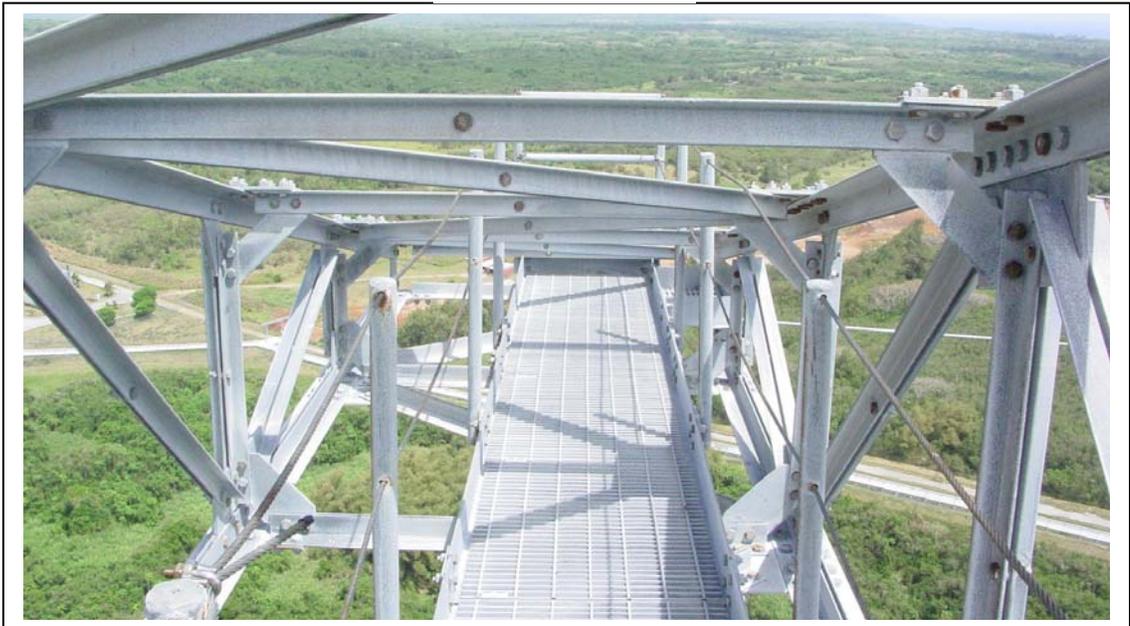
Photo Nos. T2.12 and T2.13 show the condition of the top level outrigger at the 422-ft elevation.

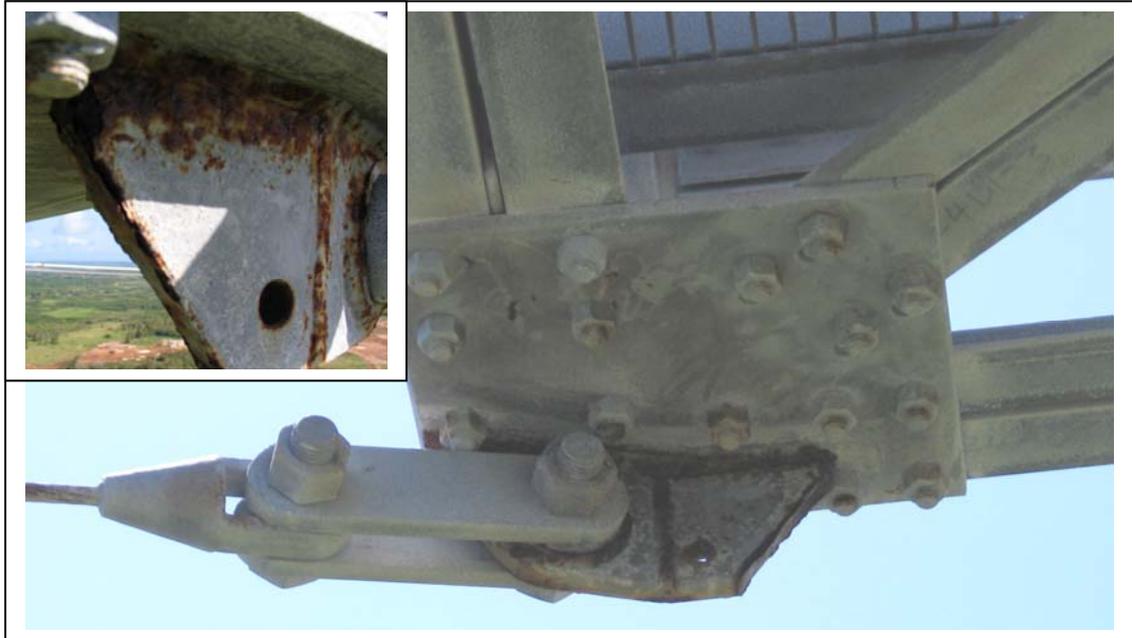
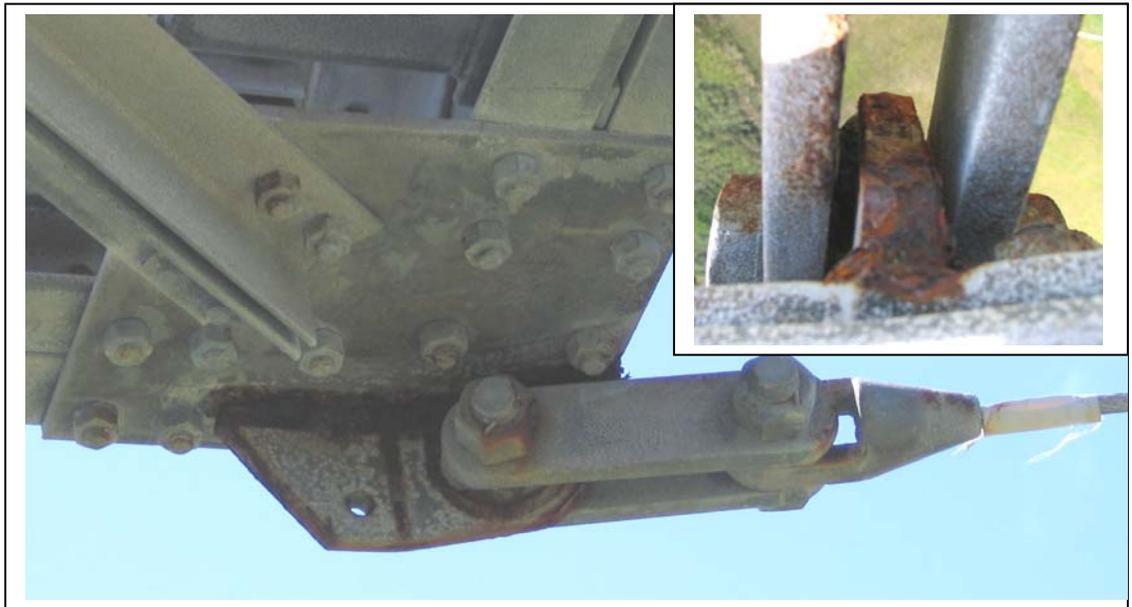
Photo Nos.T3.2 and T3.3 show two catenary connection plates at the northwest side of the outrigger. Note the rusted condition of the plates.

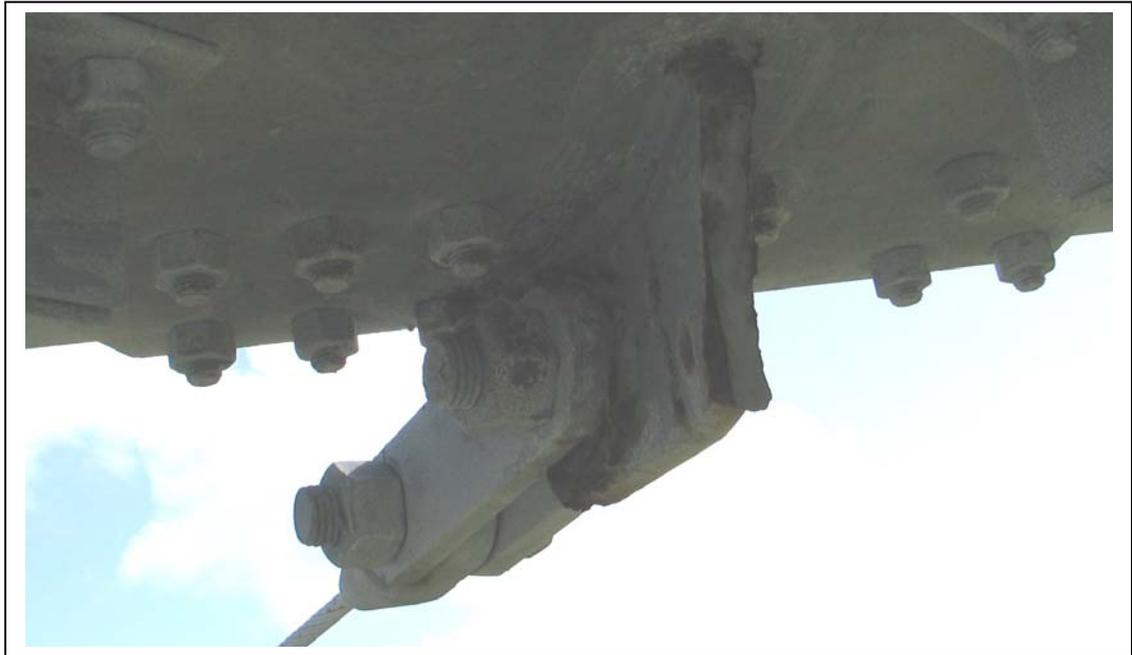
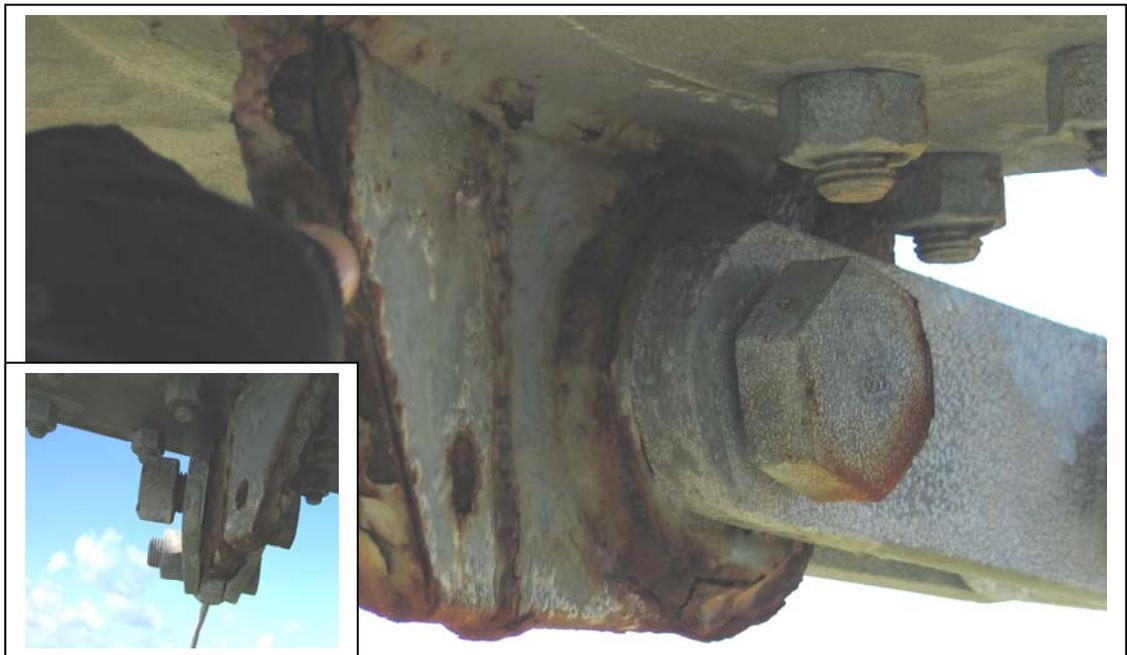
Photo Nos.T3.6 and T3.7 show two catenary connection plates at the middle of the outrigger. Note the rusted condition of the plates and the loose bolt on one of the plates.

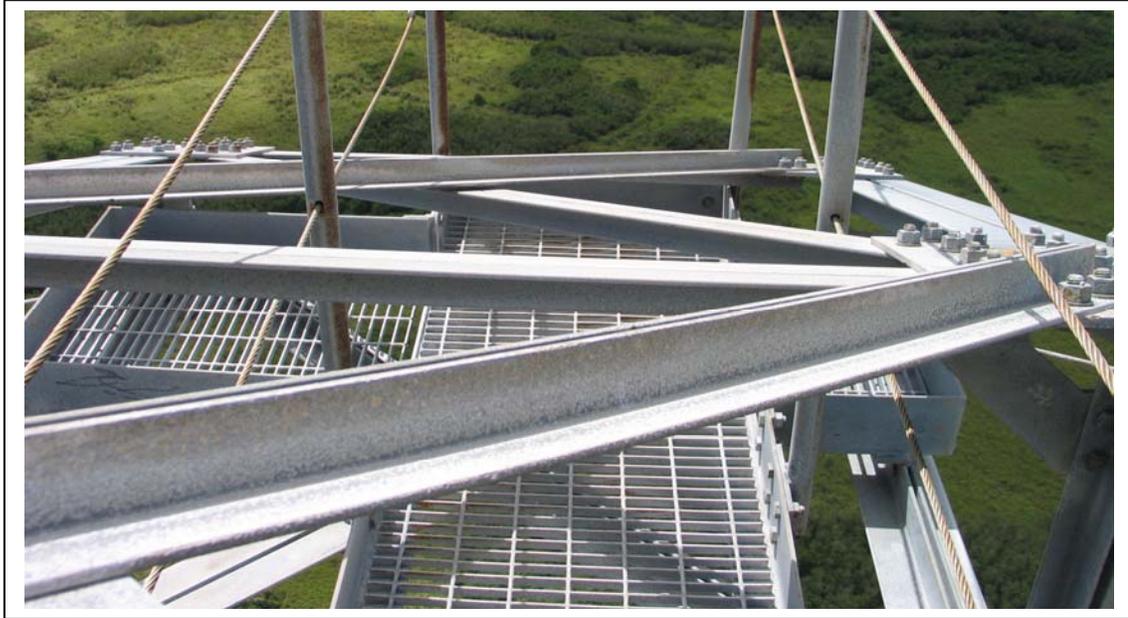
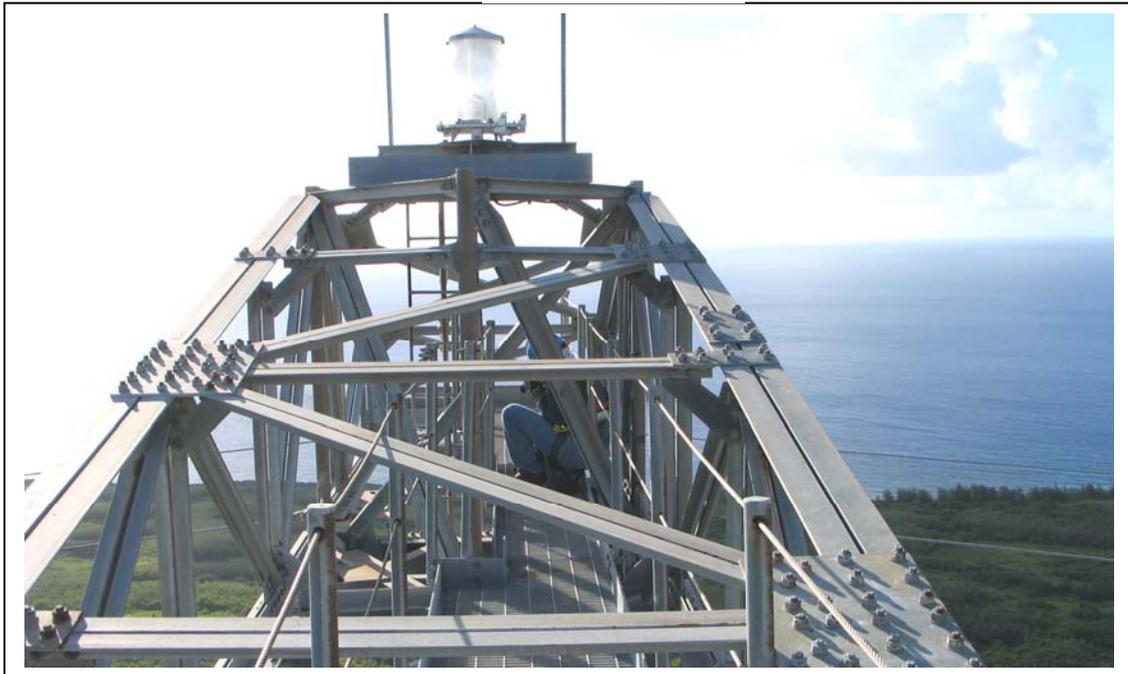
Photo Nos. T3.8 and T3.9 show the condition of the outrigger at the 422-ft elevation.

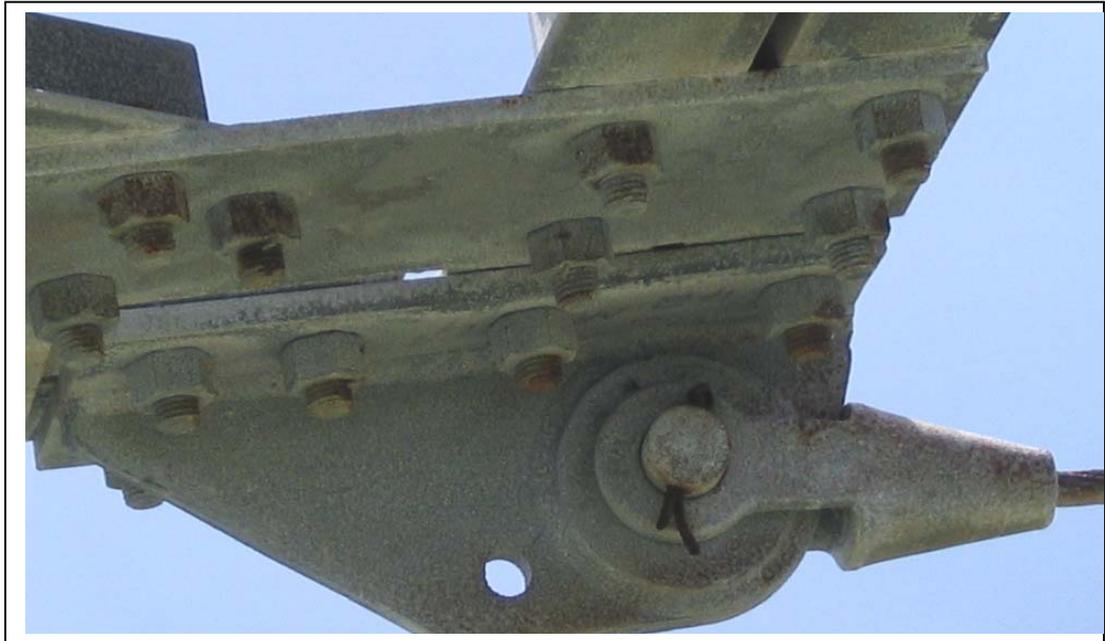
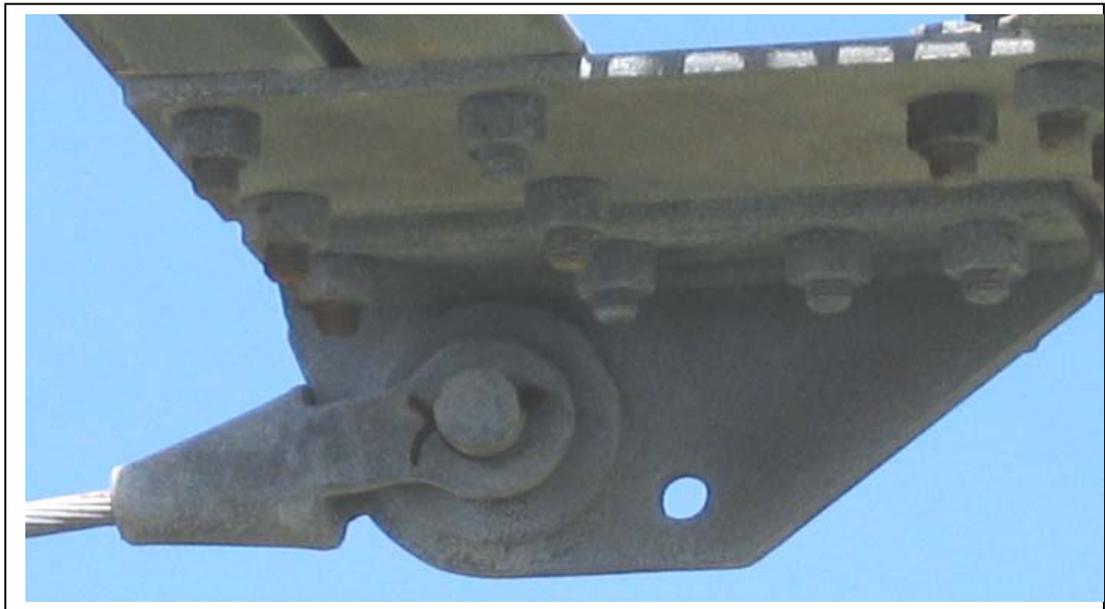
Photo No.T4.8 is a view of the catenary connection plate at the northwest side of the top level outrigger. Photo No.T4.9 is a view of the catenary connection plate at the southeast side of the top level outrigger. Note the rusted condition of the cotter pins.
