2004 BRIDGE INSPECTION

APALACHICOLA NATIONAL FOREST
BRIDGE NO. 115-02.3
RIVER STYX BRANCH

2004 USFS BRIDGE INSPECTION
APALACHICOLA NATIONAL FOREST

BRIDGE NO. 115-02.3
RIVER STYX BRANCH

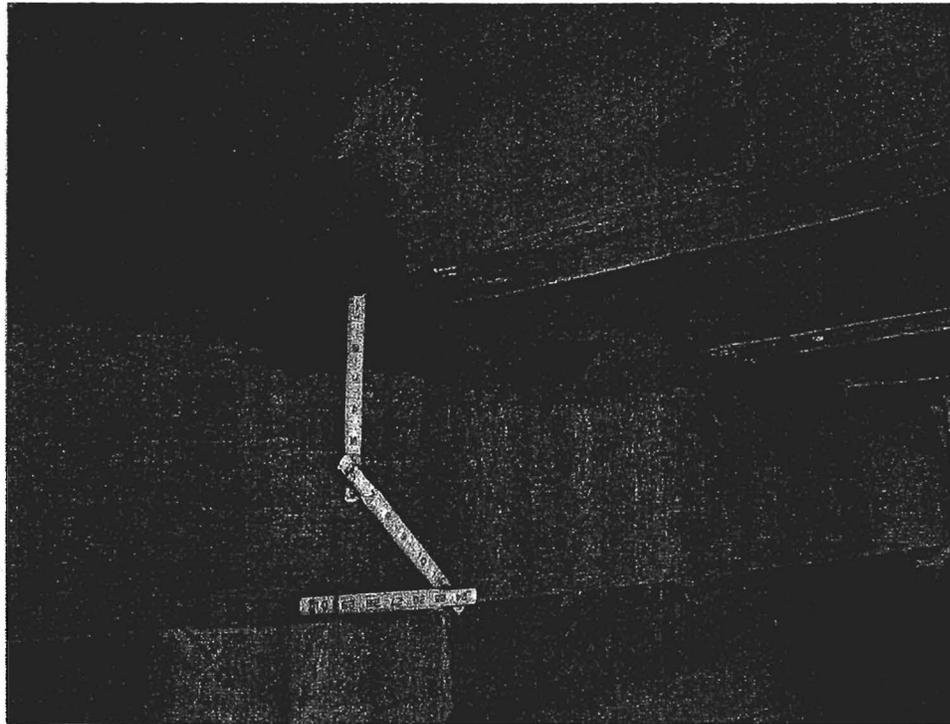
1. The deck running boards are soft at random locations with ½" pick penetrations.
2. Hardware is missing from the bridge rail in four locations.
3. The beams at the West Abutment typically have 1" deep decay in the bottom half at the bearing area (see Photo 7). Typical pick penetrations into the beams at Bents 1 and 2 are ½" to ¾". Beams 3, 4 and 6 are decayed at the East Abutment bearing area (see Photo 8).

7. The West Abutment Cap is decayed up to 2½" high x 4½" deep at the top below Beams 2 through 8 (see Photo 7).
8. Pile 3 at the West Abutment is decayed up to 2" deep for the full height and full circumference (see Photo 13). Pile 1 at the East Abutment has severe decay (see Photo 14). Piles 2 and 3 have areas of moderate decay at the waterline.

Photo 7 – Decay in the West Abutment Cap and Beam 5.

59.2- Isolated areas on the timber beams have heavy stains. The timber beams typically have longitudinal checks up to 1/16" wide. The beams at the West Abutment typically have 1" deep decay in the bottom half of the beam at the bearing area. Typical pick penetrations into the beams at Bents 1 and 2 are 1/2" to 3/4". Beams 3, 4 and 6 are decayed at the East Abutment bearing area.

60.4- The West Abutment Timber Cap is decayed up to 2 1/2" high x 4 1/2" deep at the top below Beams 2 through 8. There is moderate debris on the caps between the beams.

1. Replace the bridge.

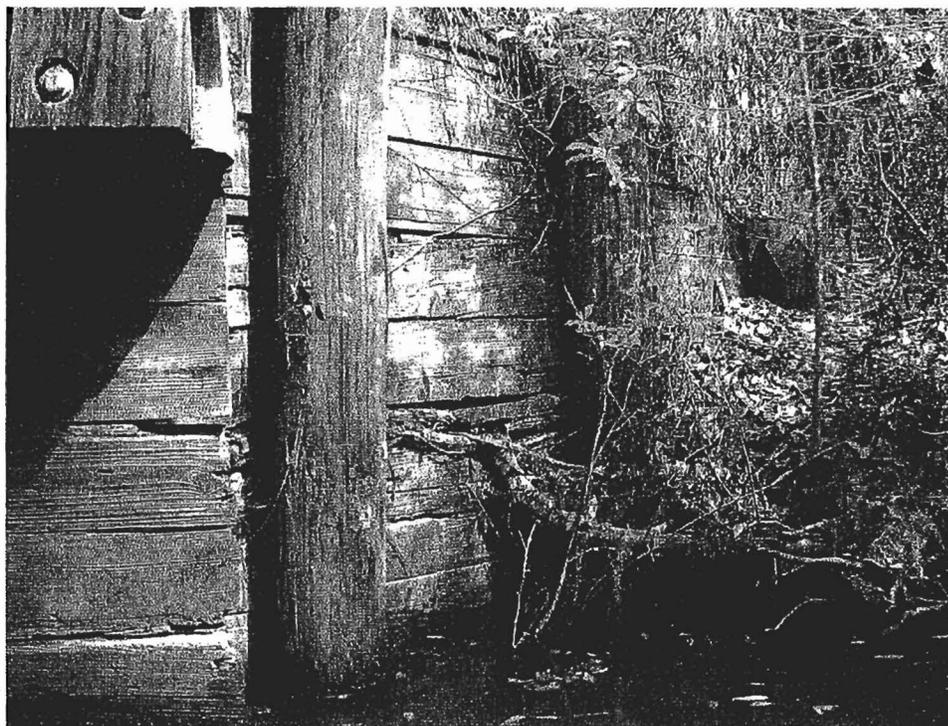
4. The sheeting at each wingwall has numerous areas of severe decay with full depth pick penetrations and loss of fill (see Photos 9 and 10).
5. The inner pile at the Southwest Wingwall has a heavy termite infestation that has destroyed the pile (see Photo 11).

Photo 9 – Decayed Sheeting in the Southeast Wingwall.

60.2- The timber sheeting at each wingwall has numerous areas of severe decay with full depth pick penetrations and loss of fill. The second pile from the bridge on the Northwest Wingwall has severe rot on the bottom half up to 1 1/2" deep. The inner timber pile at the Southwest Wingwall has heavy termite infestation that has destroyed the pile.

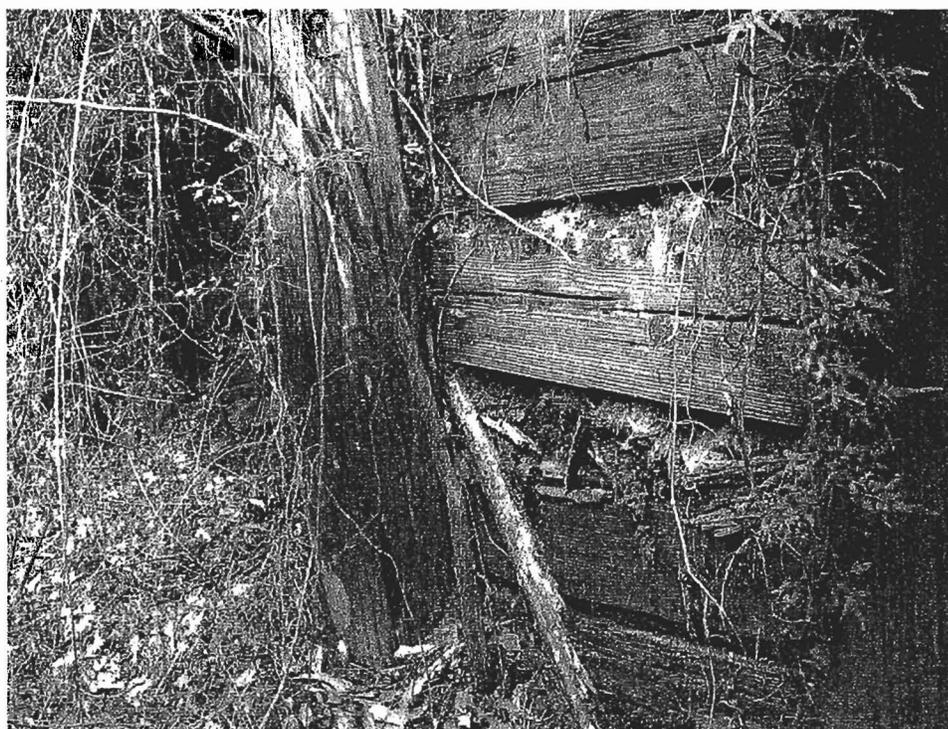
Photo 10 – Failed Sheeting in the Northeast Wingwall.

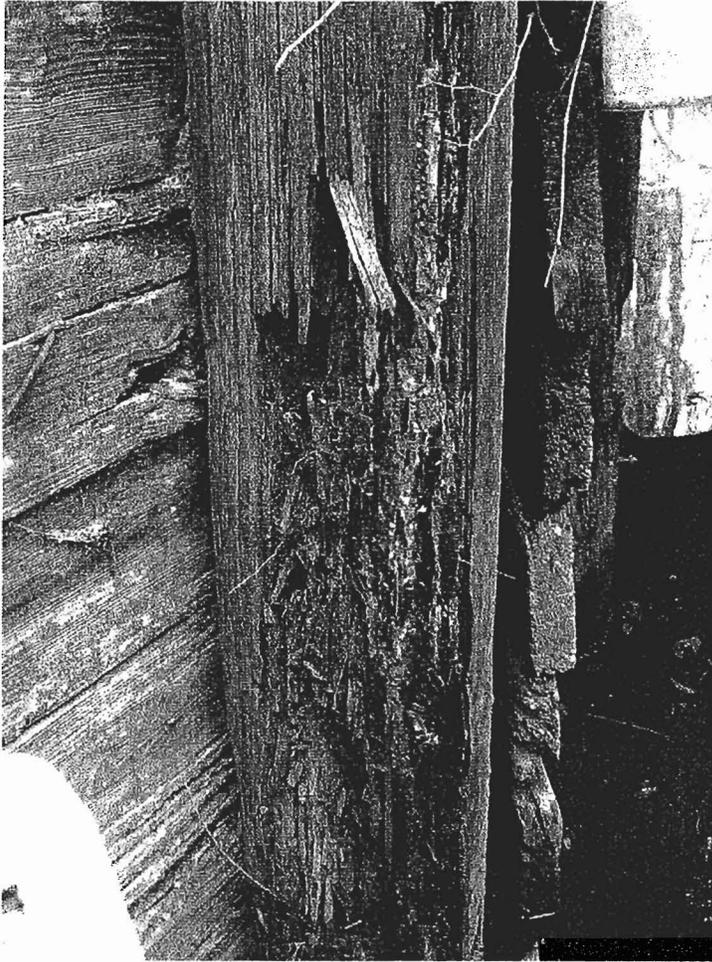
*Photo 11 (left) – Termite Infestation
of Inner Pile at the Southwest
Wingwall.*

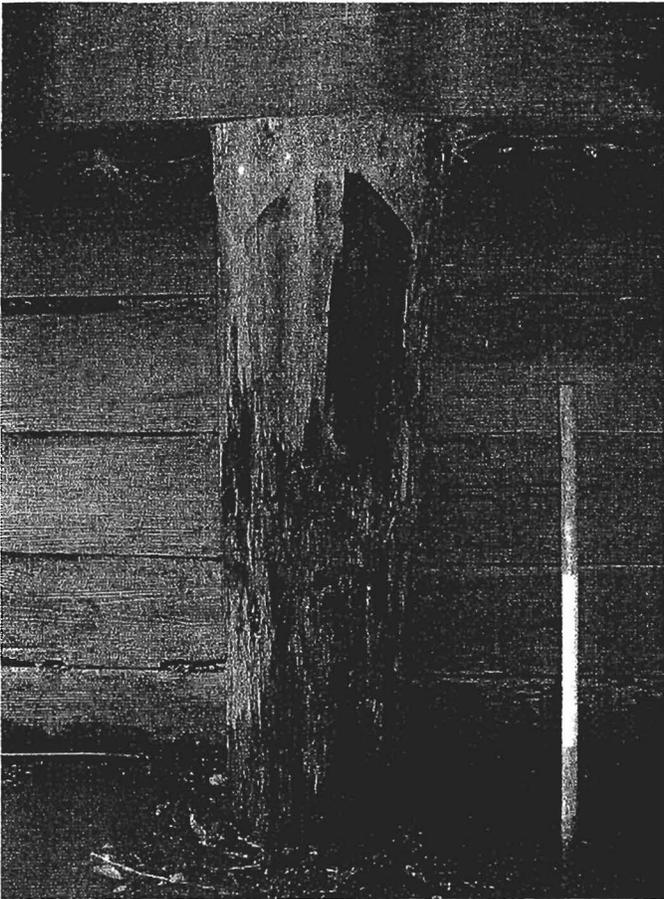
Photo 13 (left) – Decay in Pile 3 at the West Abutment.

60.7- Timber Pile 3 at the West Abutment is decayed up to 2" deep for the full height and full circumference. Pile 1 at the East Abutment has severe decay. Piles 2 and 3 have areas of moderate decay at the waterline.

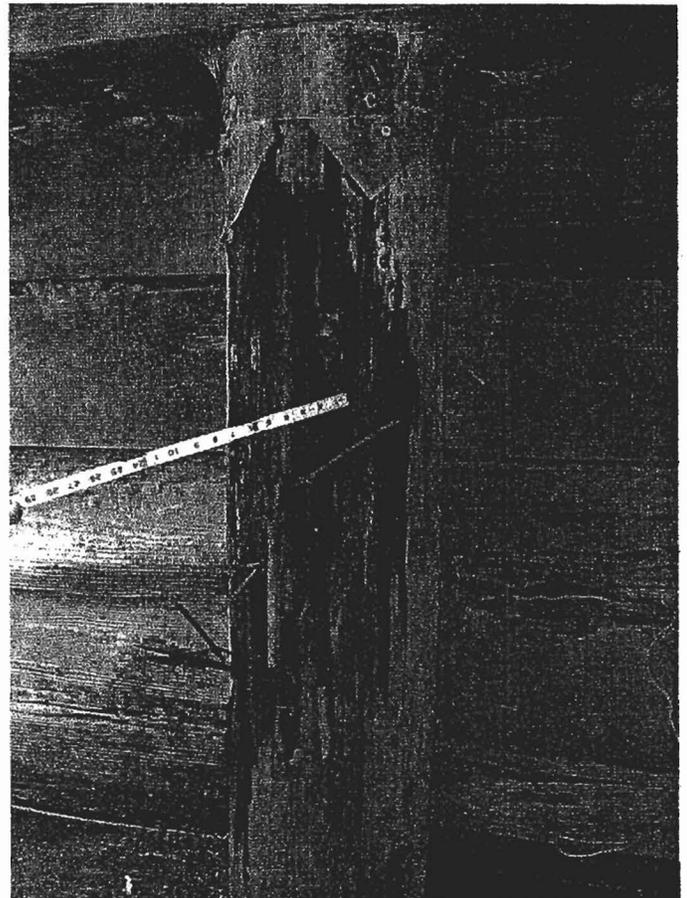
Photo 14 (right) – Decay in Pile 1 at the East Abutment.

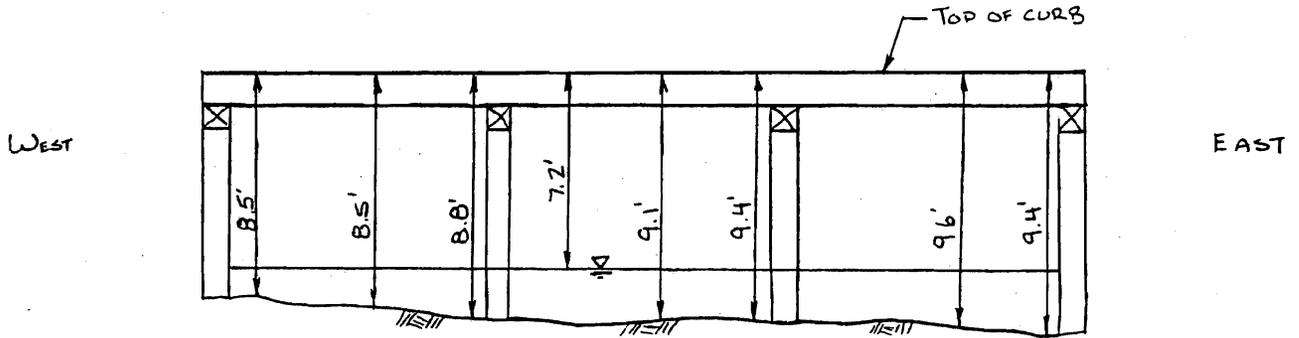
UPSTREAM PROFILE

61.3 & 61.4- Heavy vegetation and debris (tree stumps) in channel.
