**SOILS AND FOUNDATION  
REPORT NO. 06-07**

**PROJECT BLRI 2E15  
LANDSLIDE REPAIR, MP 270.3**

**BLUE RIDGE PARKWAY  
WILKES COUNTY, NORTH CAROLINA**

**February 2008**

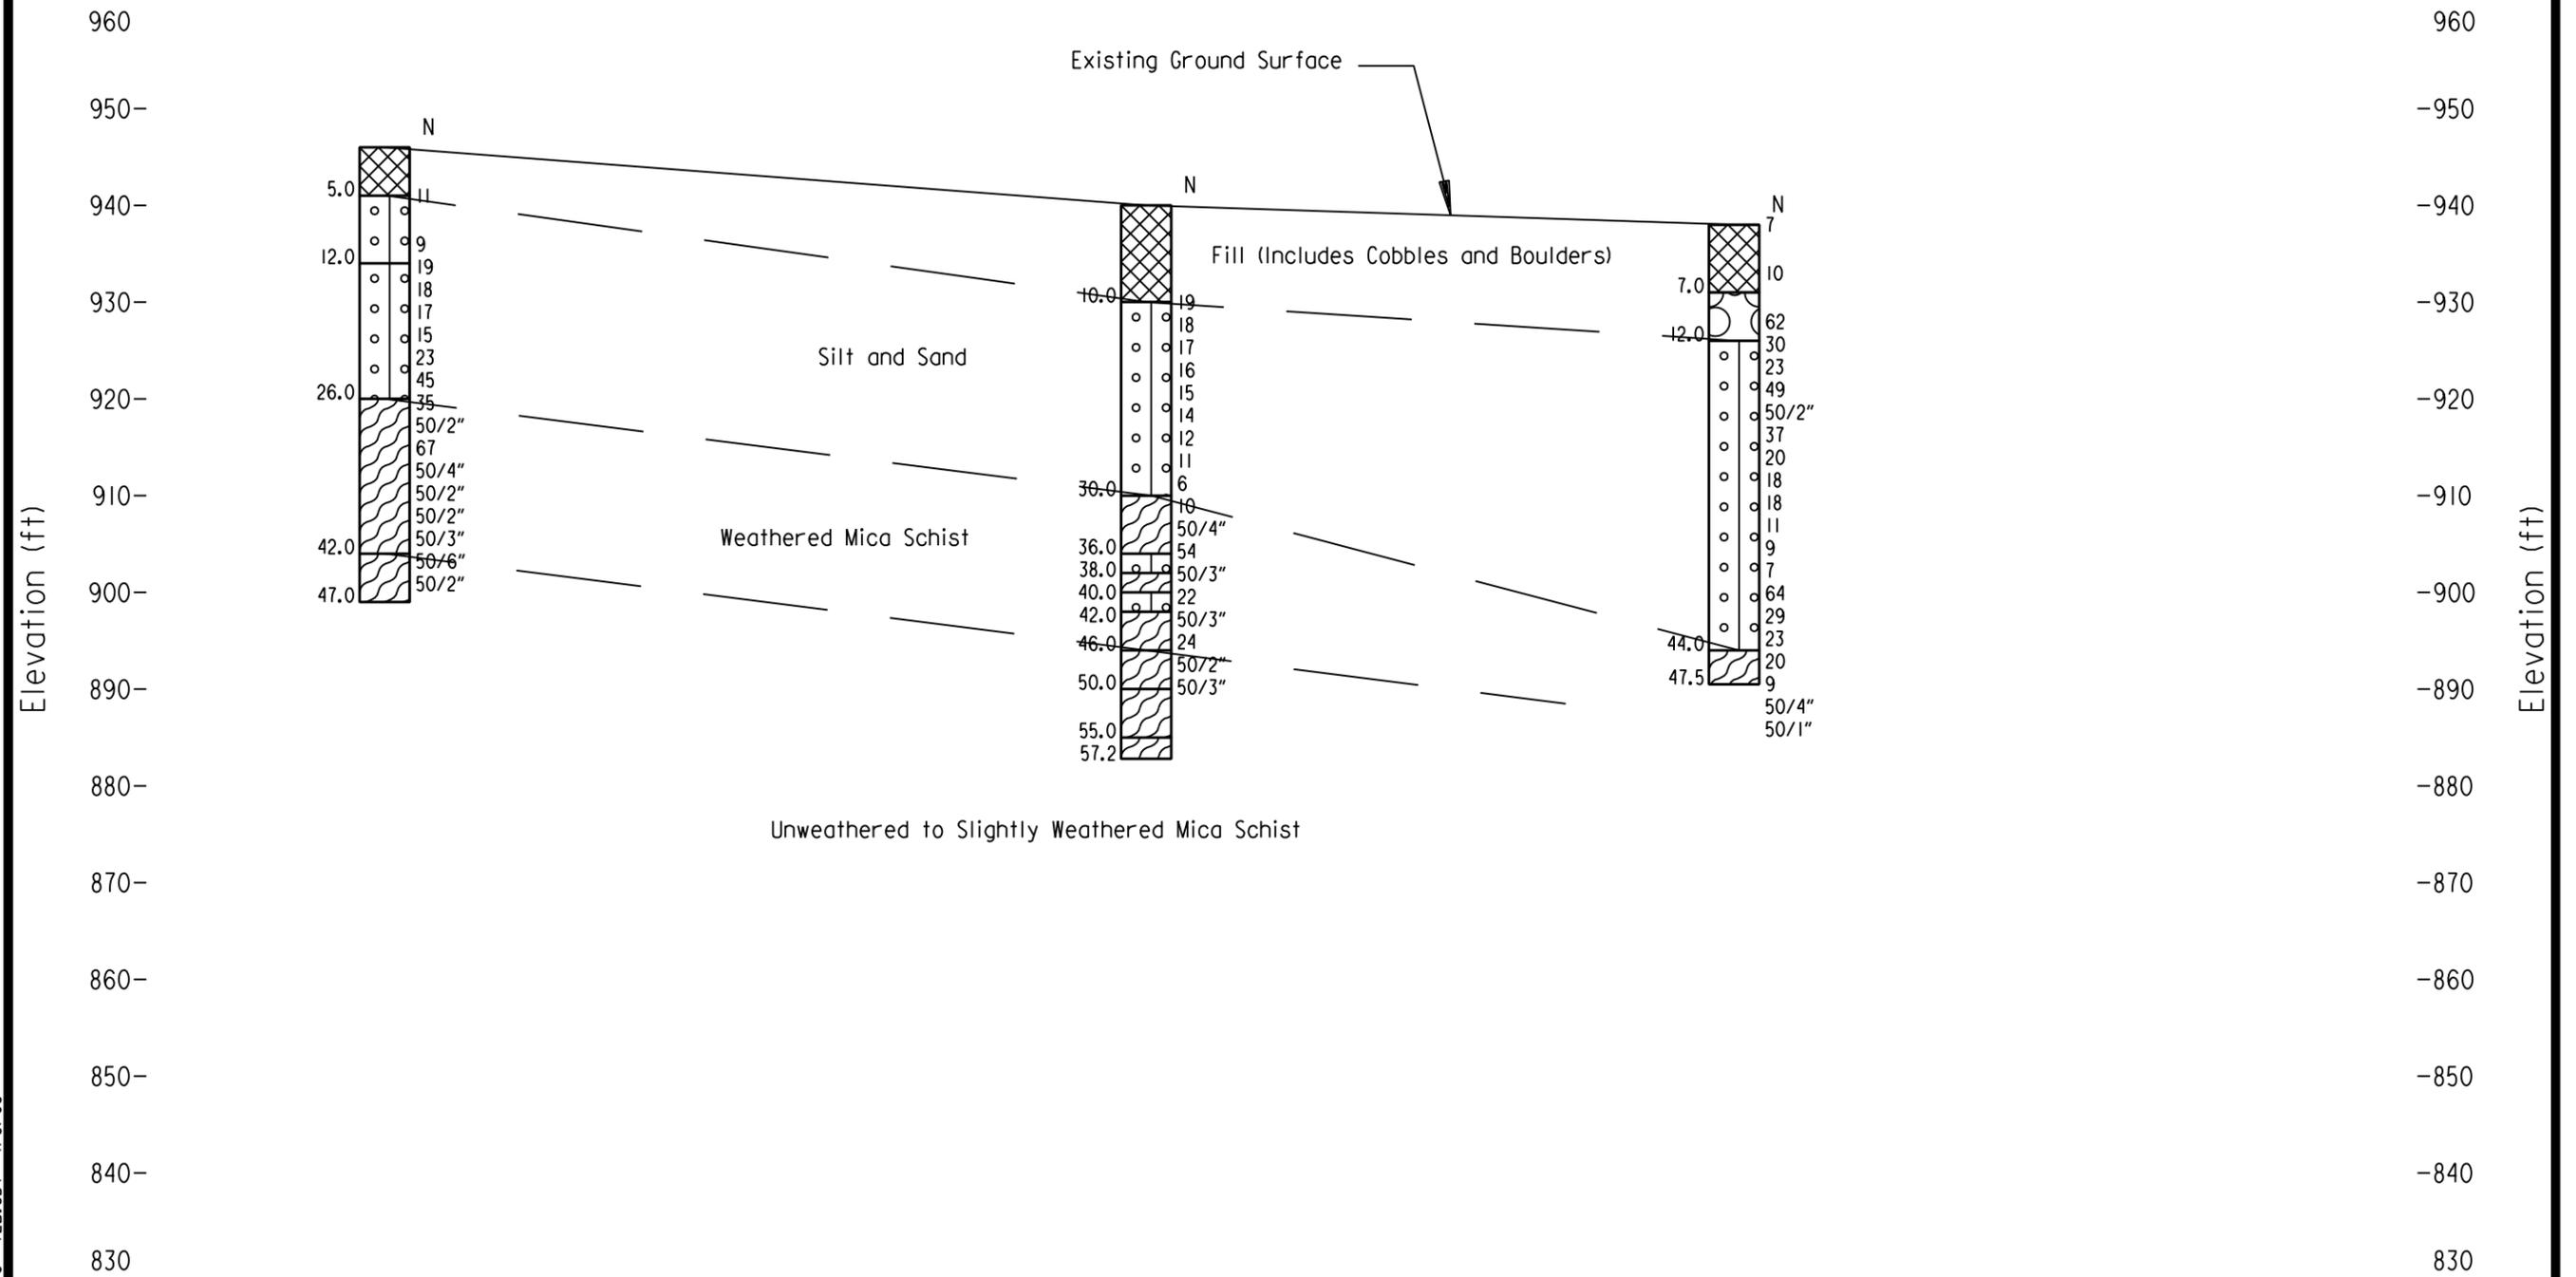
Note: Strata changes shown on this profile represent generalizations based on average conditions indicated by soil test borings.

Descriptions of the soil conditions encountered during the subsurface explorations conducted at the site are provided below in order of increasing depth below the ground surface. The stratification lines designating the interfaces between soil types on the boring logs in Appendix C represent approximate boundaries. The transition between materials

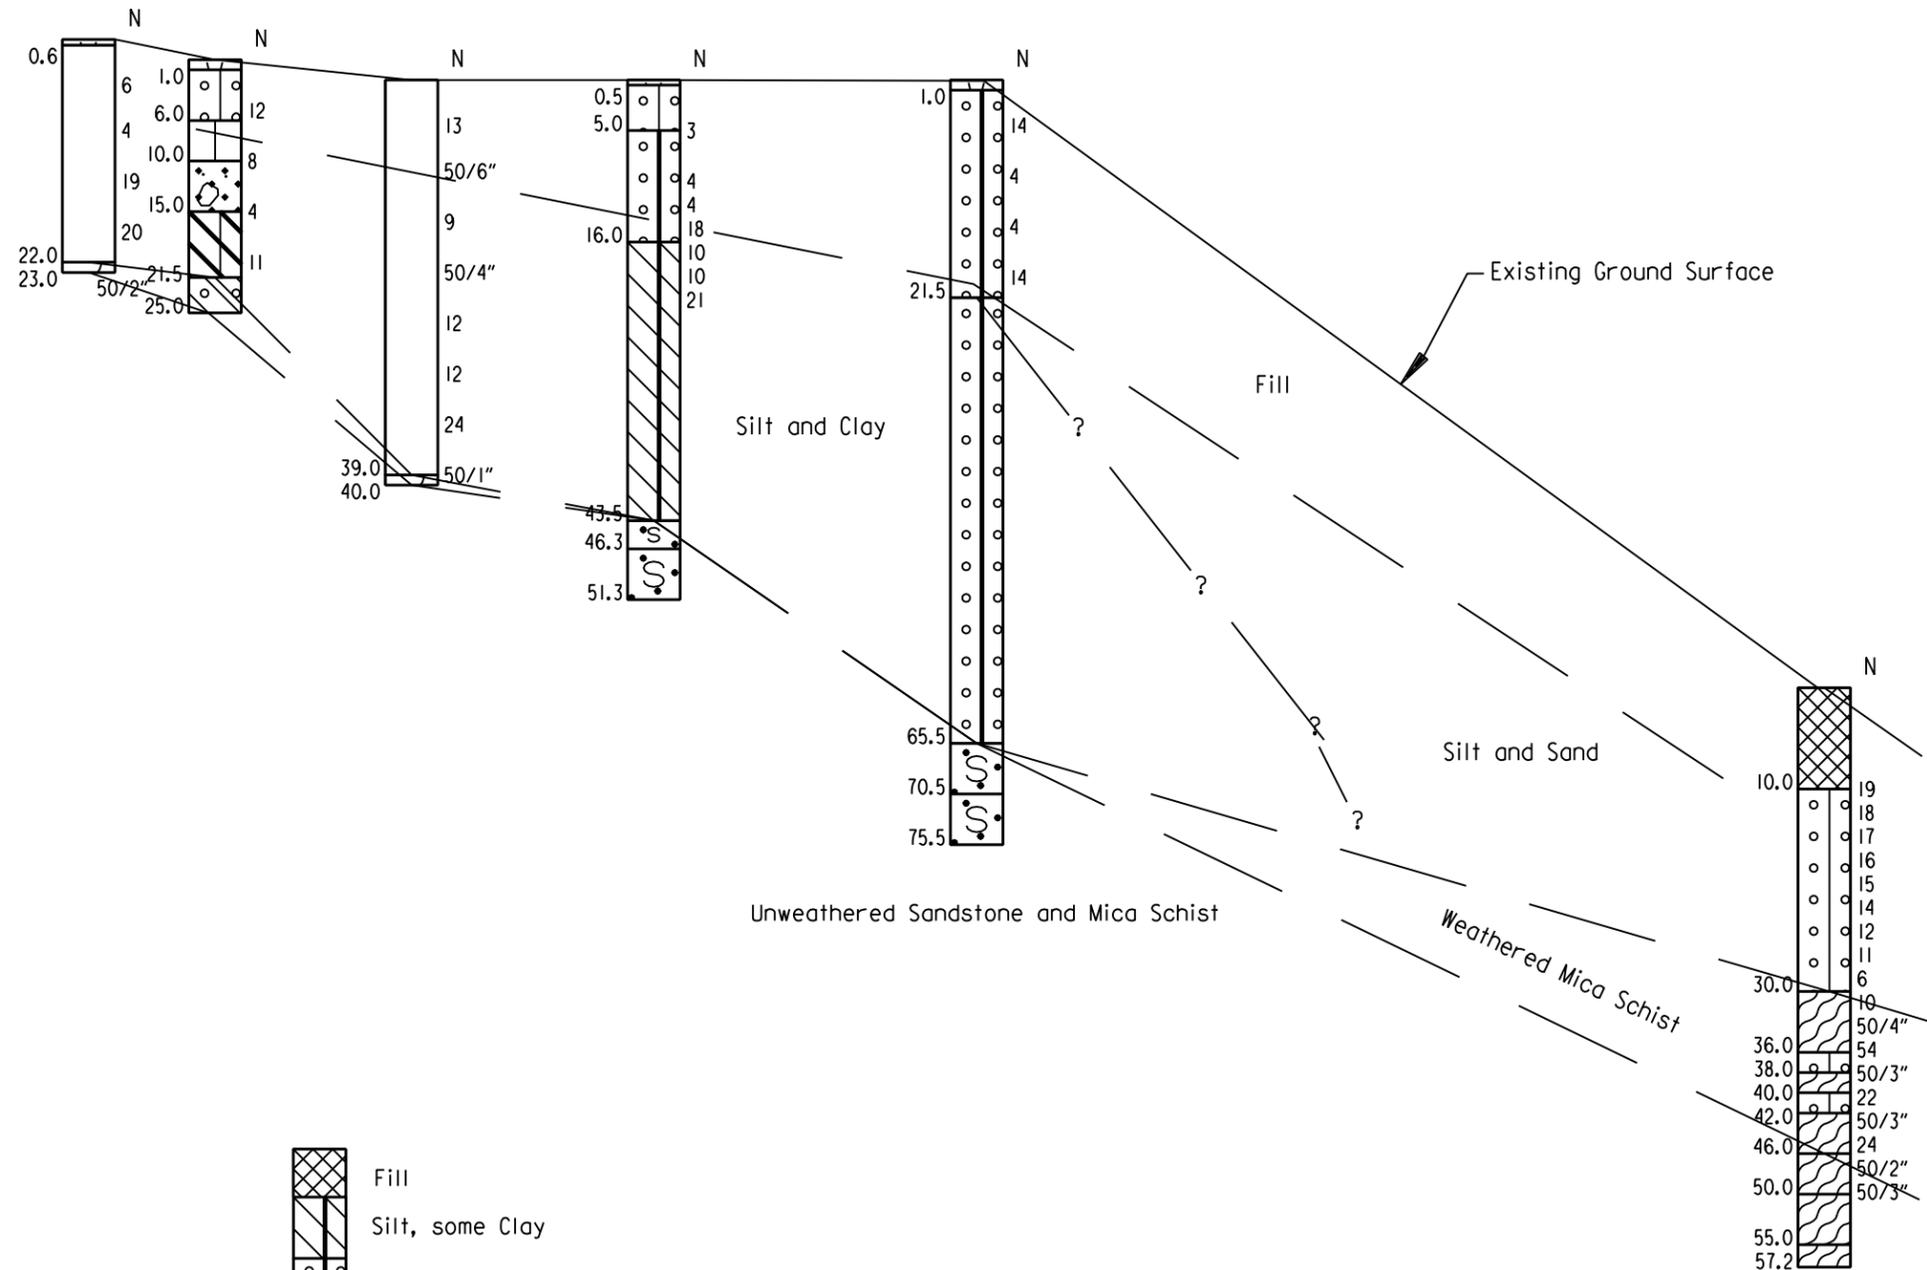
GENERALIZED SUBSURFACE PROFILE		
Scale: 1H = 1V	Date: 1/8/08	Drawn By: BL
PRA-BLRI 2E15, Blue Ridge Parkway MP 270.3, Deep Gap, NC		
Downslope Profile		Drawing No: 1 of 2

Note: Strata changes shown on this profile represent generalizations based on average conditions indicated by soil test borings.

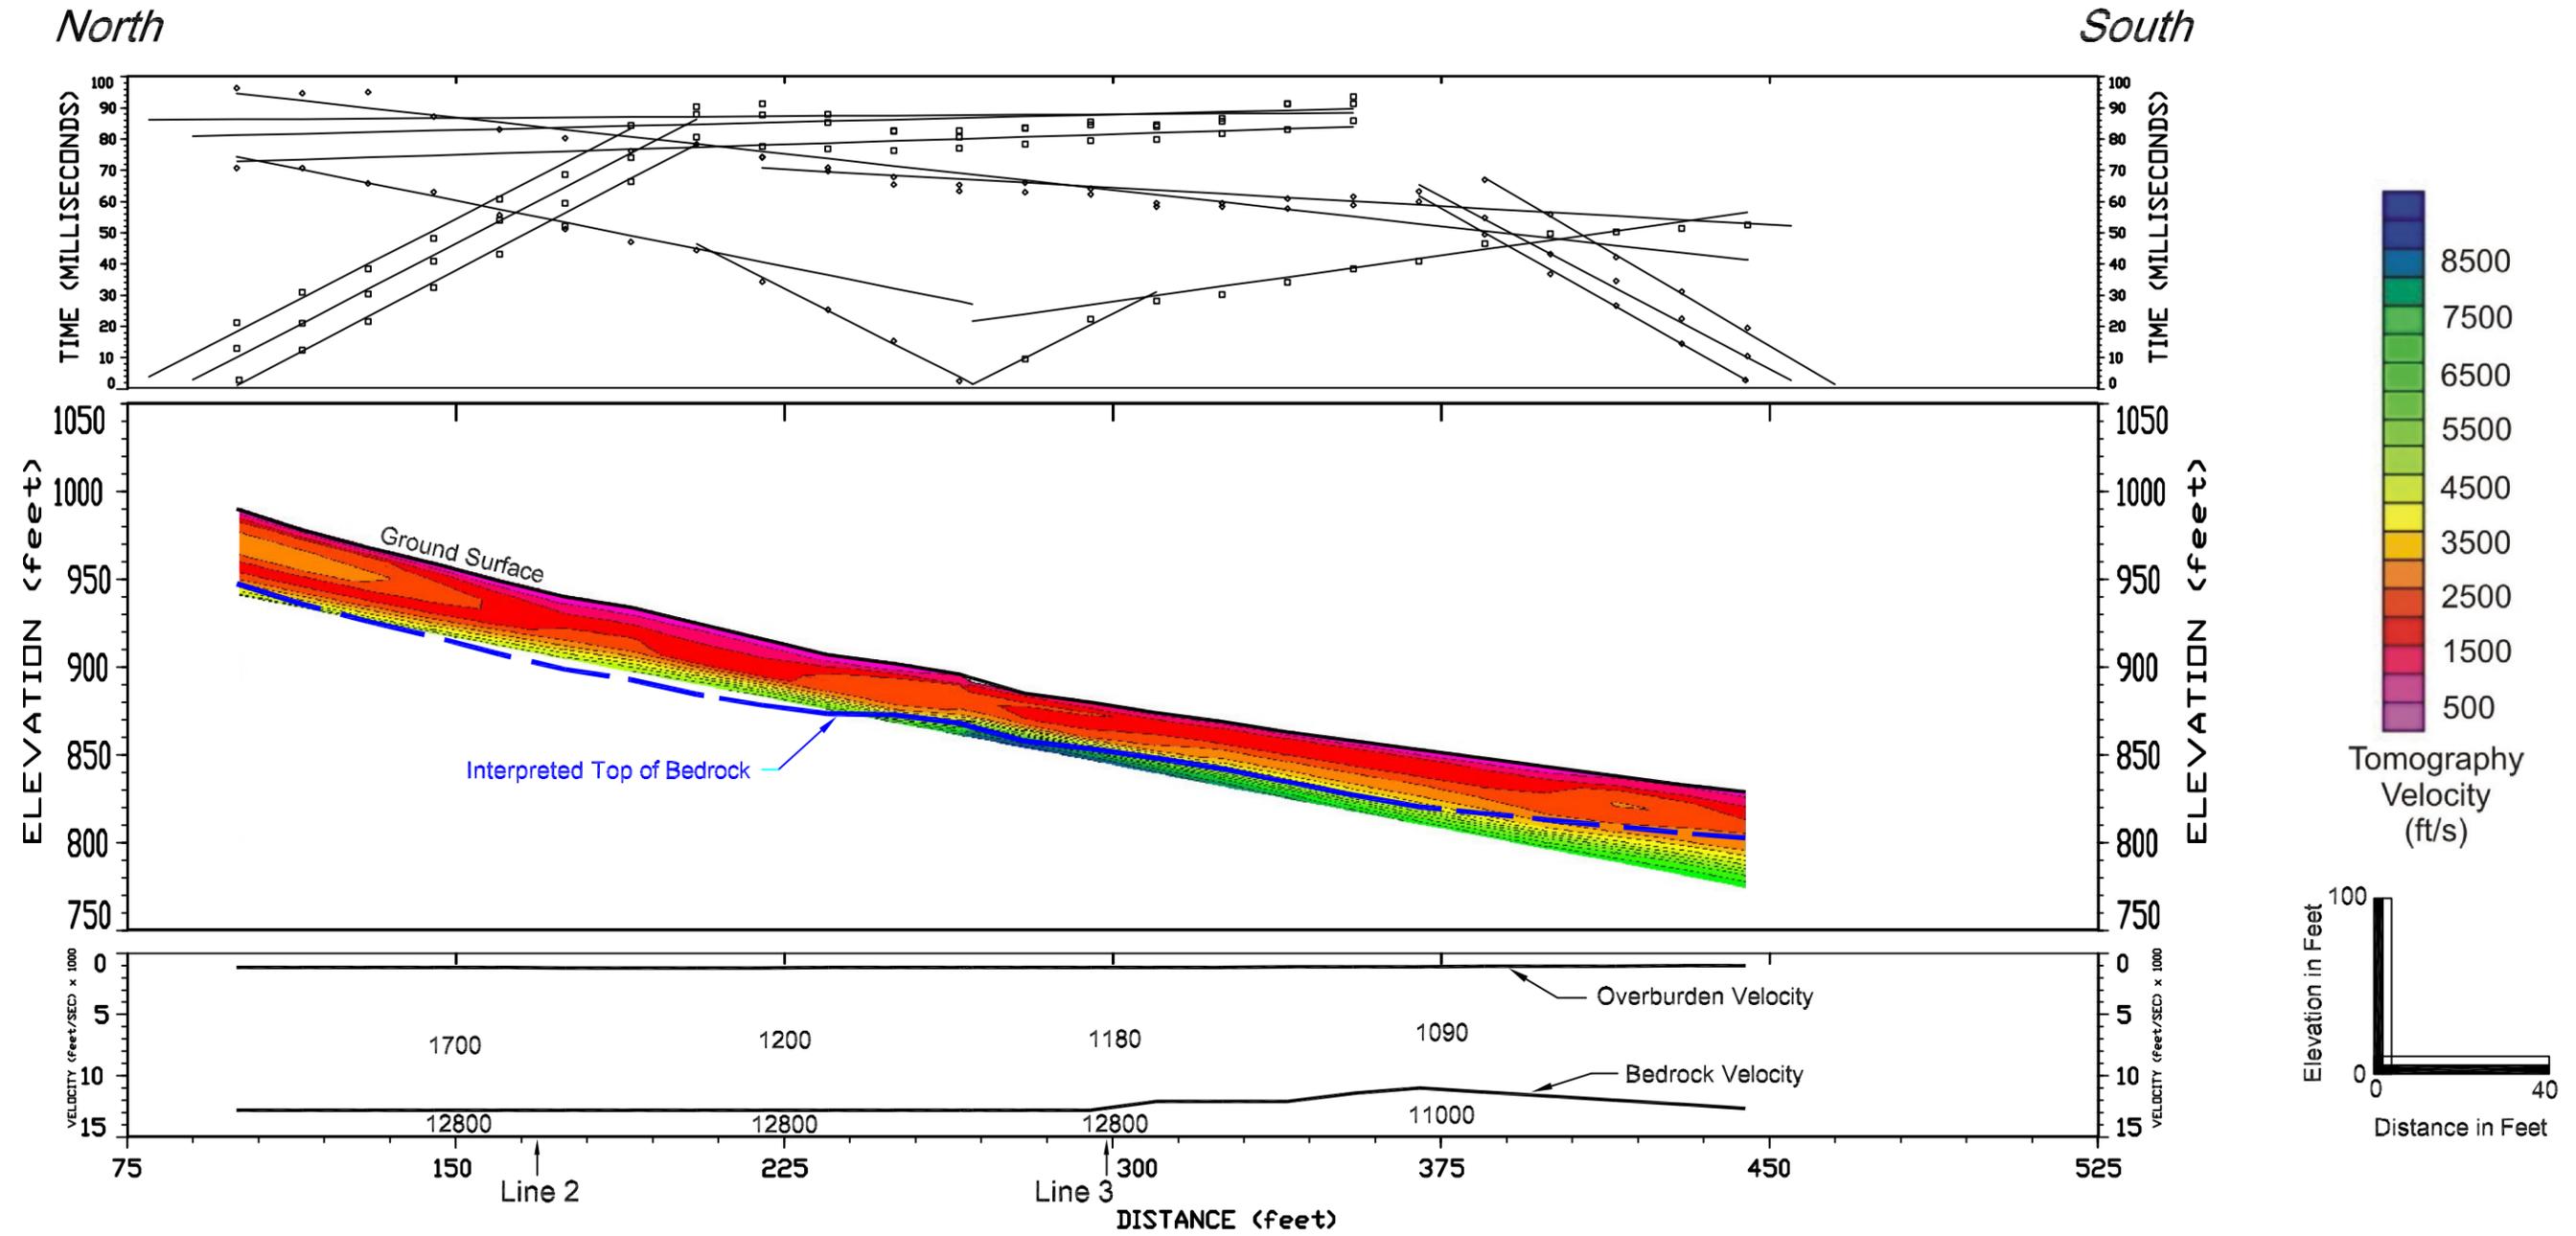
Figure:  
1

NOTE:  
Dashed Line = Greater Uncertainty  
Due to Limited Data Coverage

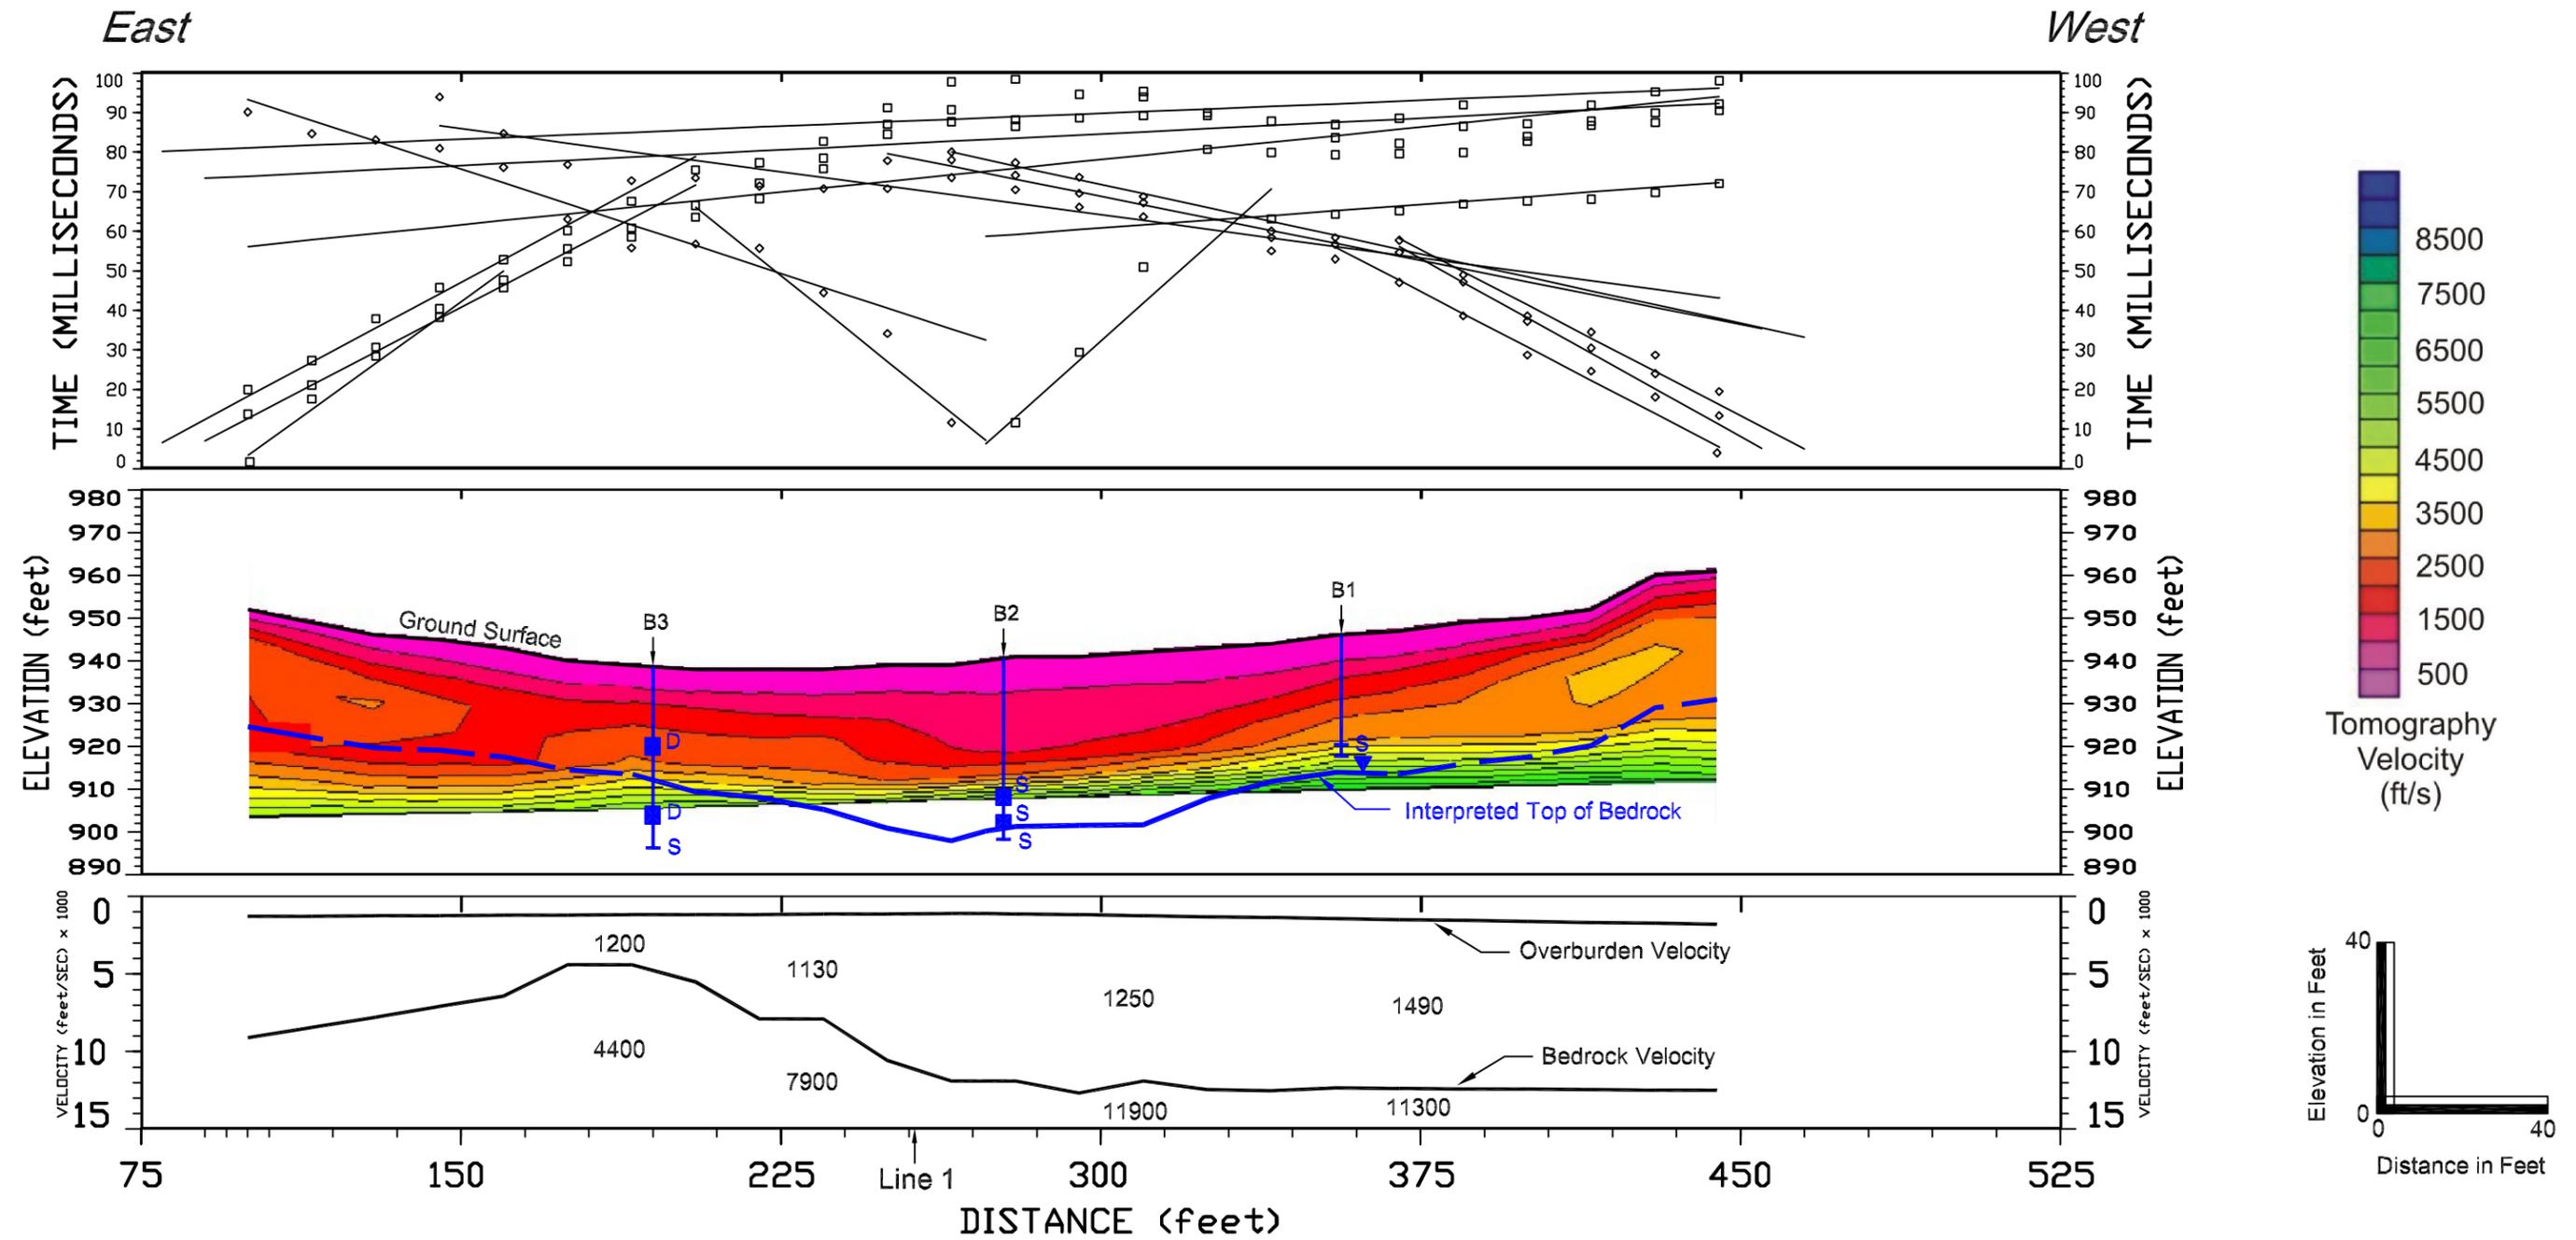
Project No: 5100	Date: October, 2007	Drawn By: HJV	Checked By: JP	Scale: H40' - V40'	Figure: 2
---------------------	------------------------	------------------	-------------------	-----------------------	--------------

NOTE:  
 Dashed Line = Greater Uncertainty  
 Due to Limited Data Coverage

Data from Borehole Logs  
 D = Dense Layer  
 S = Mica Schist

Line 2  
 Seismic Refraction GRM &  
 Tomography Survey  
 Deep Gap  
 North Carolina

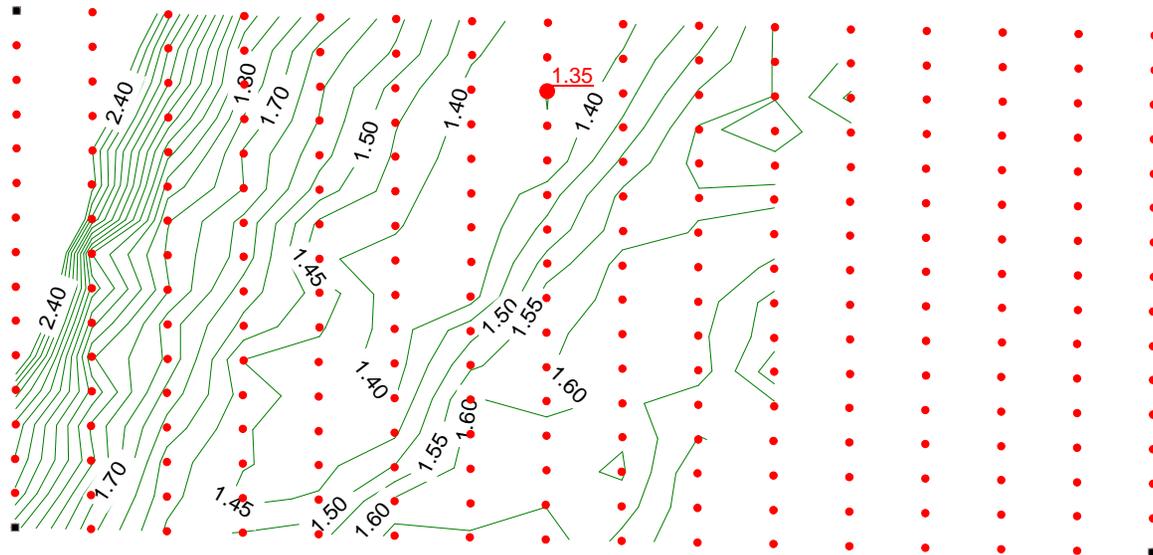
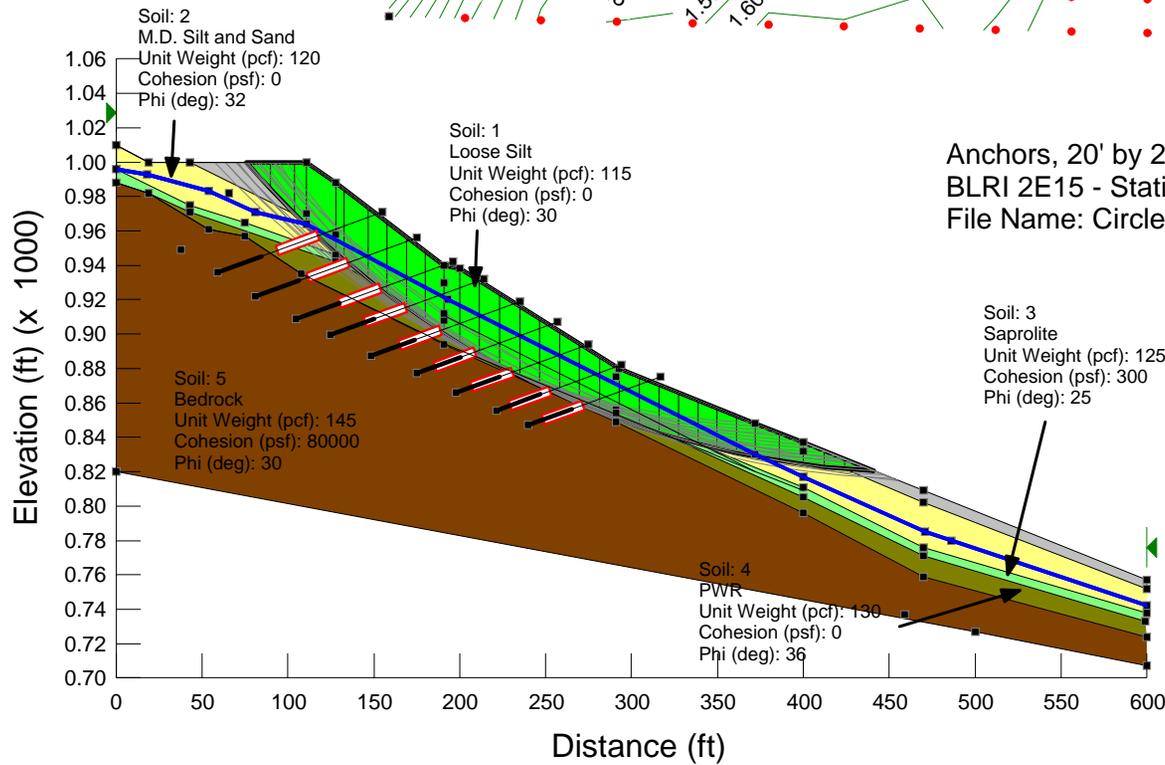
Anchors, 20' by 20' Spacing, Circular  
BLRI 2E15 - Station 3+20 (Approx CL Slide)  
File Name: Circle Anchor 20W\_20L.slz

Analyses results indicate that the ground anchors and concrete blocks will provide adequate stability of the slope. Refer to Appendix F for examples of landslide repair design calculations.

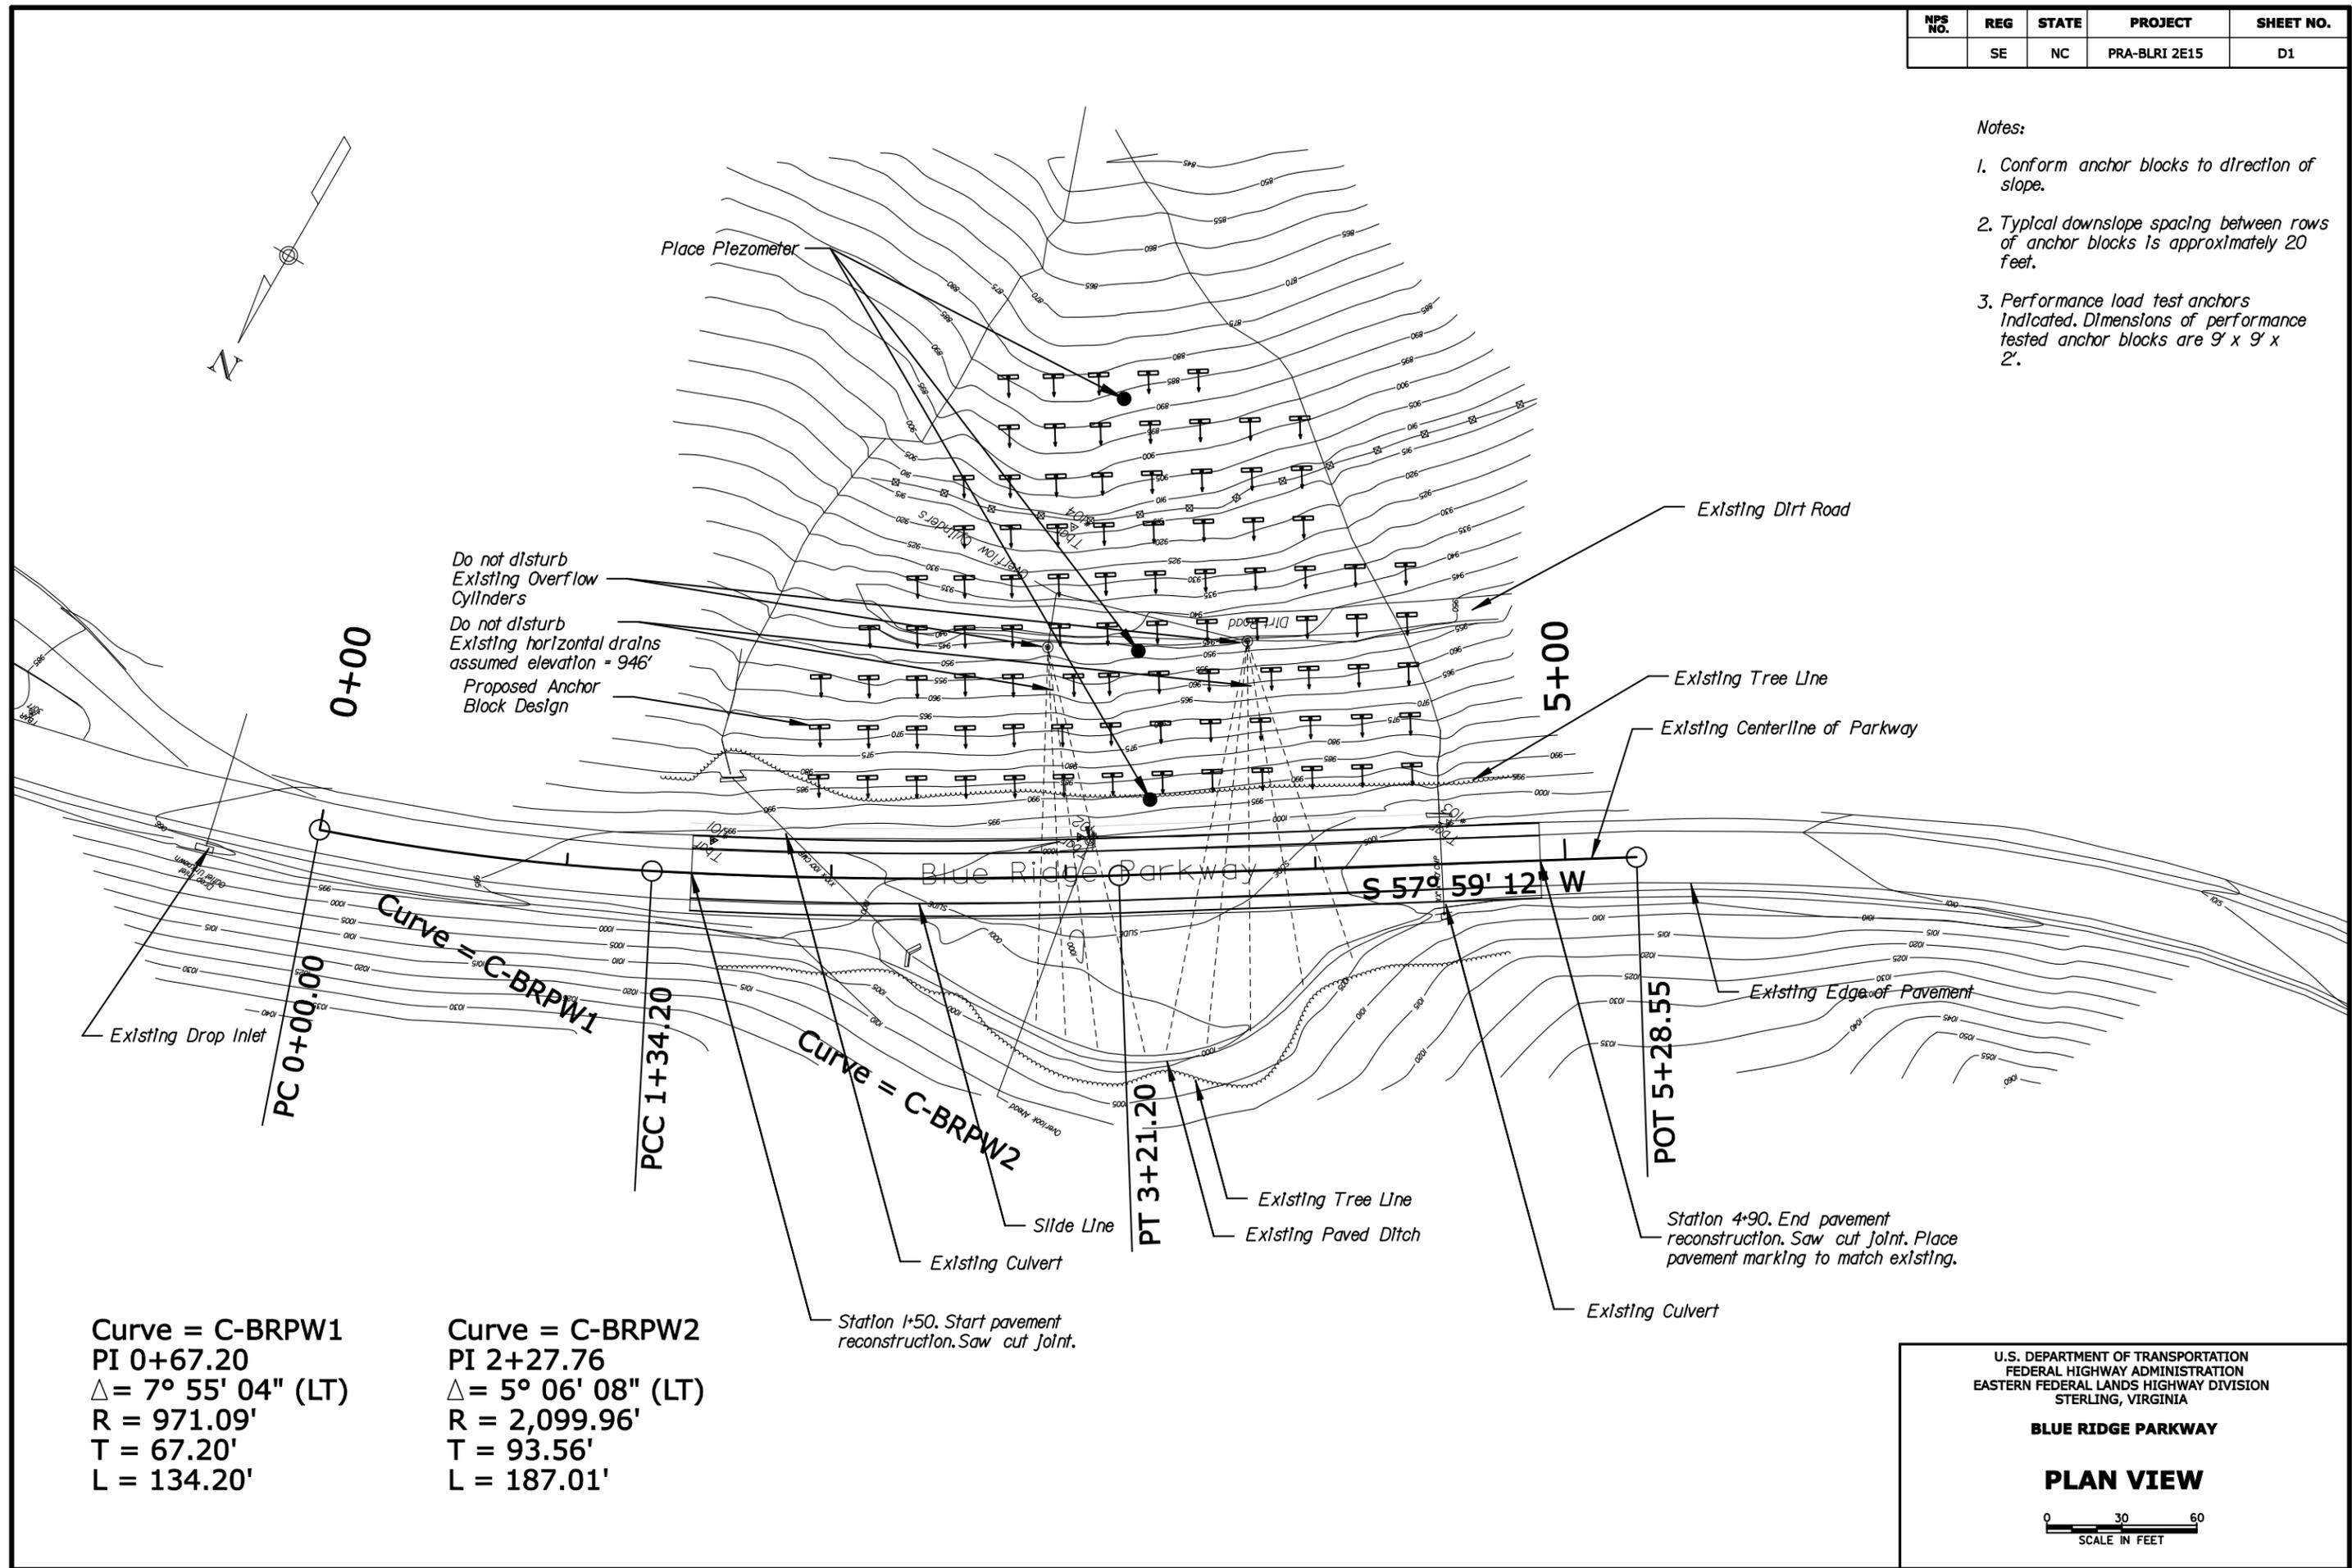
NPS NO.	REG	STATE	PROJECT	SHEET NO.
	SE	NC	PRA-BLRI 2E15	D1

1. Conform anchor blocks to direction of slope.
2. Typical downslope spacing between rows of anchor blocks is approximately 20 feet.
3. Performance load test anchors indicated. Dimensions of performance tested anchor blocks are 9' x 9' x 2'.

Curve = C-BRPW1  
 PI 0+67.20  
 $\Delta = 7^\circ 55' 04''$  (LT)  
 R = 971.09'  
 T = 67.20'  
 L = 134.20'

Curve = C-BRPW2  
 PI 2+27.76  
 $\Delta = 5^\circ 06' 08''$  (LT)  
 R = 2,099.96'  
 T = 93.56'  
 L = 187.01'

The proposed landslide repair consists of installing ground anchors with concrete blocks at a 20-foot by 20-foot grid pattern. Anchors were designed for 280 kips capacity with 9-foot by 9-foot concrete blocks. The design of landslide slope repair components is described as follows.
