**SAIPAN TRANSMITTING STATION  
PHOTOGRAPH LOG**

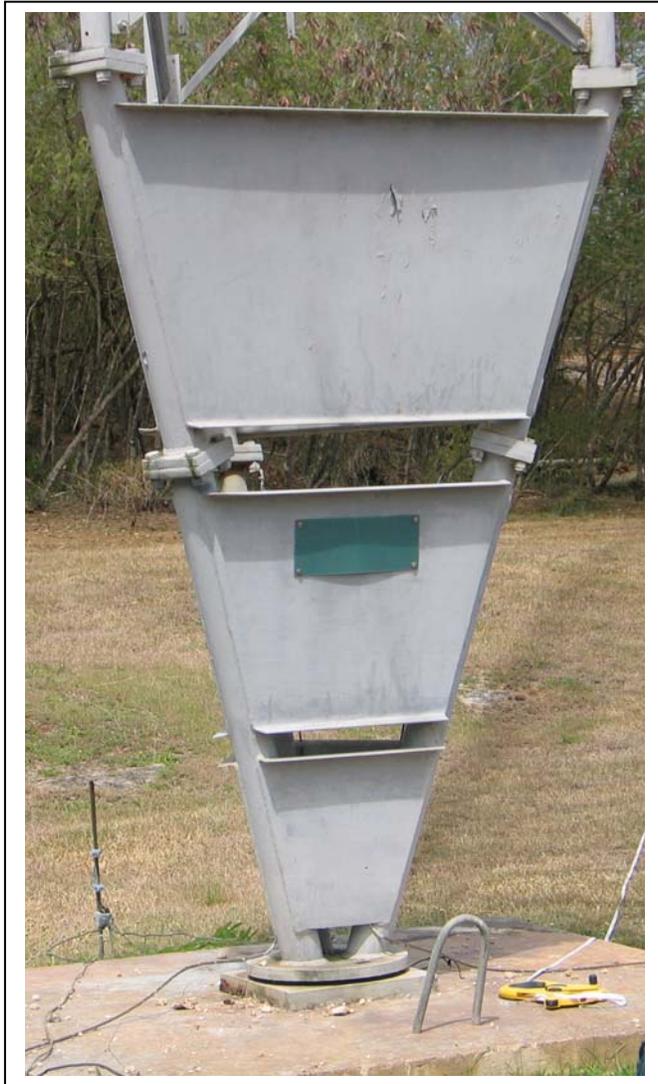
Photo No. 3 is a close up view of a tapered tower base.  
Photo No. 4 shows a typical tower section.

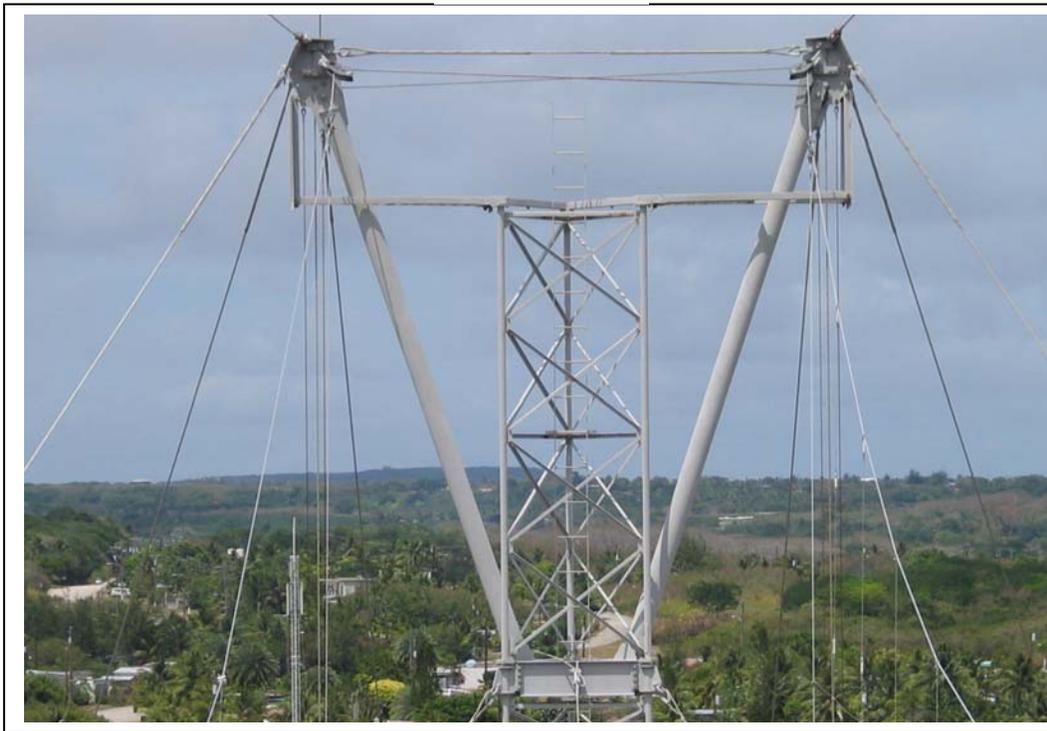
Photo Nos. 5 and 6 show the boom assembly at the top of the tower.

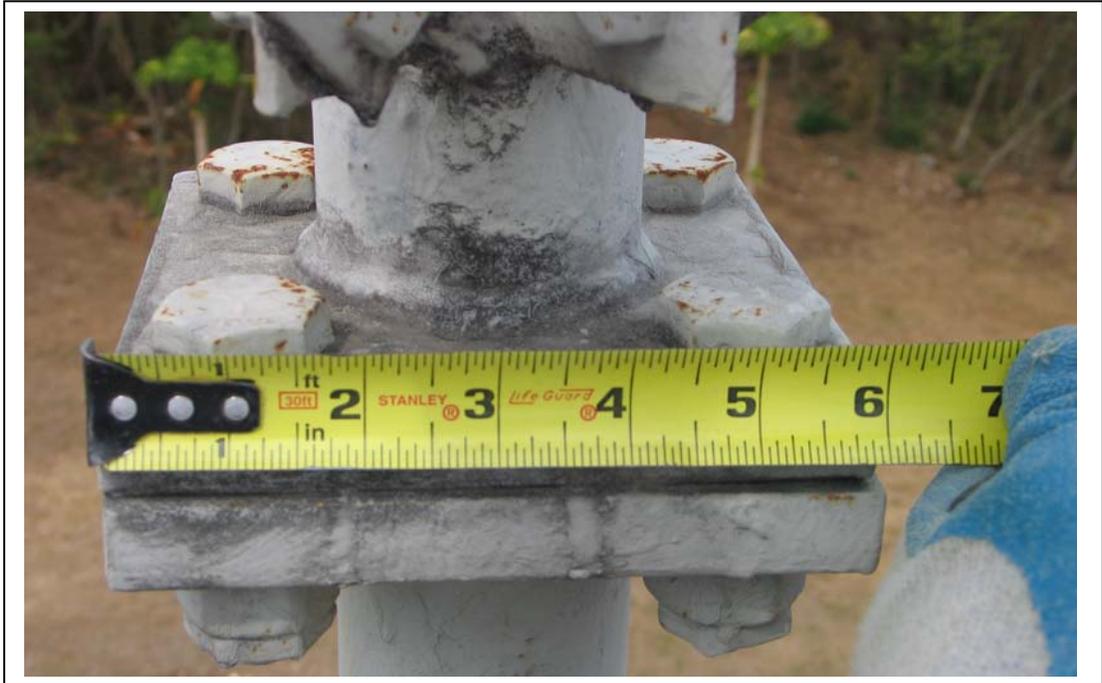
**Photo No. 7**

Photo No. 7 is a view of a typical leg splice connection.  
Photo No. 8 is a view of a typical diagonal and horizontal connection to the leg.

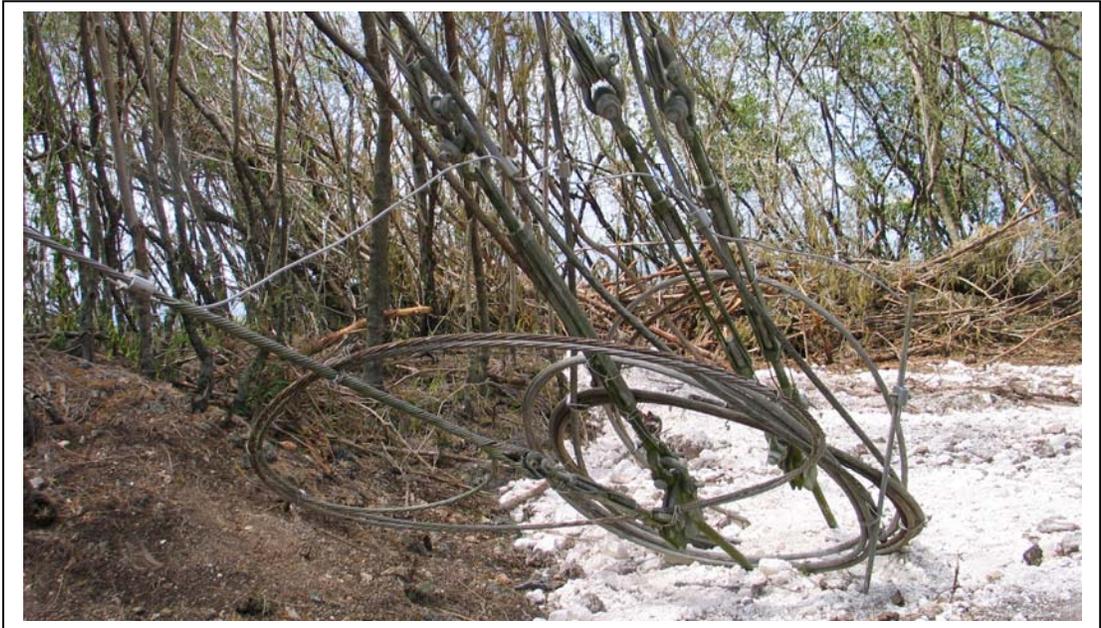
**Photo No. 11**

Photo No. 11 is a view of anchor 'A2'.  
Photo No. 12 is a view of anchor 'A3'.

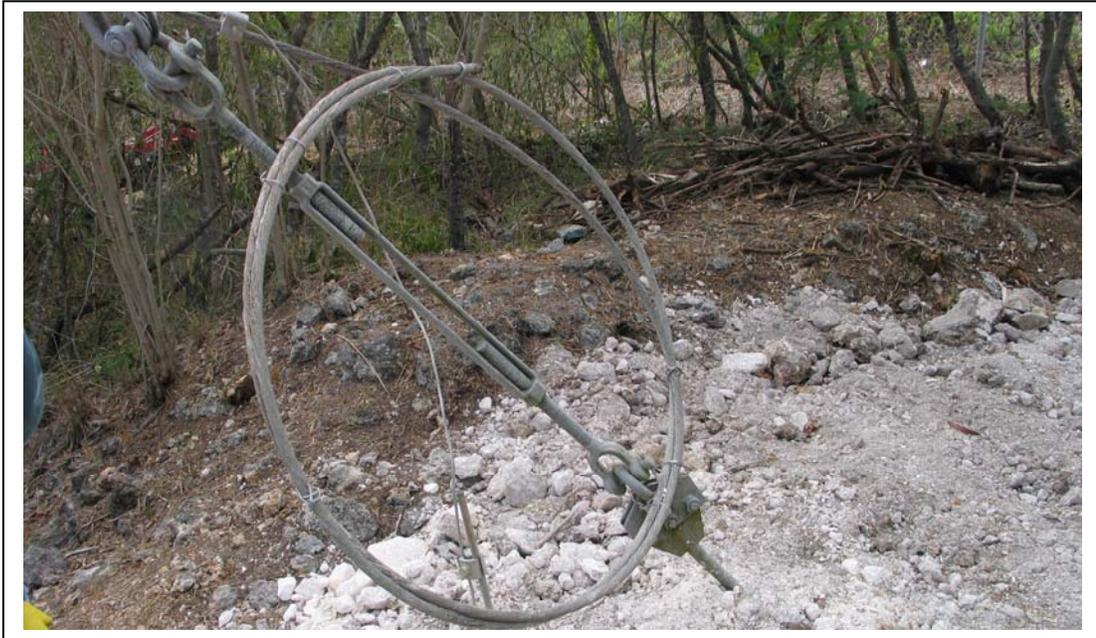
**Photo No. 13**

Photo No. 13 is a view of anchor 'A4'.  
Photo No. 14 is a view of anchor 'A5'.

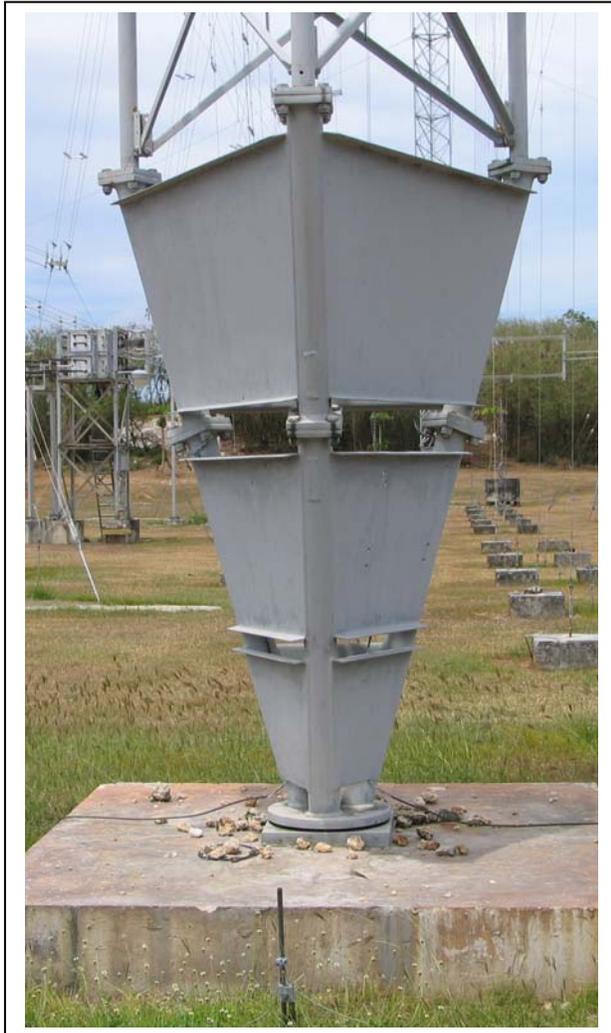
**Photo No. 20**

Photo No. 20 is a close up view of a tapered tower base.  
Photo No. 21 shows a typical tower section.

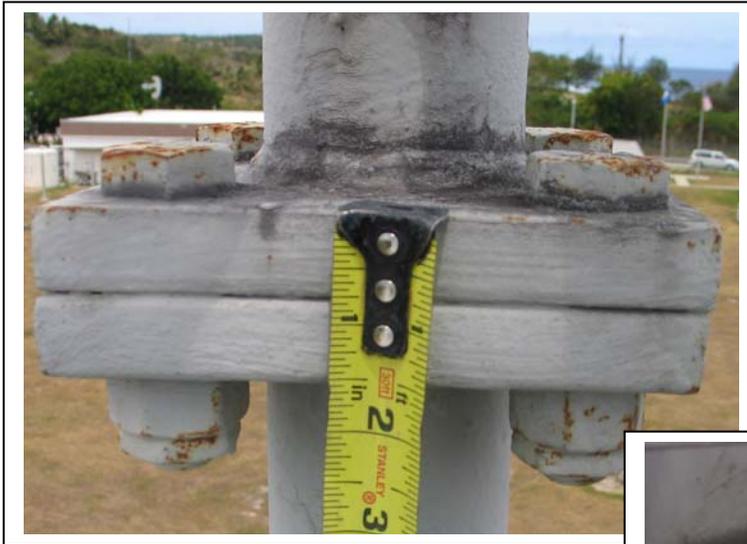
**Photo No. 24**

Photo No. 24 is a view of a typical leg splice connection.

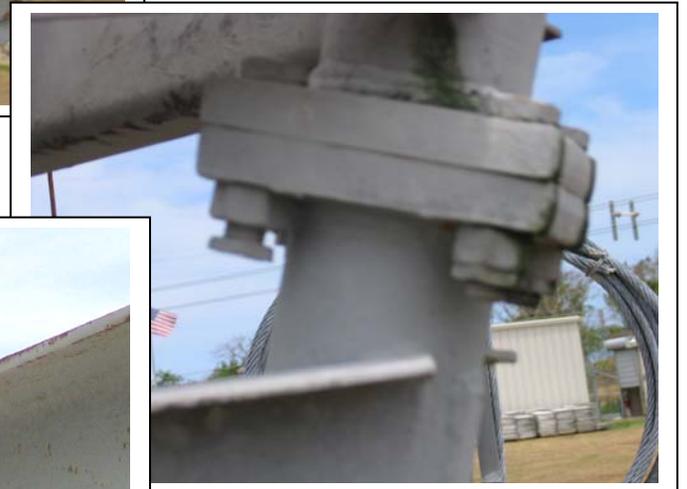
**Photo No. 25**

Photo No. 25 is a view of a leg splice connection at the midpoint of the tapered base section. Note the loose locknut on one of the bolts.

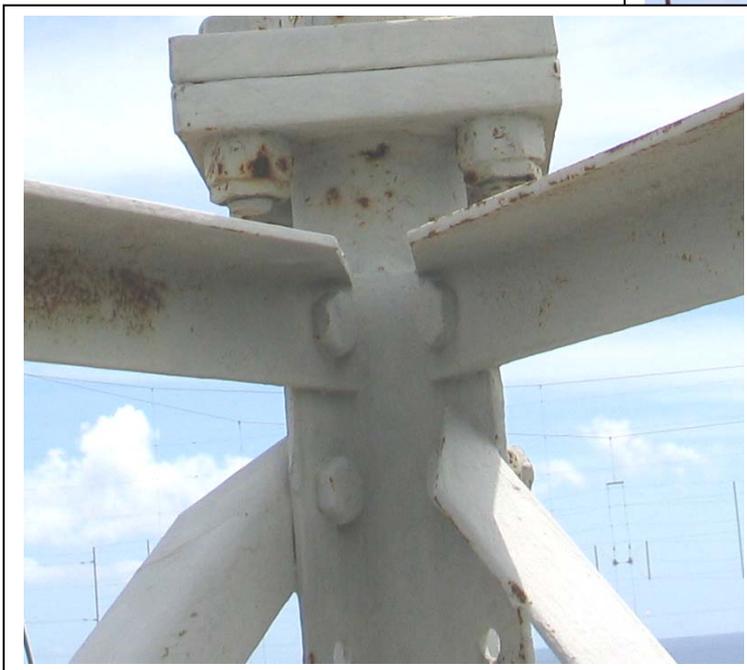
**Photo No. 26**

Photo No. 26 is a view of a typical diagonal and horizontal connection to the leg.

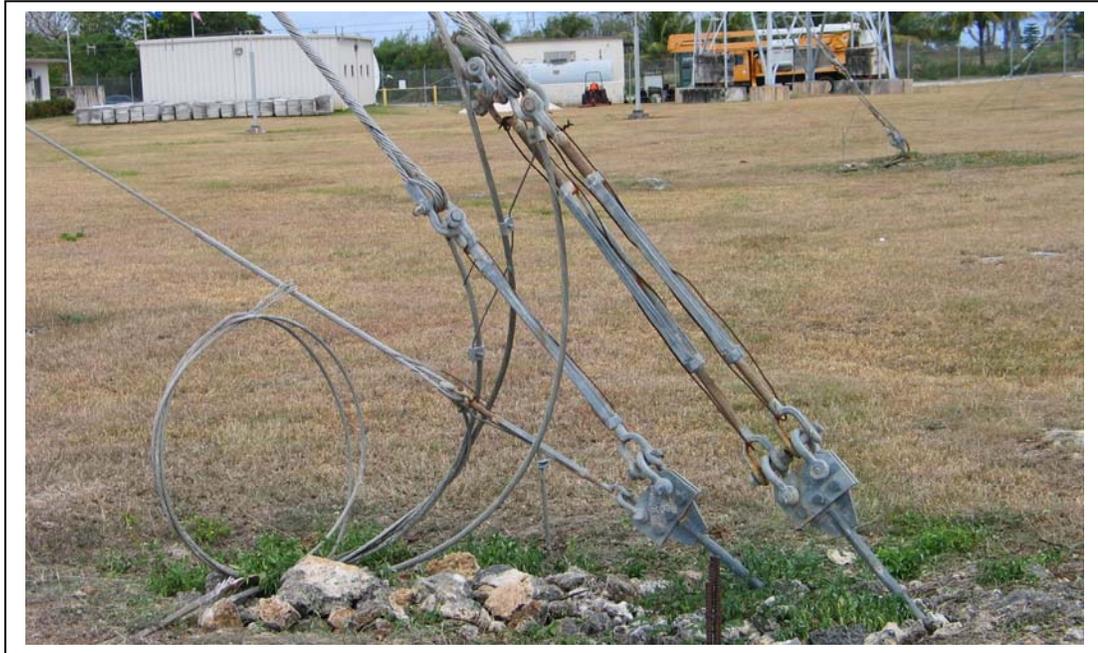
Photo No. 29 is a view of anchor 'B2'.  
Photo Nos. 30 and 31 are close up view of anchor 'B3'.

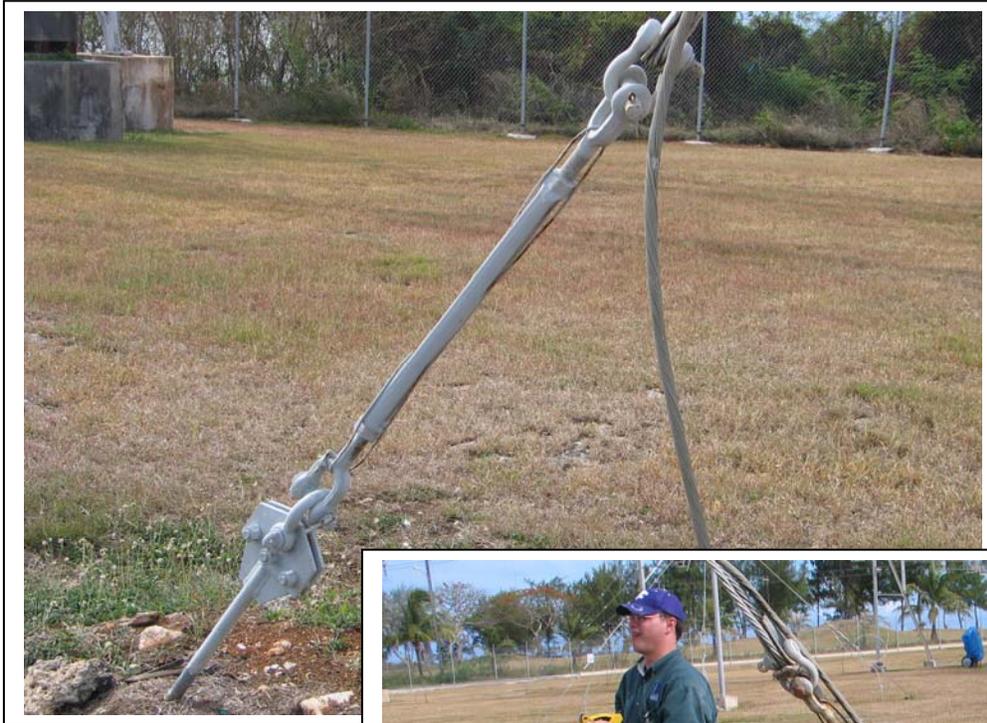
**Photo No. 32**

Photo No. 32 is a view of anchor 'B4'.  
Photo No. 33 is a view of anchor 'B5'.

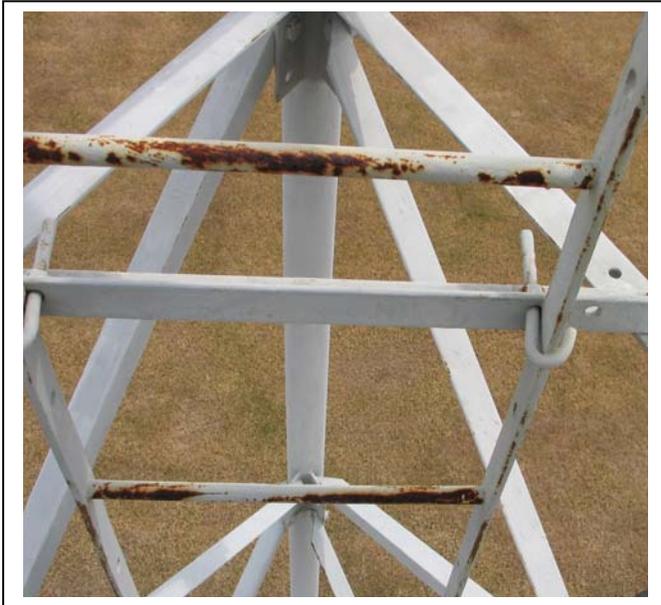
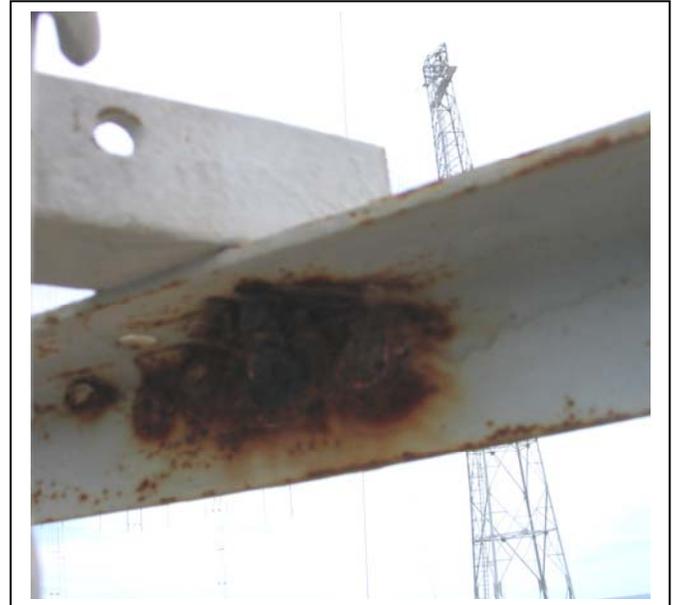
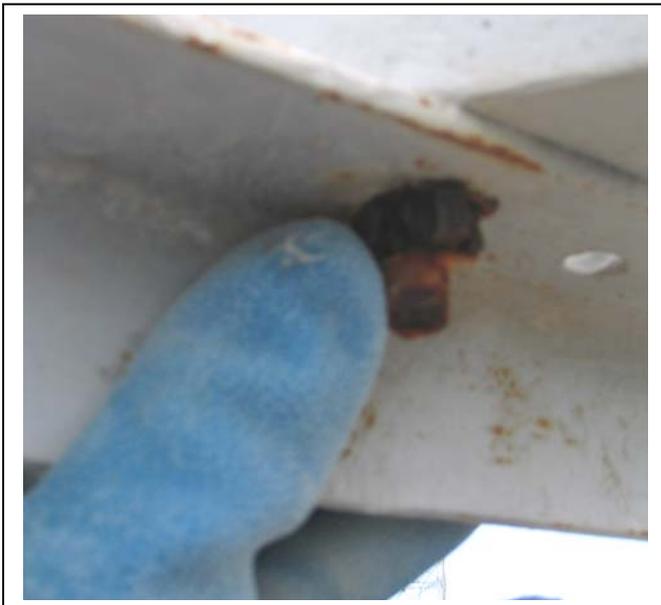
Photo Nos. 34-37 show the rusted condition of the tower members at some locations. Note the galvanizing is deteriorating and rust is beginning to form on the tower member surfaces, connection bolts and climbing ladder. The rusted condition is typical throughout the upper half of the towers.

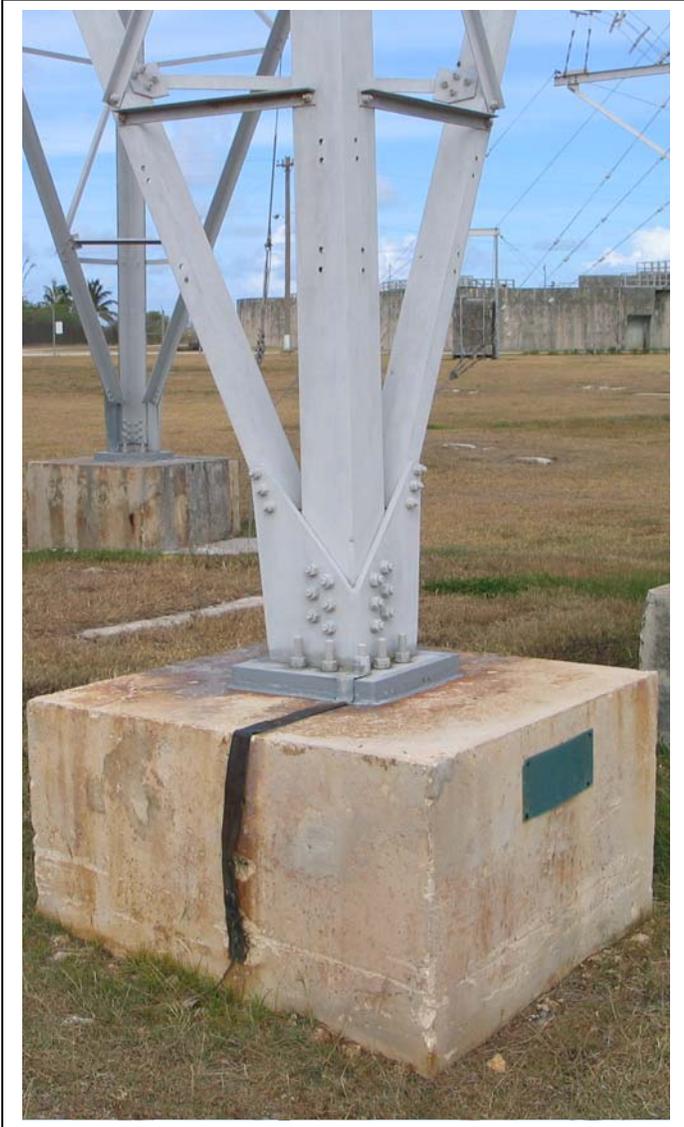
**Photo No. 39**

Photo No. 39 is a close up view of a tower base.  
Photo No. 40 shows the bottom section of the tower between the 0-ft and 40-ft elevations.

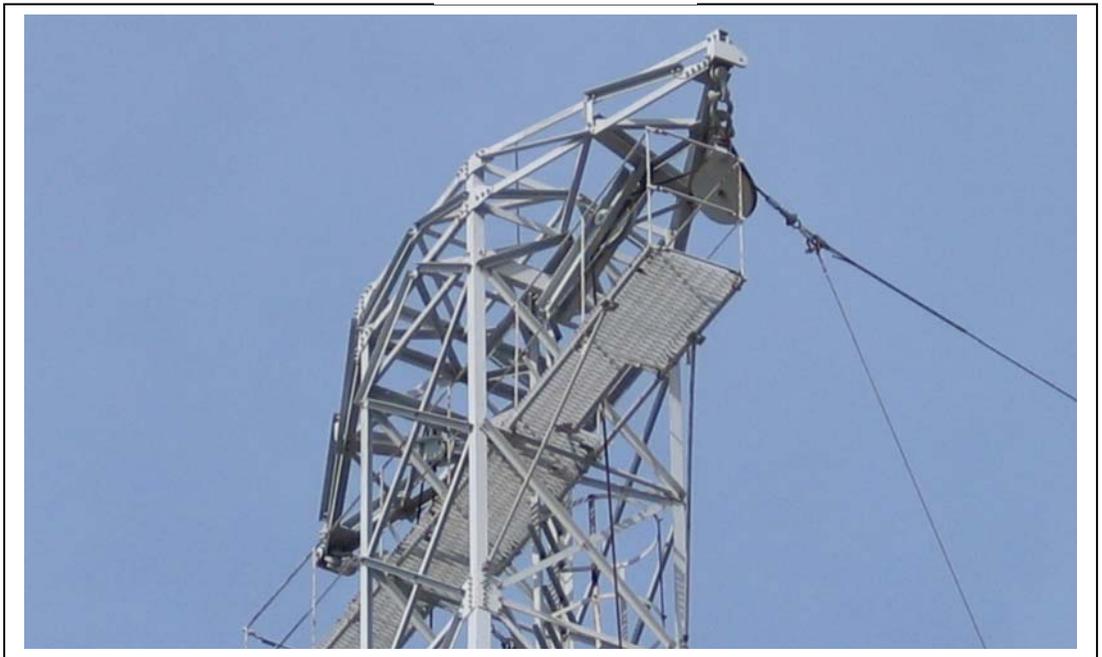
Photo Nos. 43 and 44 show the cross-arms and catwalks mounted at the top of the tower.

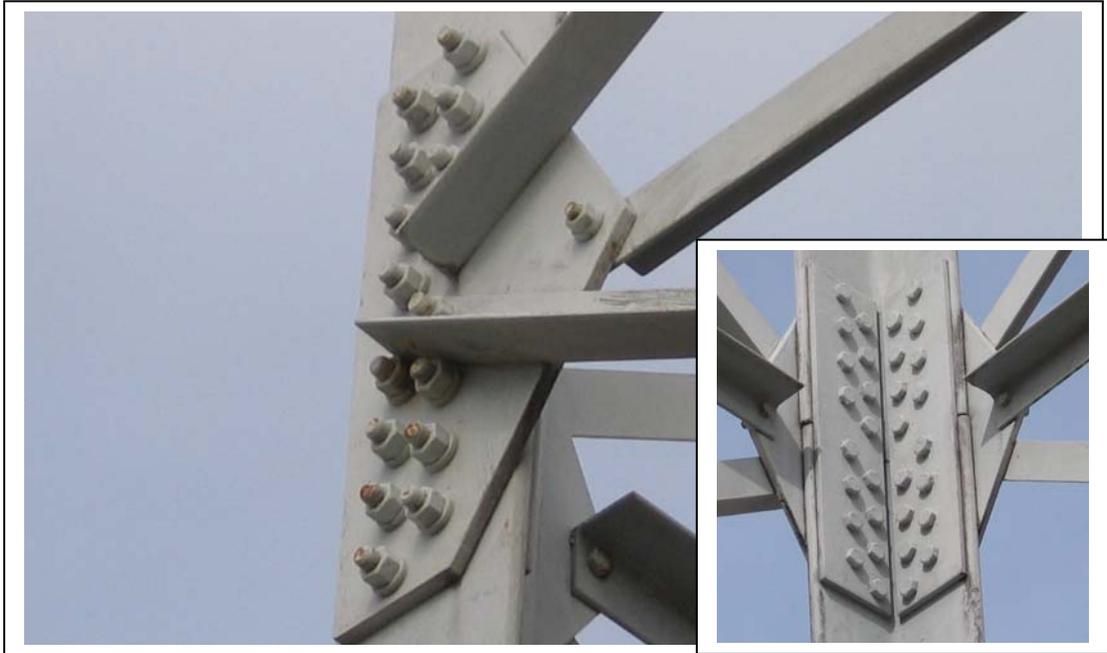
**Photo No. 45**

Photo No. 45 is a view of a typical leg splice connection.  
Photo No. 46 is a view of a typical diagonal connection at the center of the horizontal.  
Photo No. 47 is a view of a typical diagonal connection to the leg.

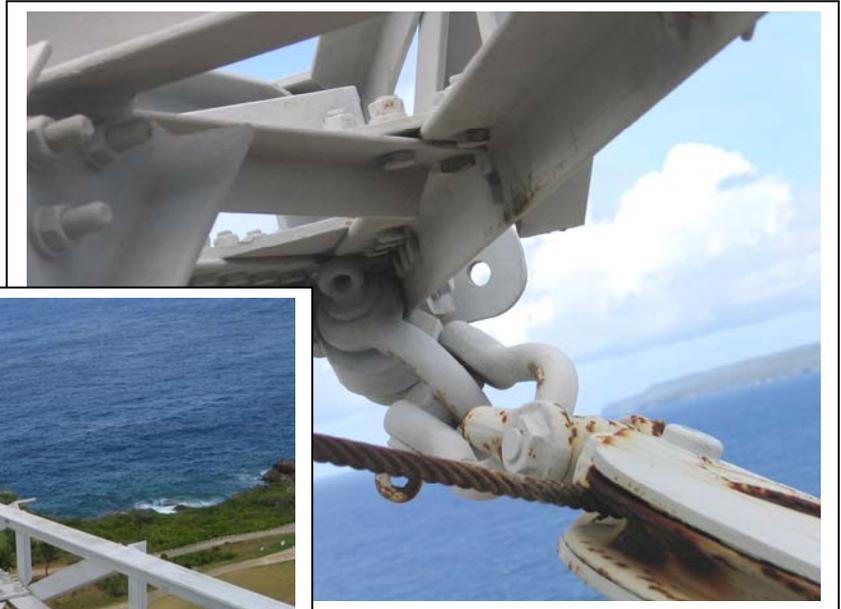
Photo No. 50

Photo Nos. 50-52 show the condition of the cross-arms at the top of tower.

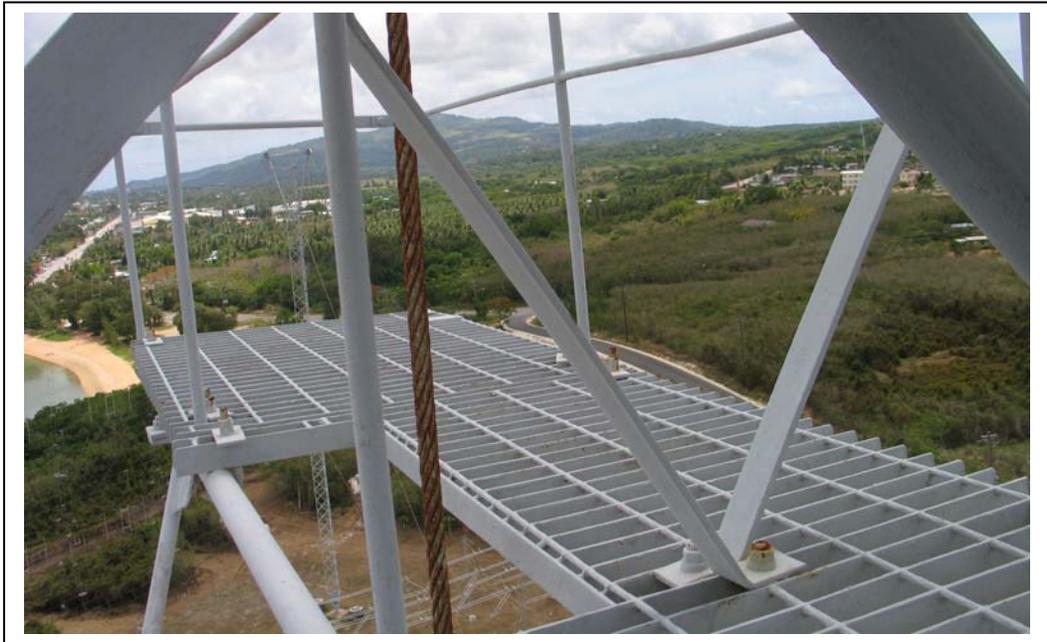
**Photo No. 53**

Photo Nos. 53 and 54 show the condition of the catwalks at the top of tower.

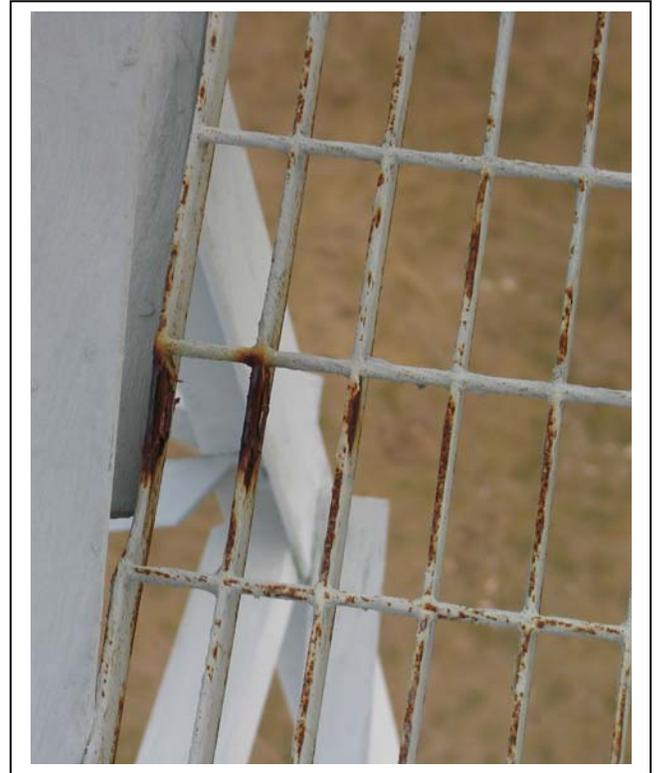
Photo No. 74

Photo Nos. 73-75 show the condition of the catwalks at the top of tower.  
Note the rusted condition of the catwalks at some locations.

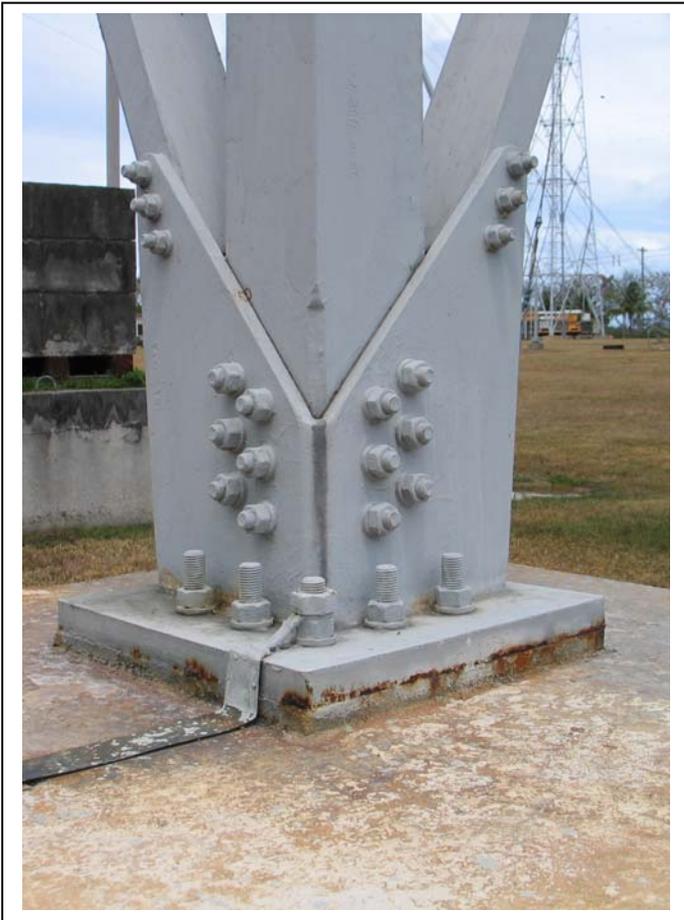
Photo No. 77

Photo Nos. 77 and 78 show a tower base.  
Note the base plate is rusted.

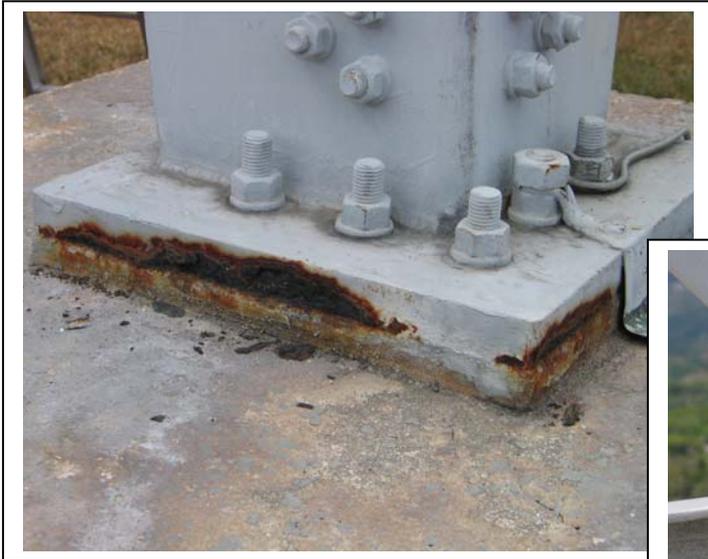
Photo No. 86 is shows the rusted condition of the tower base plate.  
Photo Nos. 87-89 show the rusted condition of the tower connection bolts at some locations.  
The rusted condition of the connection bolts is typical throughout the towers.
