**TINIAN TRANSMITTING STATION
PHOTOGRAPH LOG**

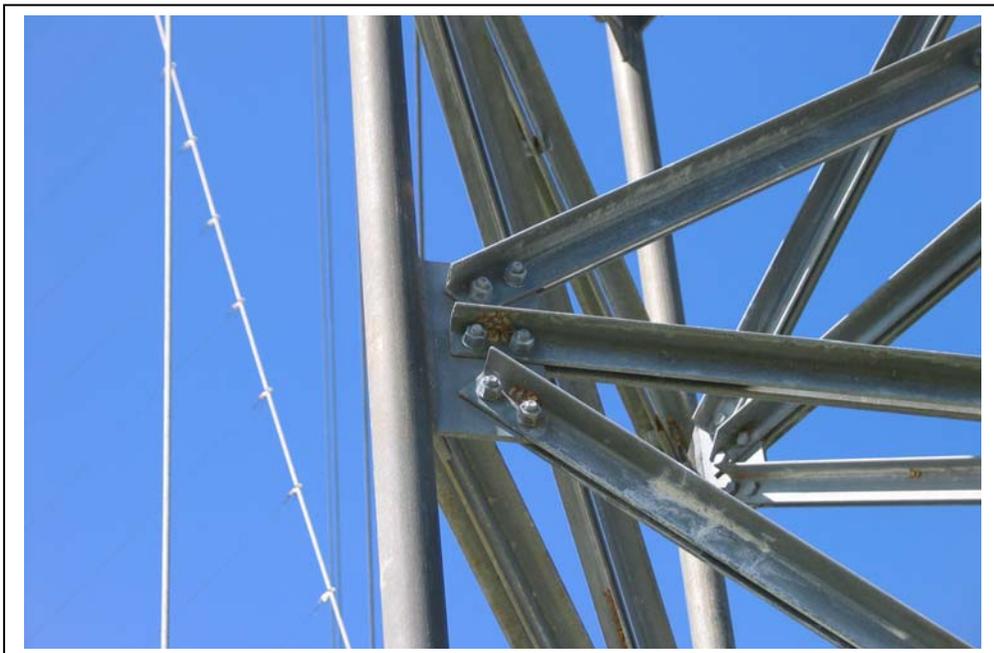
Photo No. 7 is a view of a typical leg splice connection.
Photo No. 8 is a view of a typical diagonal and horizontal connection to the leg.

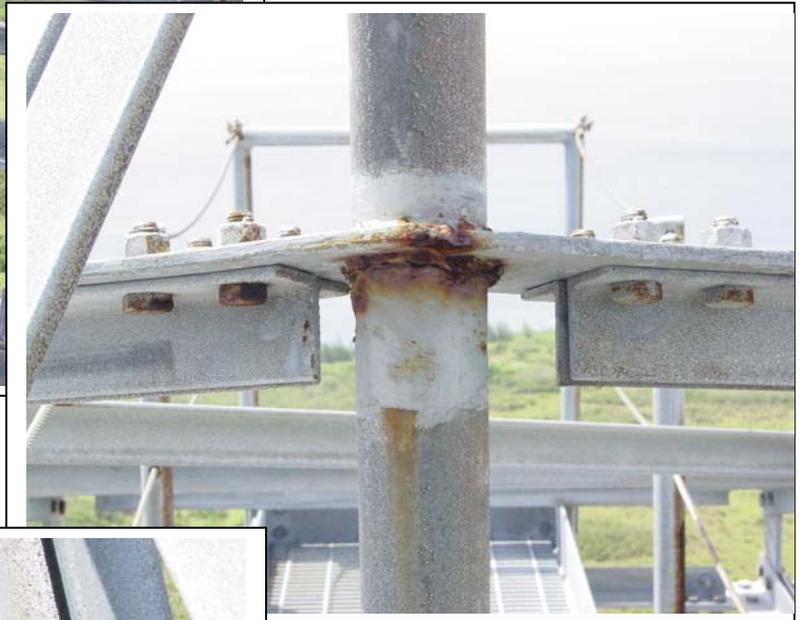
Photo No. 11

Photo Nos. 11, 12 and 13 show the rusted condition of the tower member and outrigger connection bolts. The rusted bolt condition is typical for all nine towers.

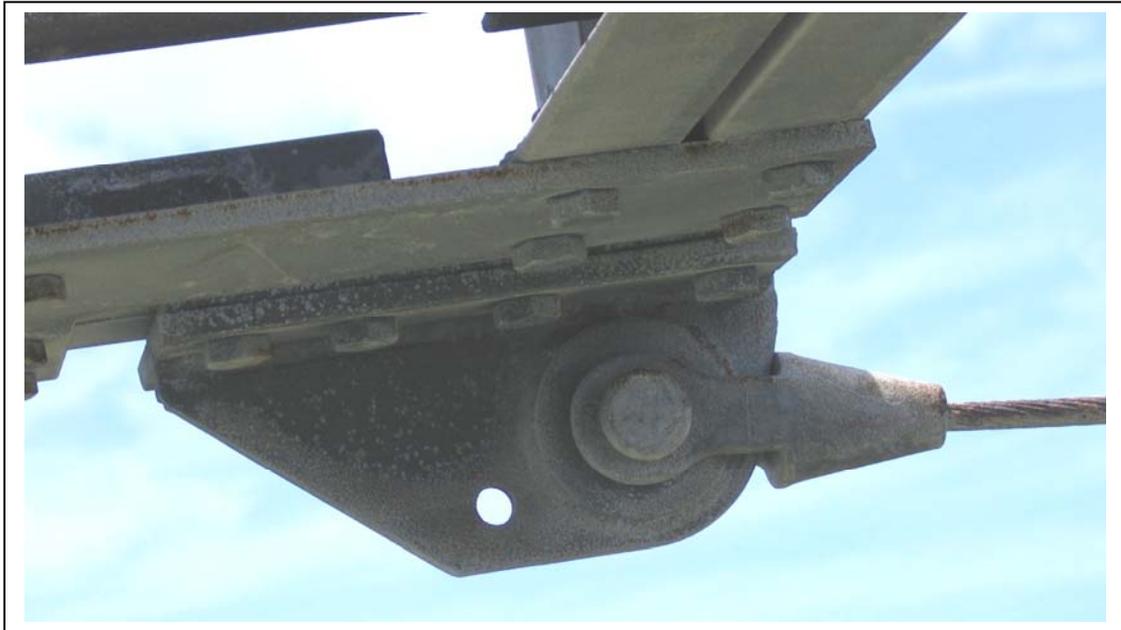
Photo No. T2.2

Photo No.T2.2 is a view of the catenary connection plate at the northwest side of the lower level outrigger.

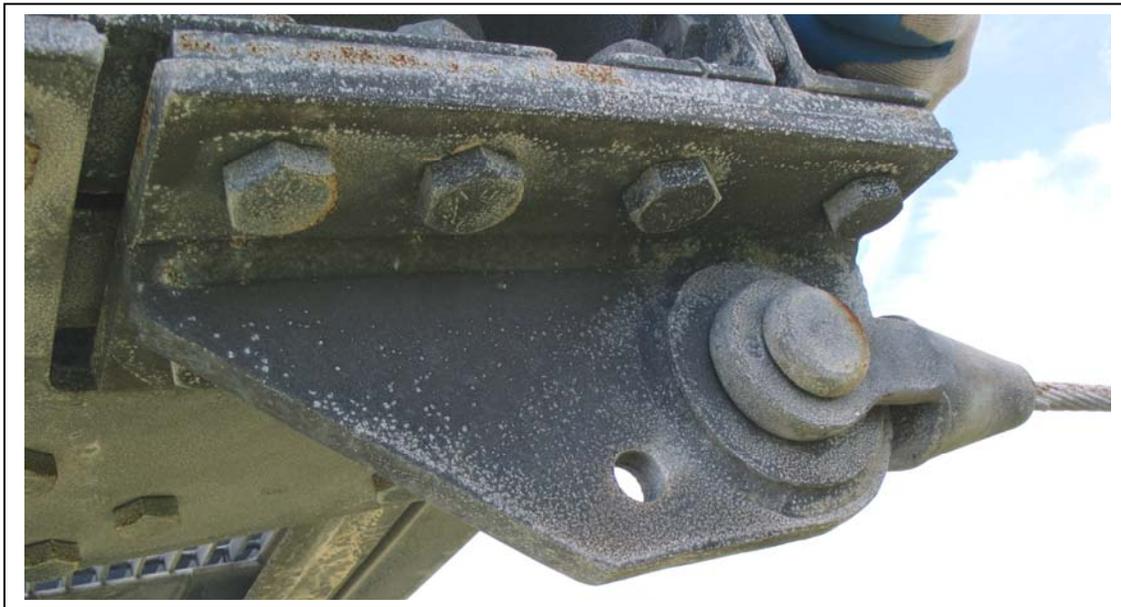
Photo No. T2.3

Photo No.T2.3 is a view of the catenary connection plate at the southeast side of the lower level outrigger.

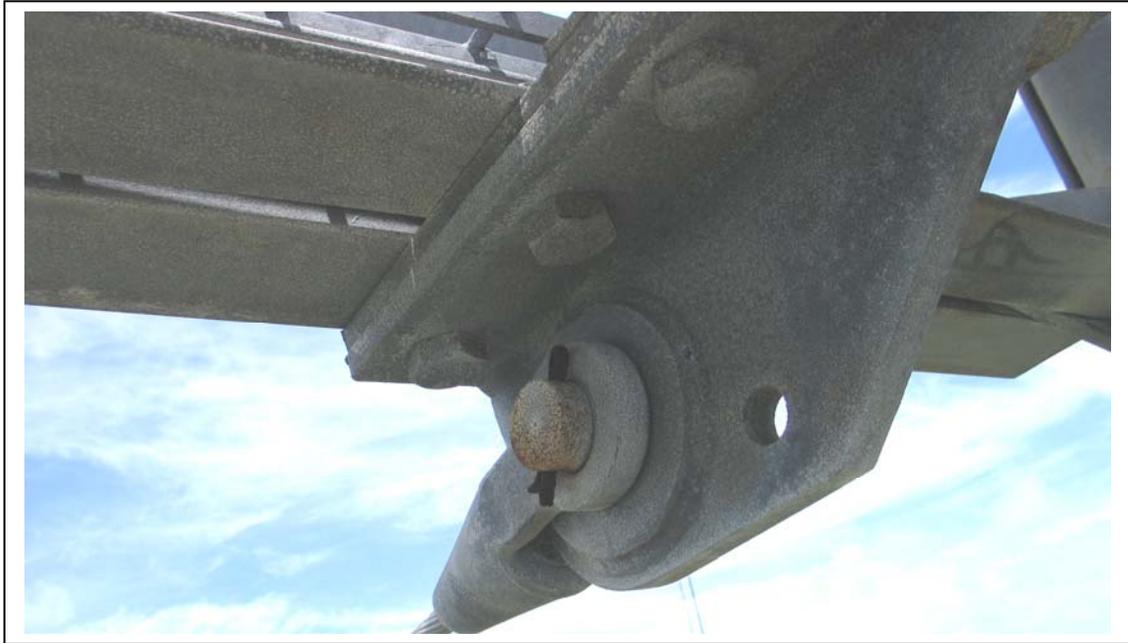
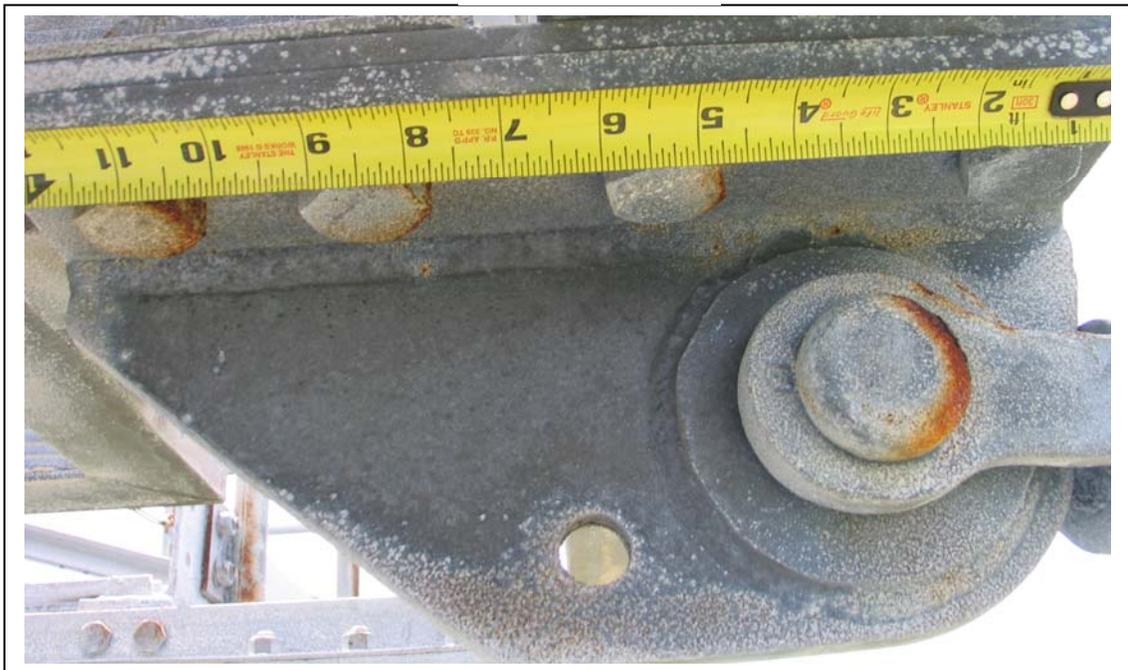
Photo Nos. T2.4 and T2.5 show the catenary connection plate at the middle of the lower level outrigger.

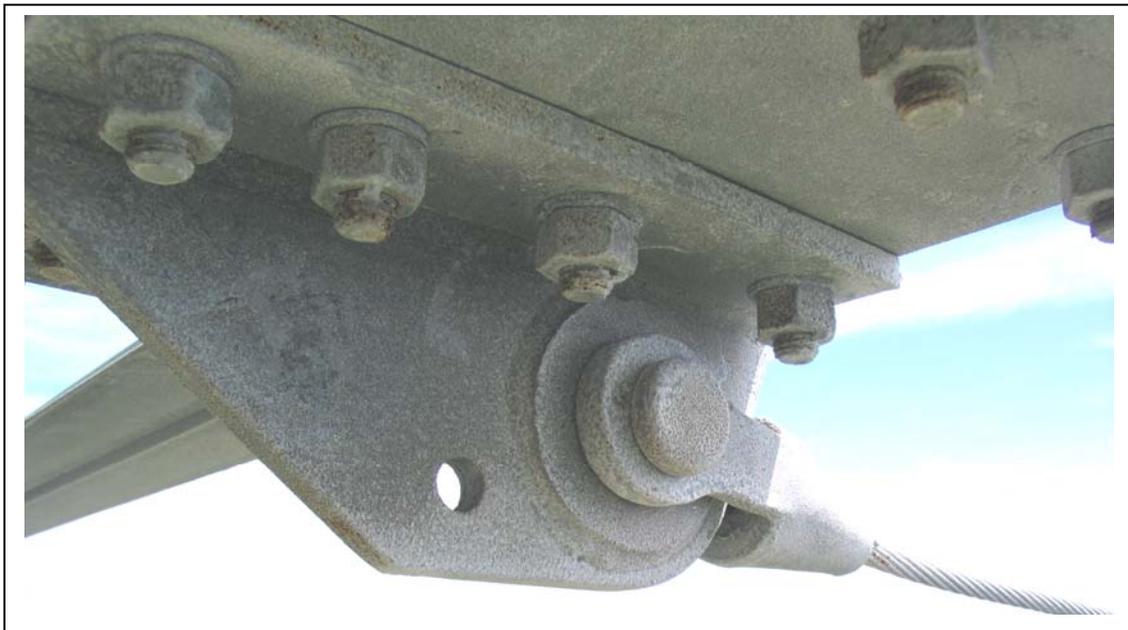
Photo Nos. T2.10 and T2.11 show the catenary connection plate at the middle of the top level outrigger.

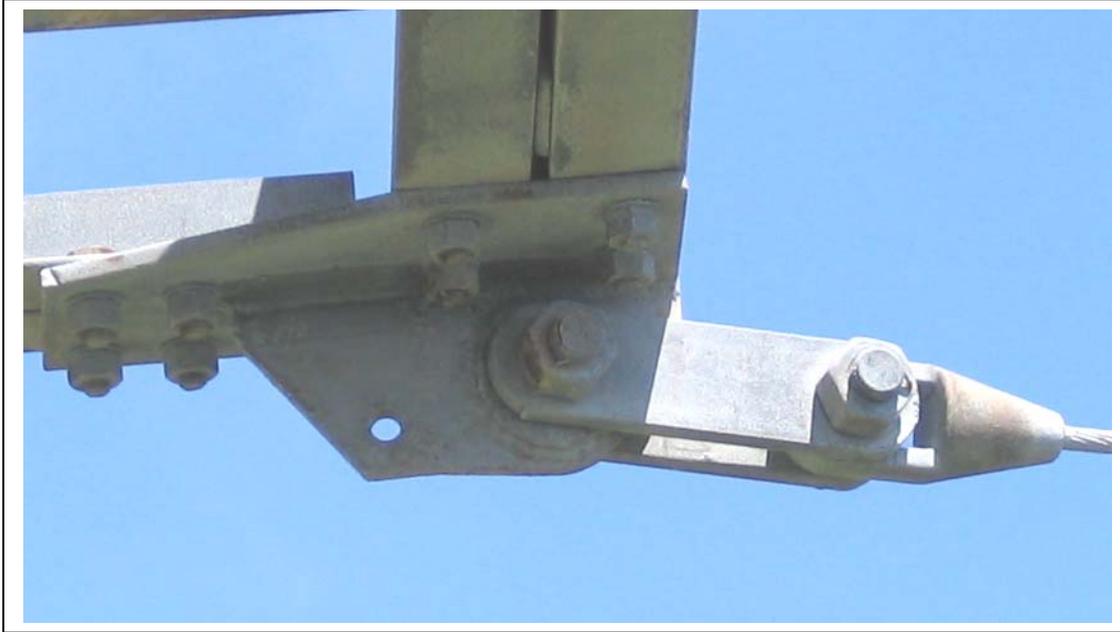
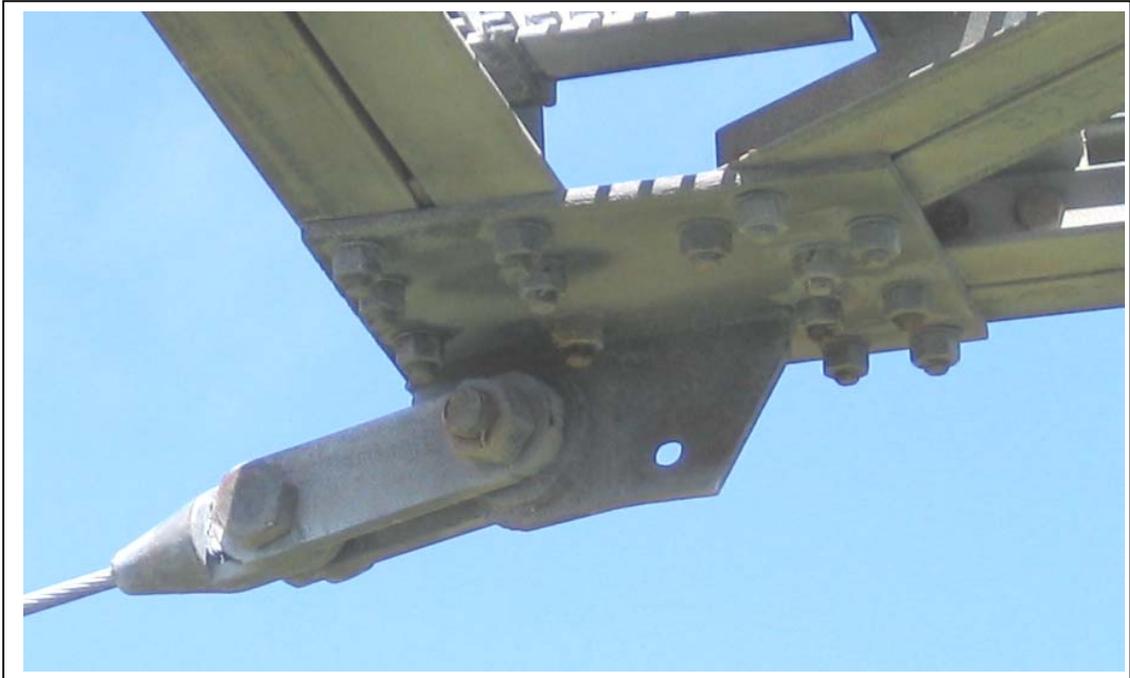
Photo Nos.T3.4 and T3.5 show two catenary connection plates at the southeast side of the outrigger.

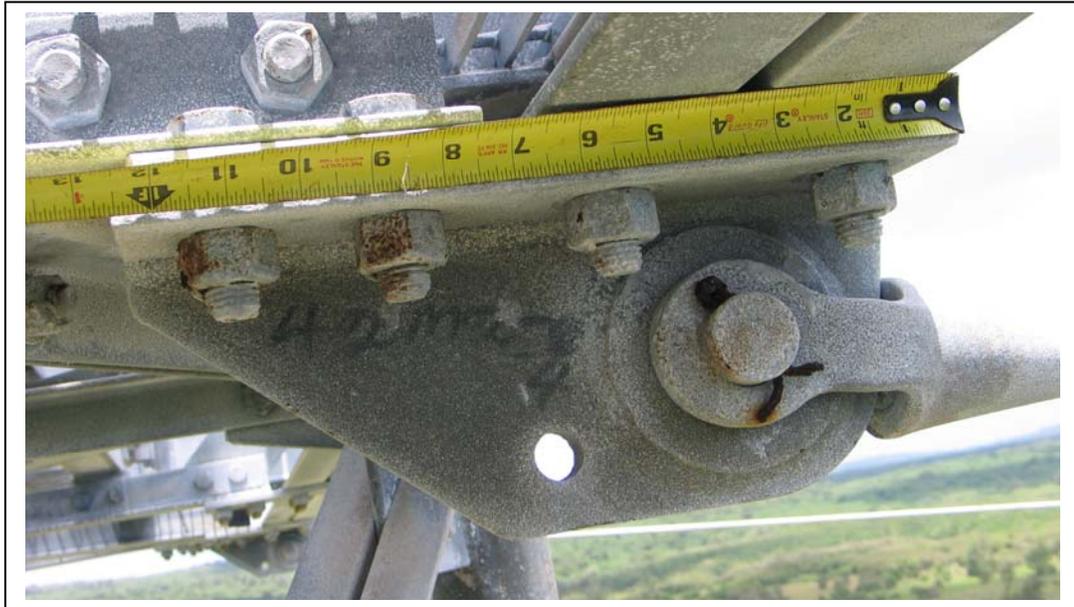
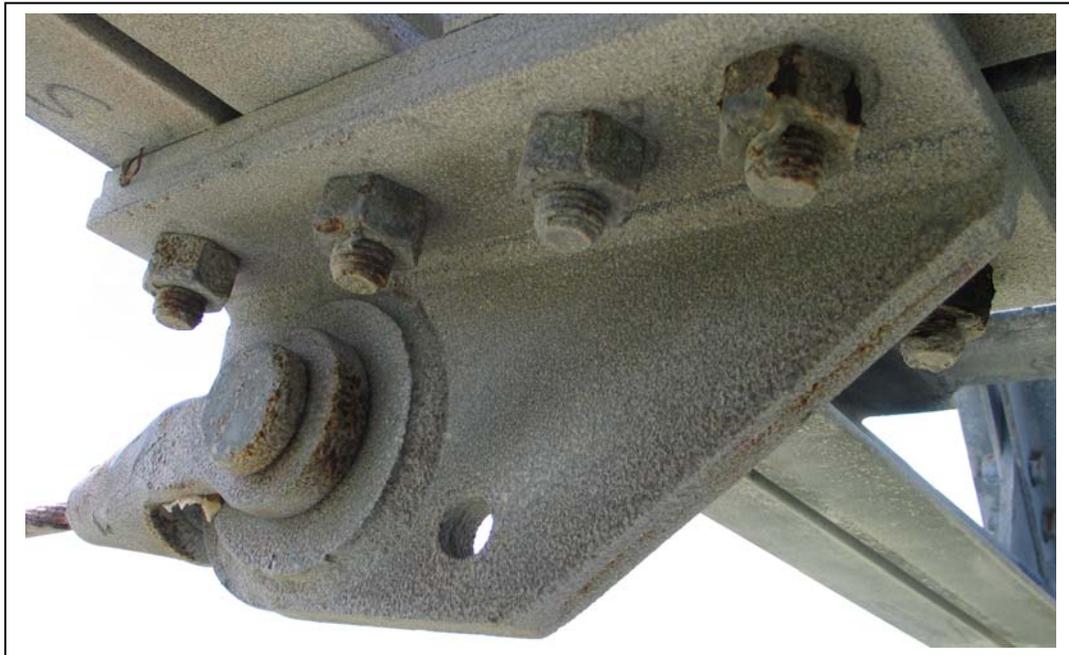
Photo Nos. T4.4 and T4.5 show the catenary connection plate at the middle of the lower level outrigger.

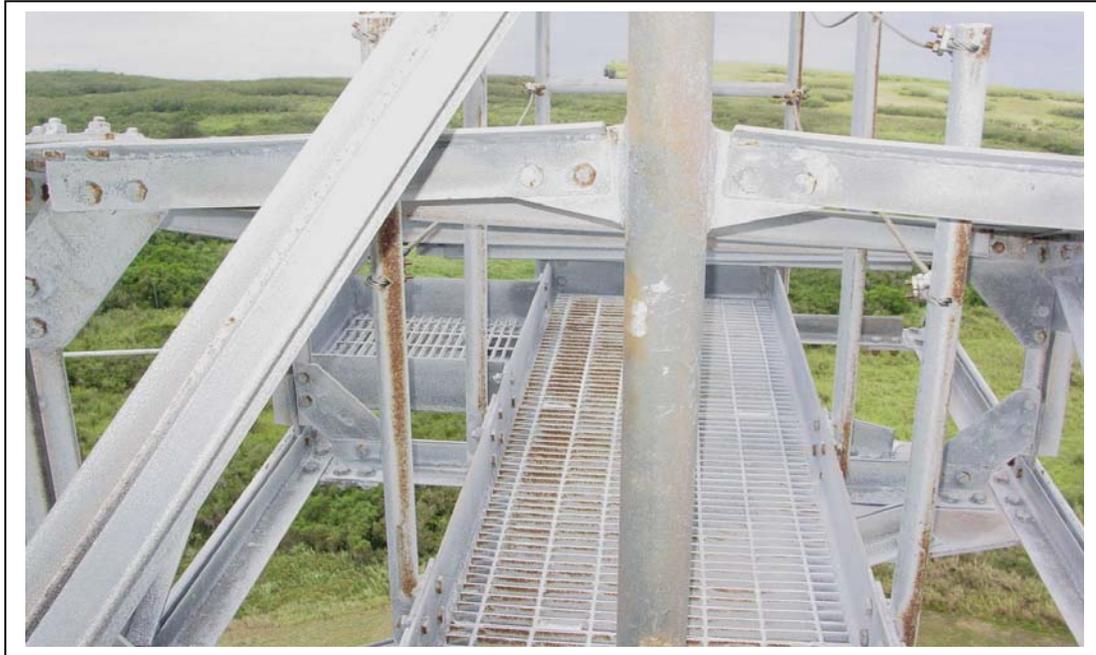
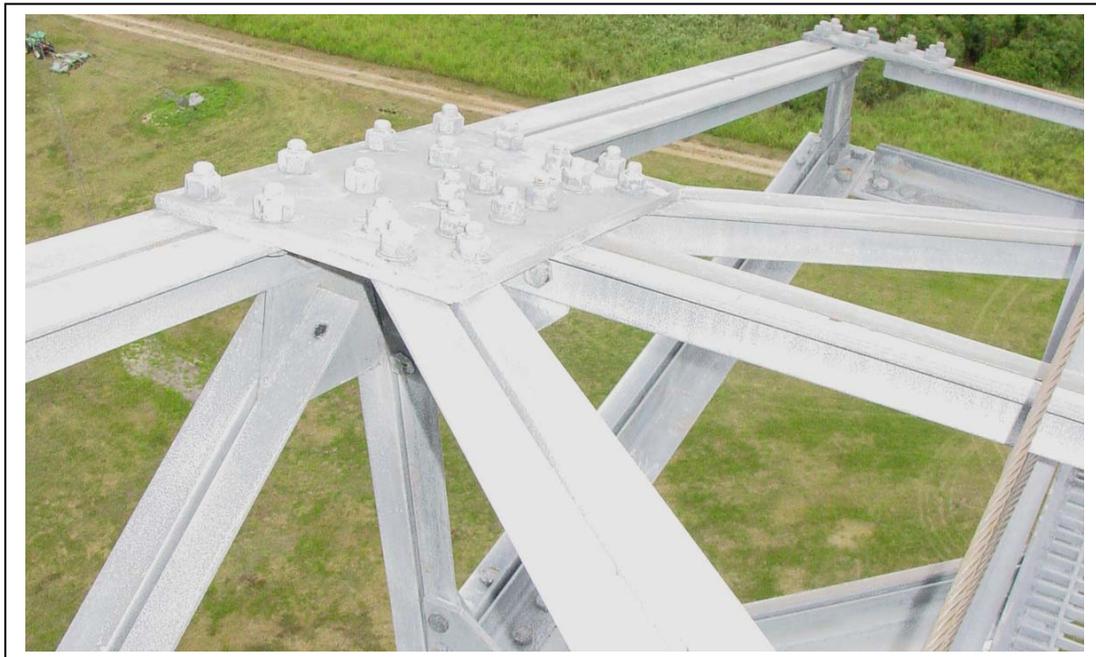
Photo Nos. T4.6 and T4.7 show the condition of the lower level outrigger at the 232.7-ft elevation.

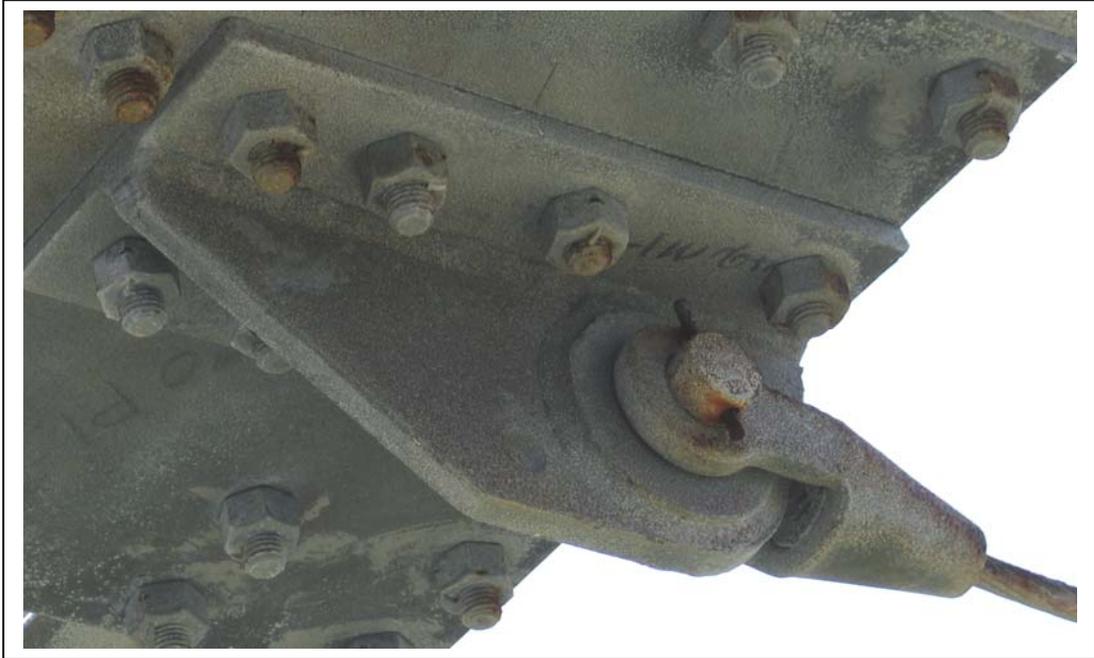
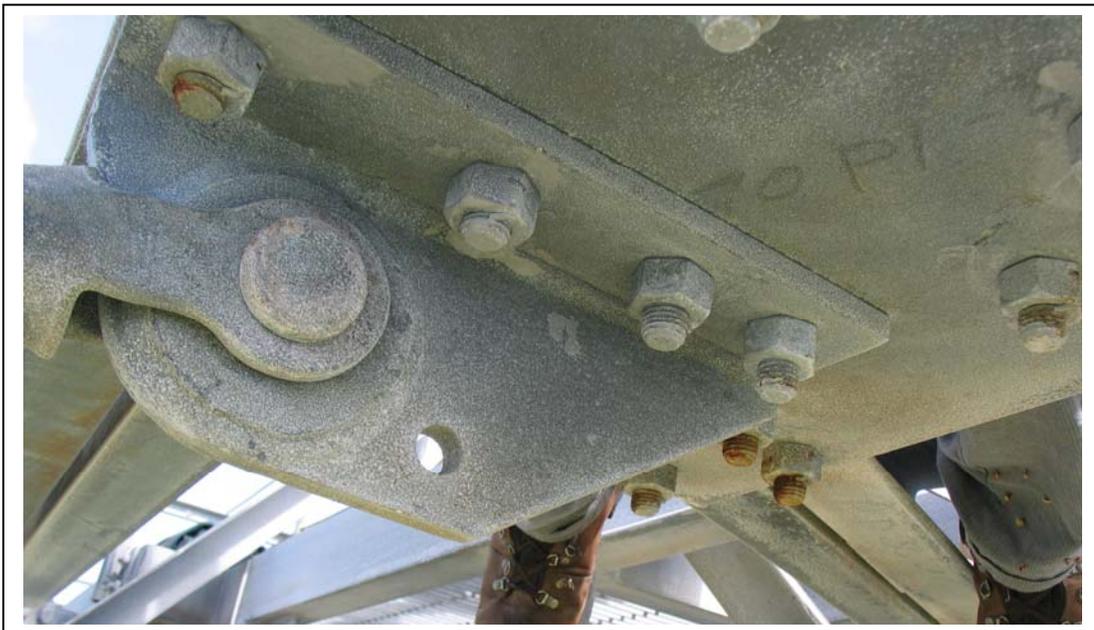
Photo Nos. T4.10 and T4.11 show the catenary connection plate at the middle of the top level outrigger.

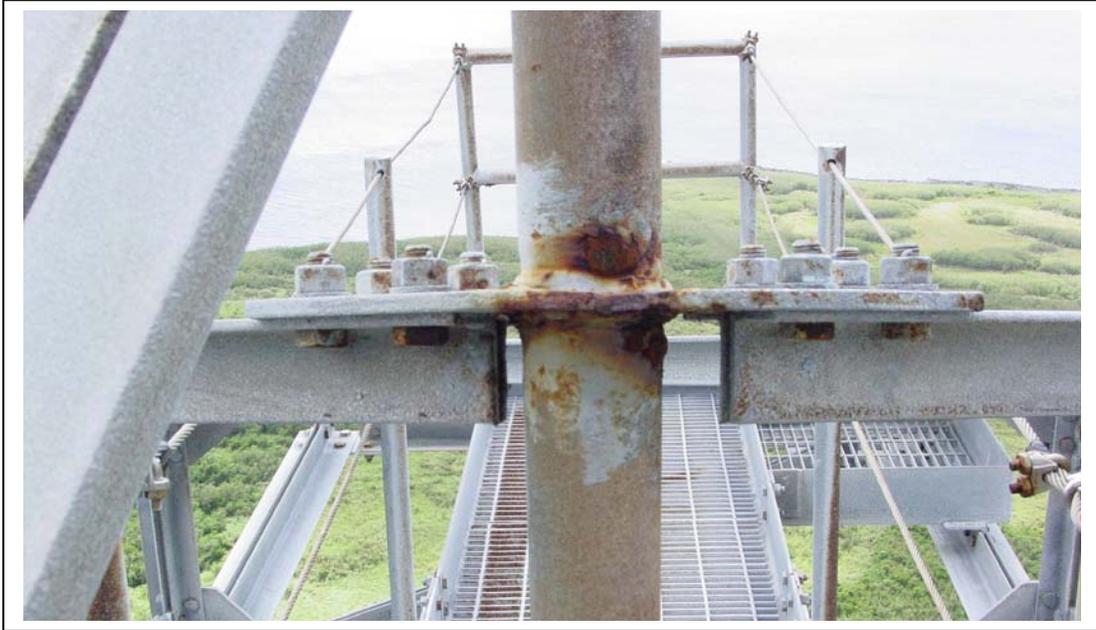
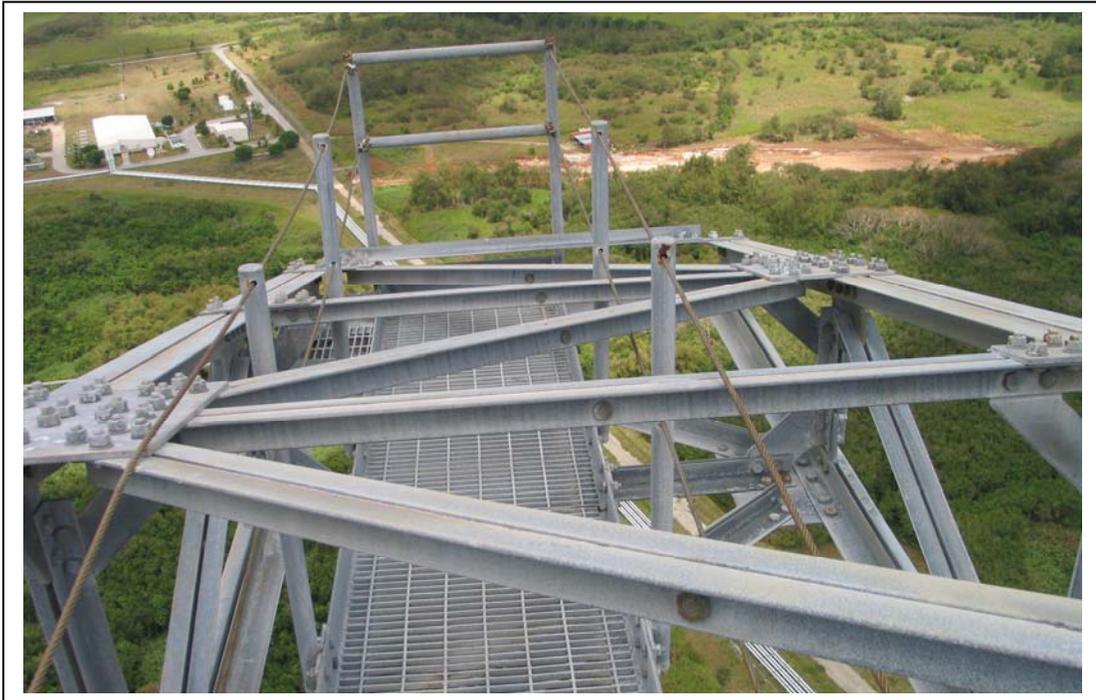
Photo Nos. T4.12 and T4.13 show the condition of the top level outrigger at the 422-ft elevation.

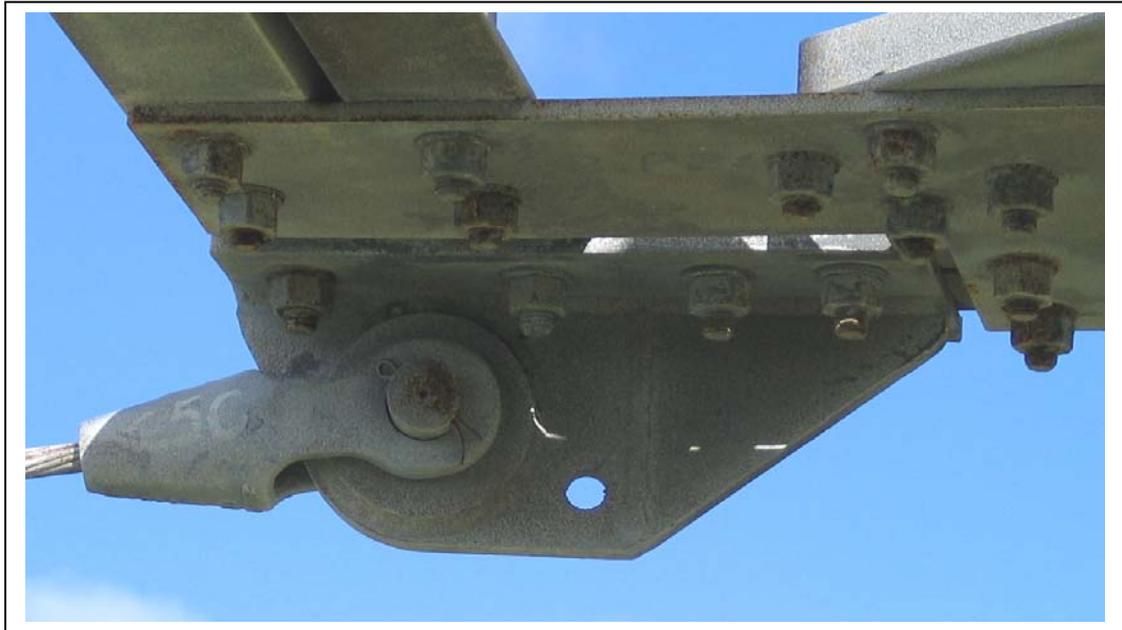
Photo No. T5.2

Photo No.T5.2 is a view of the catenary connection plate at the northwest side of the lower level outrigger.

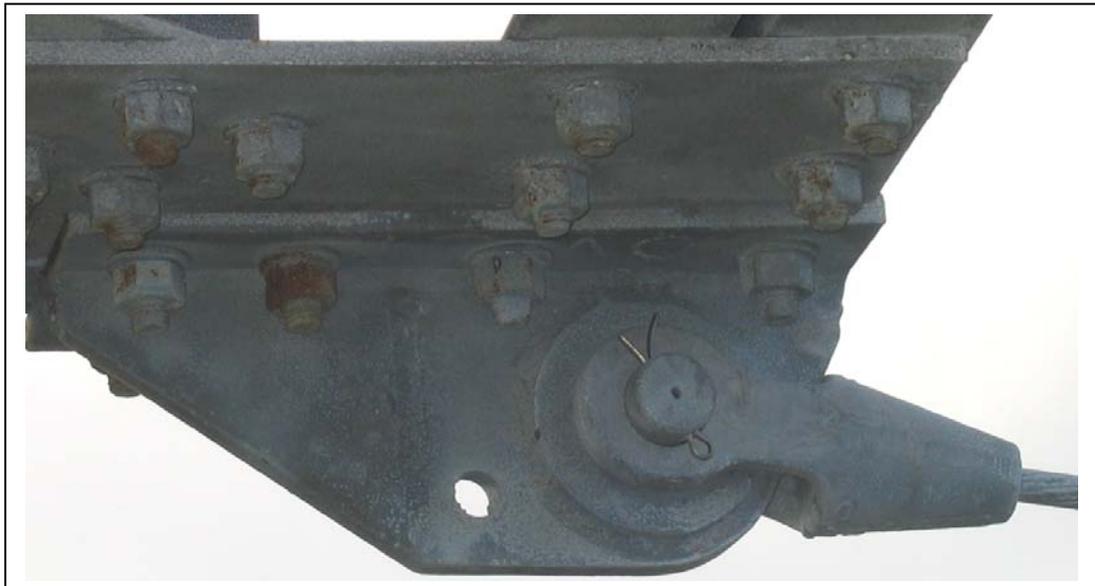
Photo No. T5.3

Photo No.T5.3 is a view of the catenary connection plate at the southeast side of the lower level outrigger.

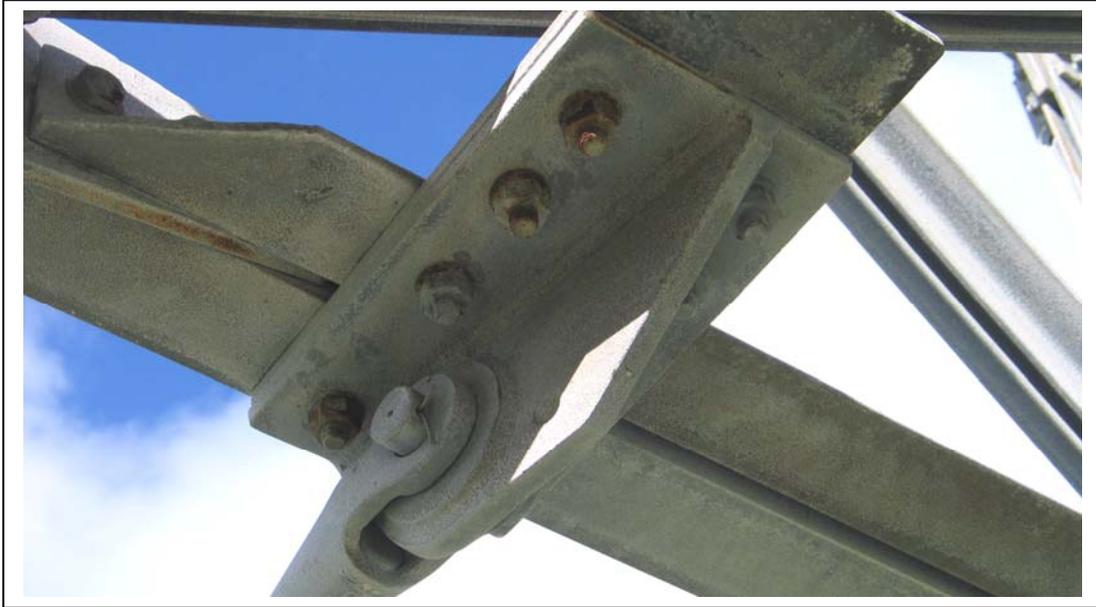
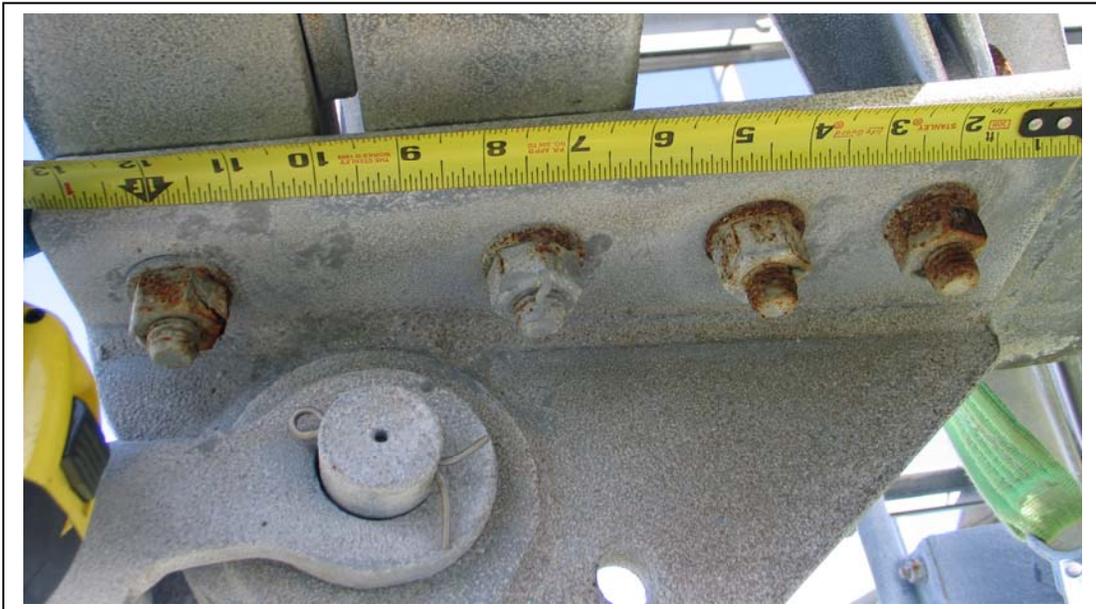
Photo Nos. T5.4 and T5.5 show the catenary connection plate at the middle of the lower level outrigger.

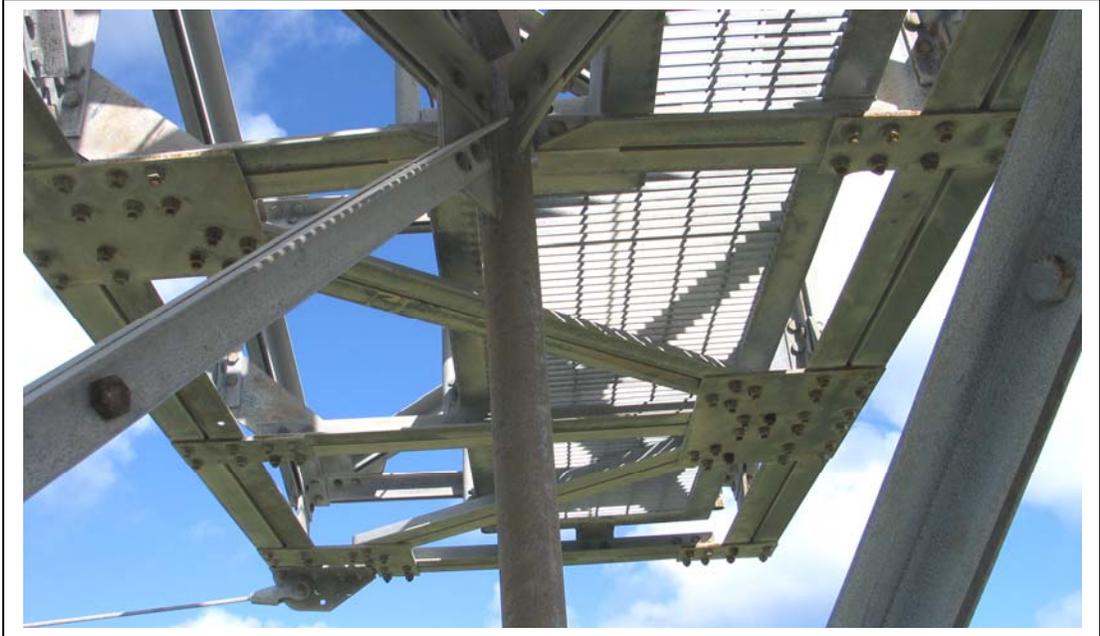
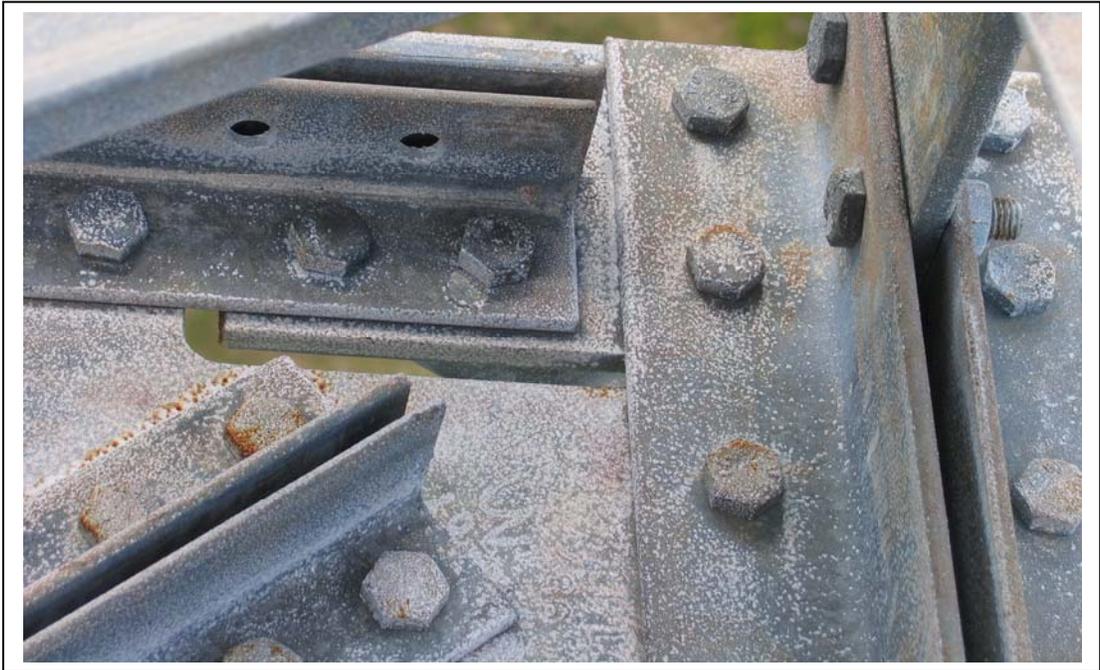
Photo Nos. T5.6 and T5.7 show the condition of the lower level outrigger at the 187.5-ft elevation.

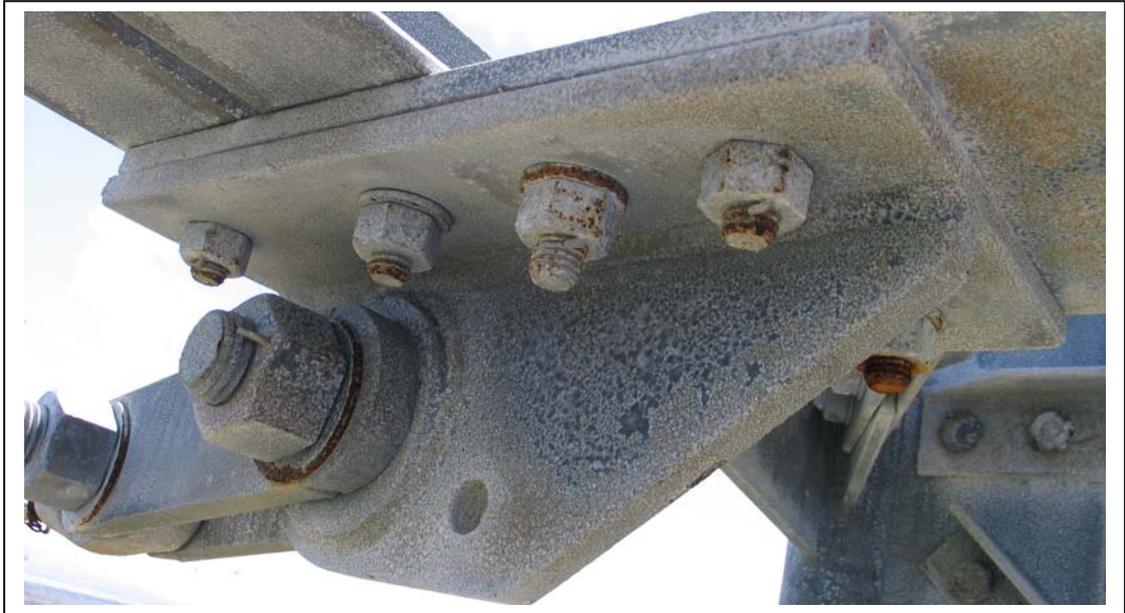
Photo No. T5.11

Photo Nos. T5.10 and T5.11 show the catenary connection plate at the middle of the top level outrigger.

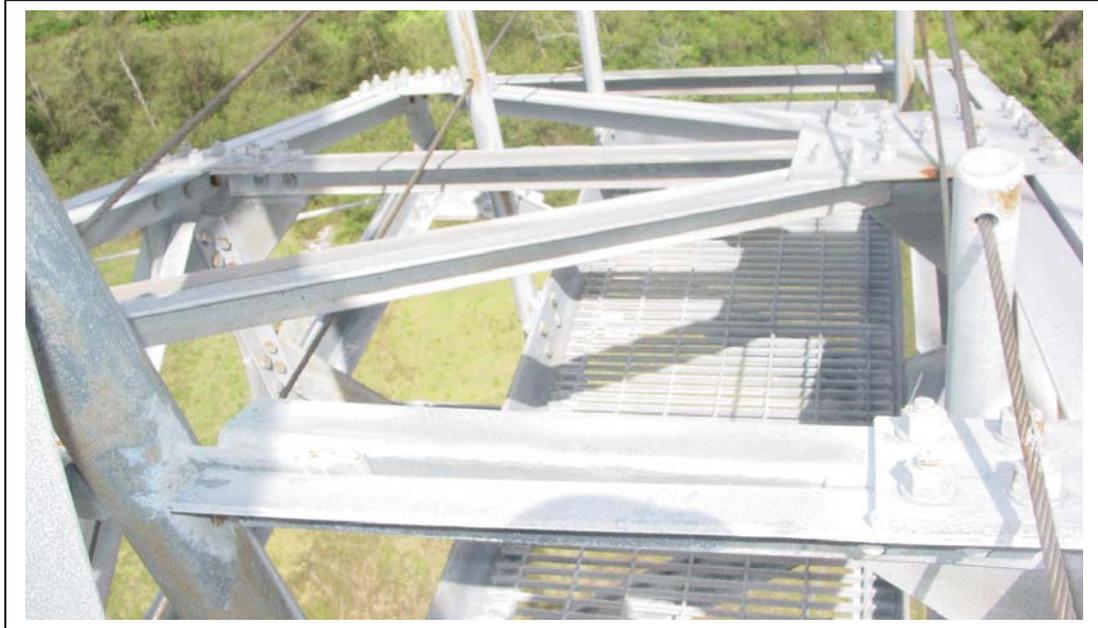
Photo No. T5.12

Photo Nos. T5.12 and T5.13 show the condition of the top level outrigger at the 232.7-ft elevation.

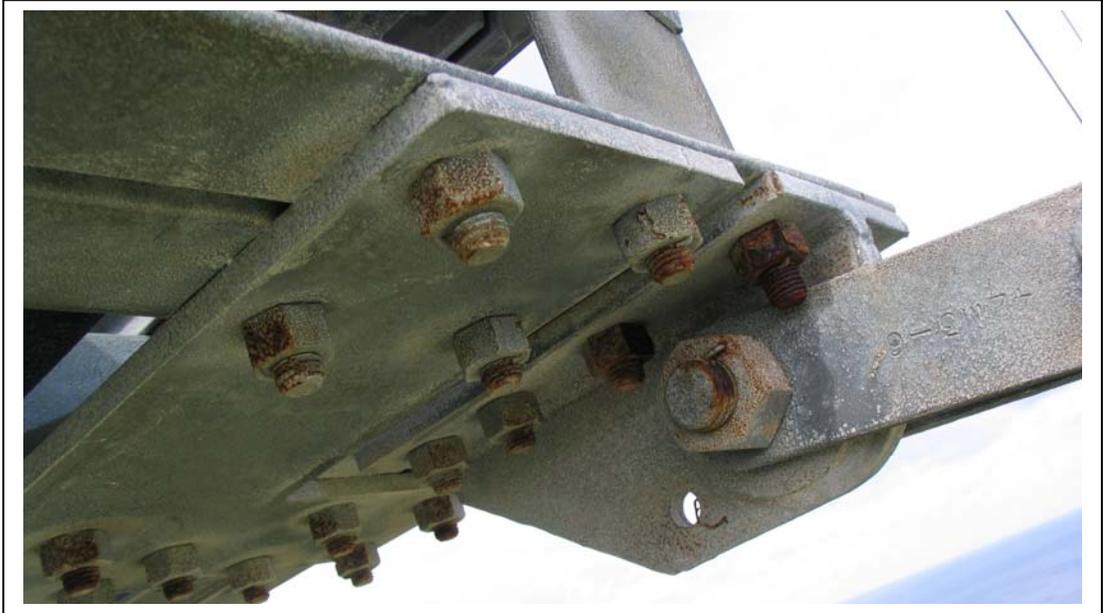
Photo No. T6.2

Photo No.T6.2 is a view of the catenary connection plate at the northwest side of the lower level outrigger.

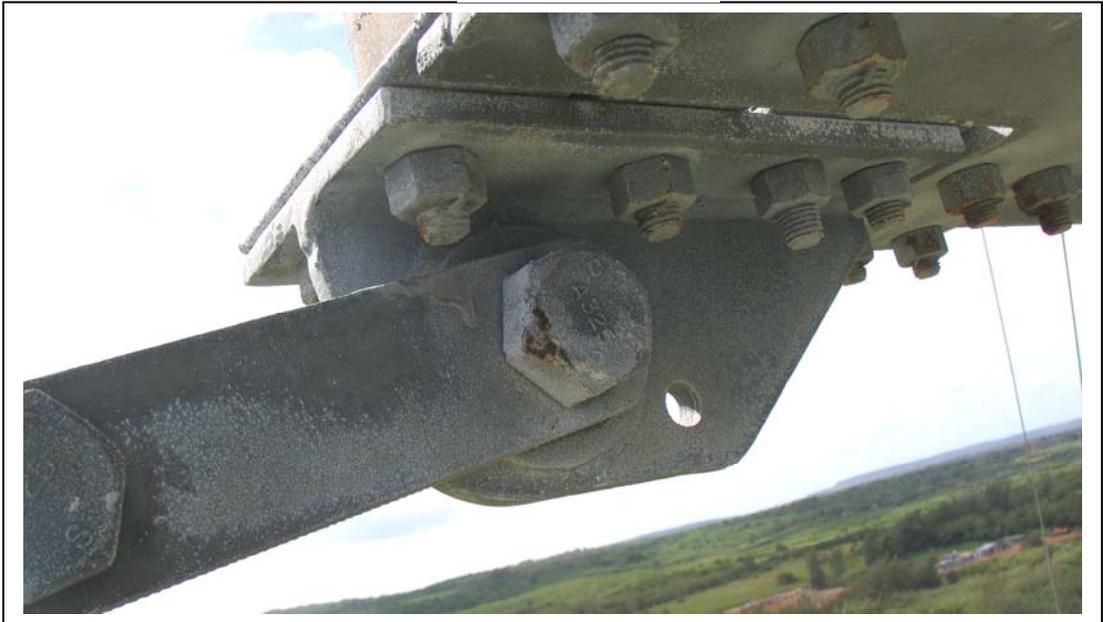
Photo No. T6.3

Photo No.T6.3 is a view of the catenary connection plate at the southeast side of the lower level outrigger.

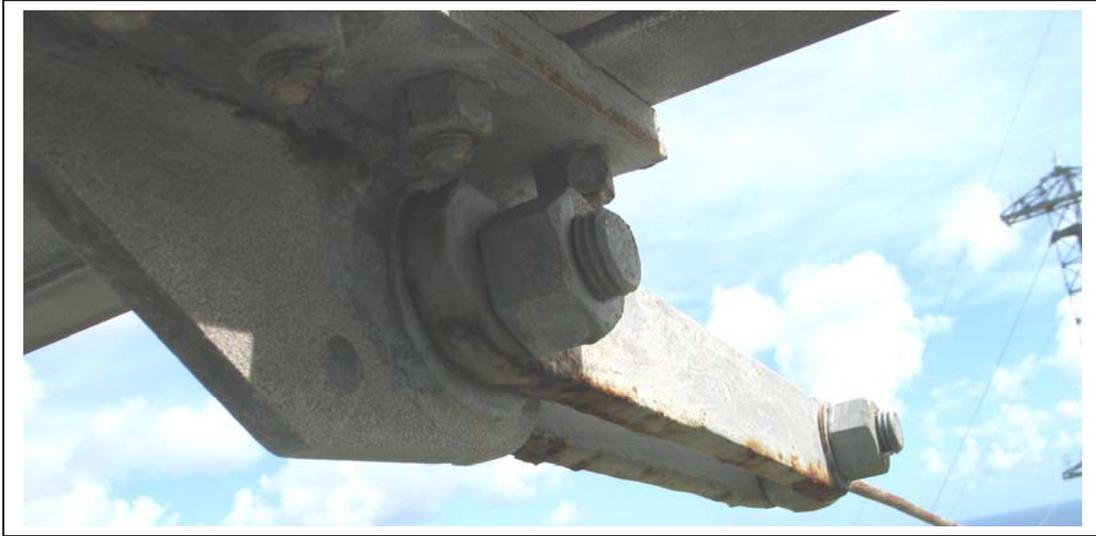
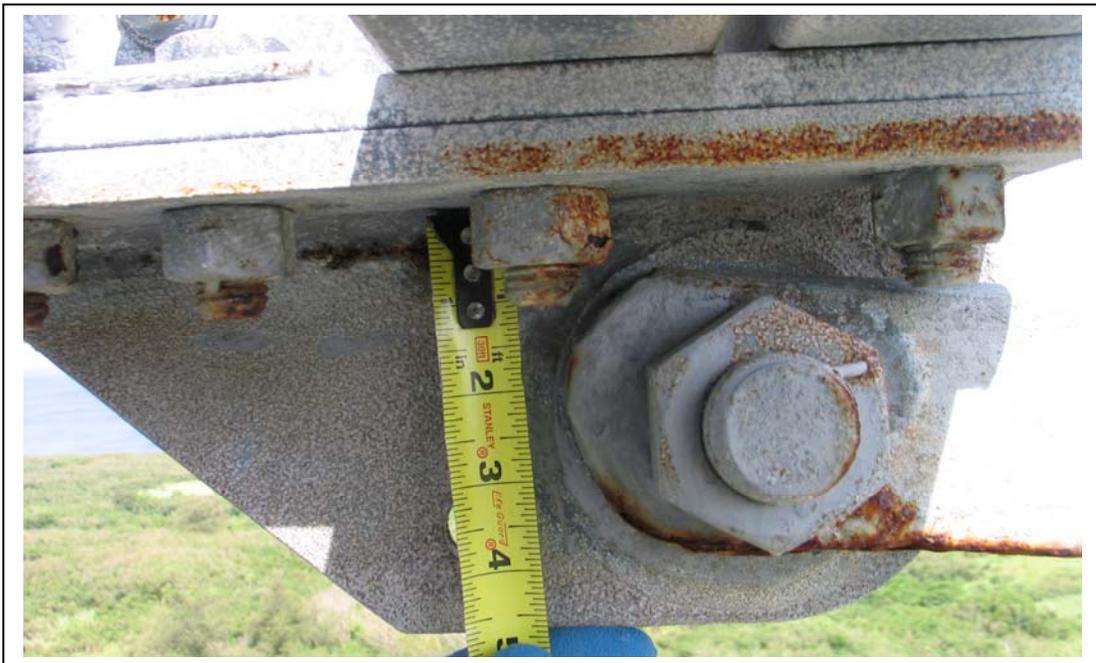
Photo Nos. T6.4 and T6.5 show the catenary connection plate at the middle of the lower level outrigger.

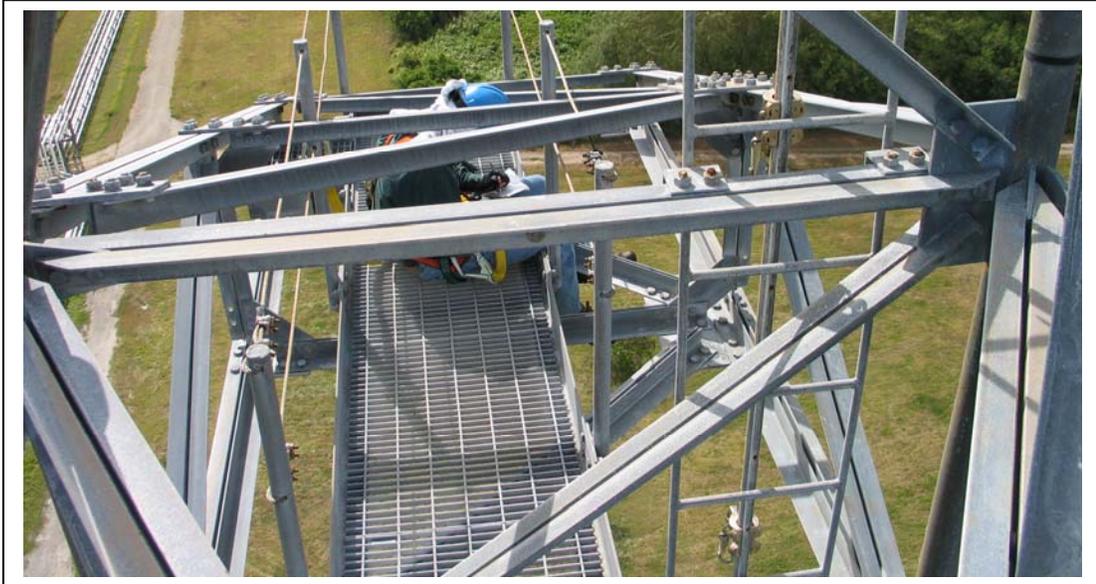
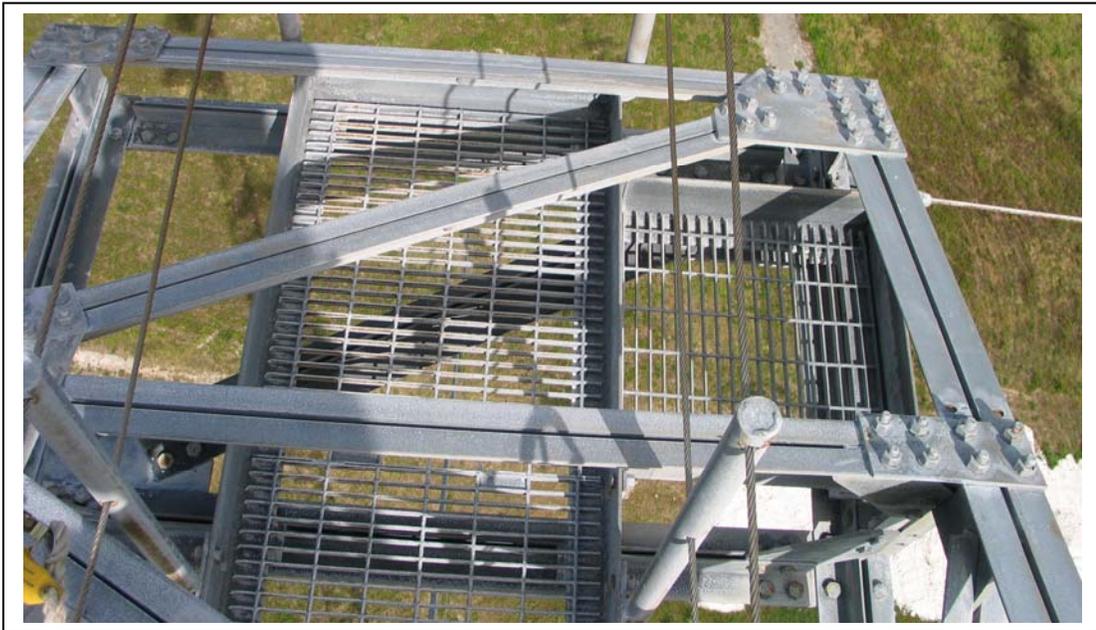
Photo Nos. T6.6 and T6.7 show the condition of the lower level outrigger at the 172.5-ft elevation.
