**TINIAN TRANSMITTING STATION
PHOTOGRAPH LOG**

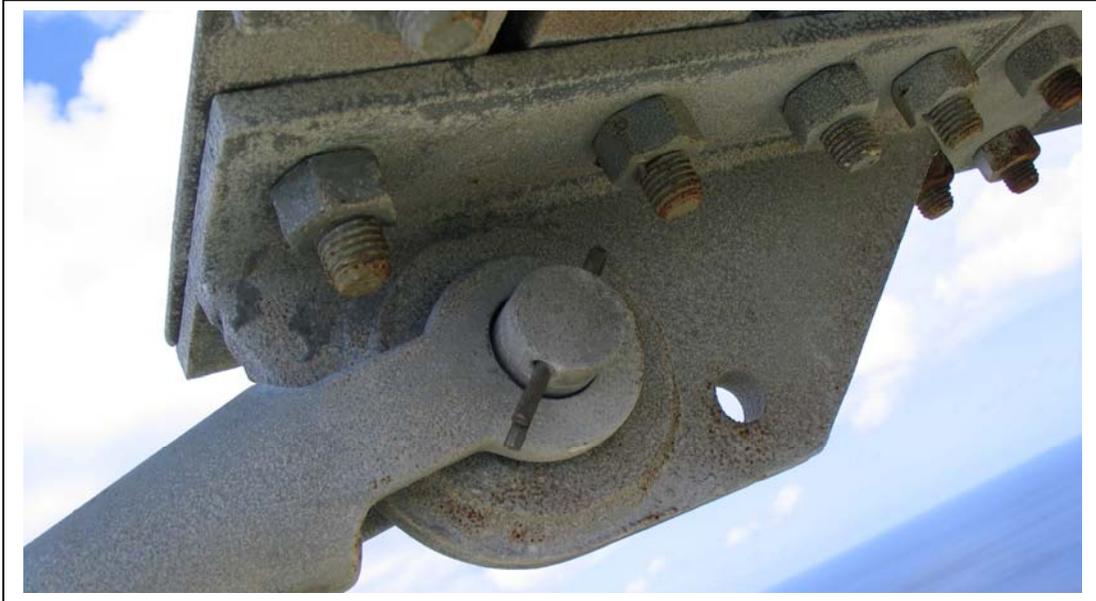
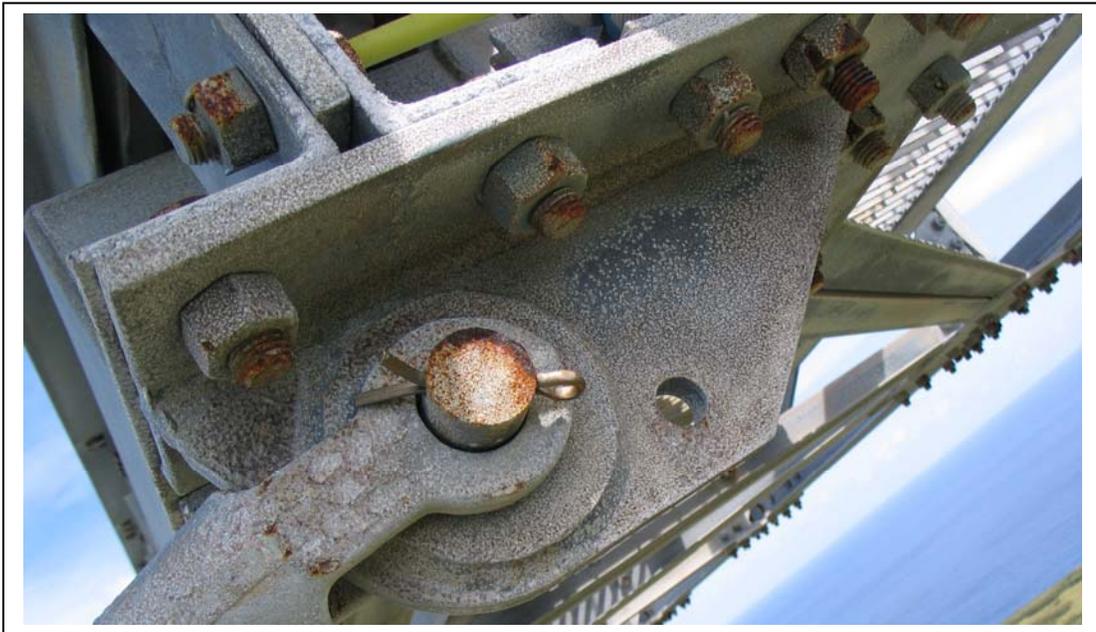
Photo No.T6.8 is a view of the catenary connection plate at the northwest side of the top level outrigger. Photo No.T6.9 is a view of the catenary connection plate at the southeast side of the top level outrigger.

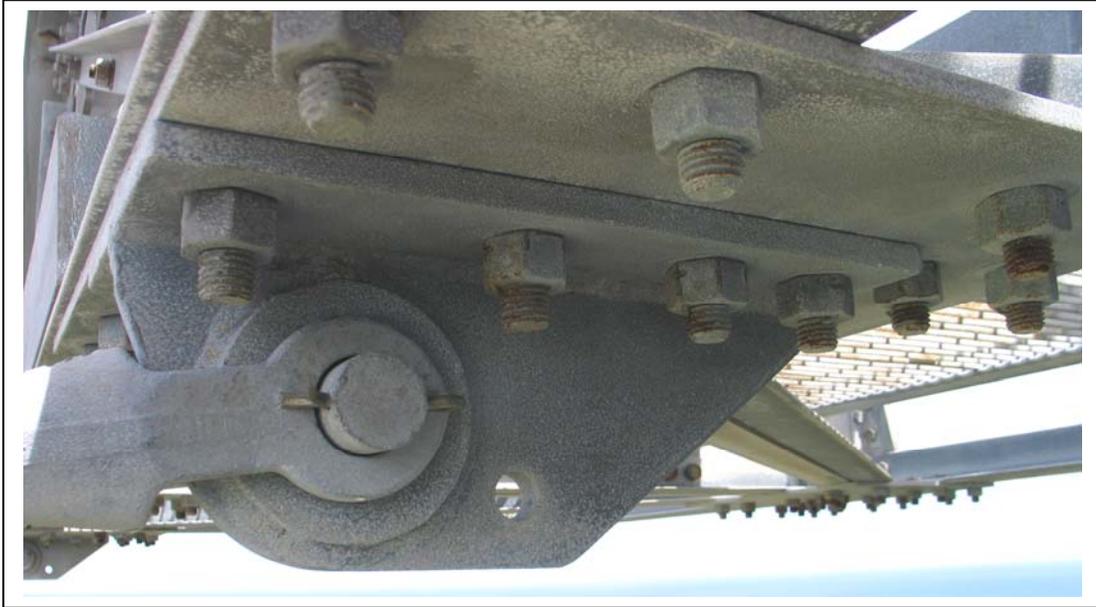
Photo Nos. T6.10 and T6.11 show the catenary connection plate at the middle of the top level outrigger.

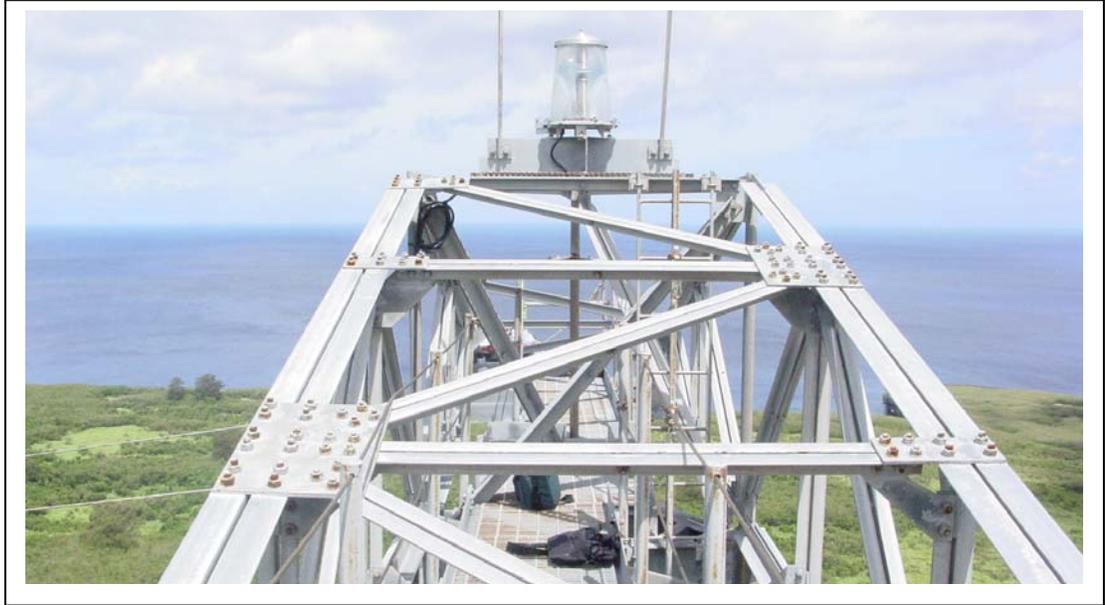
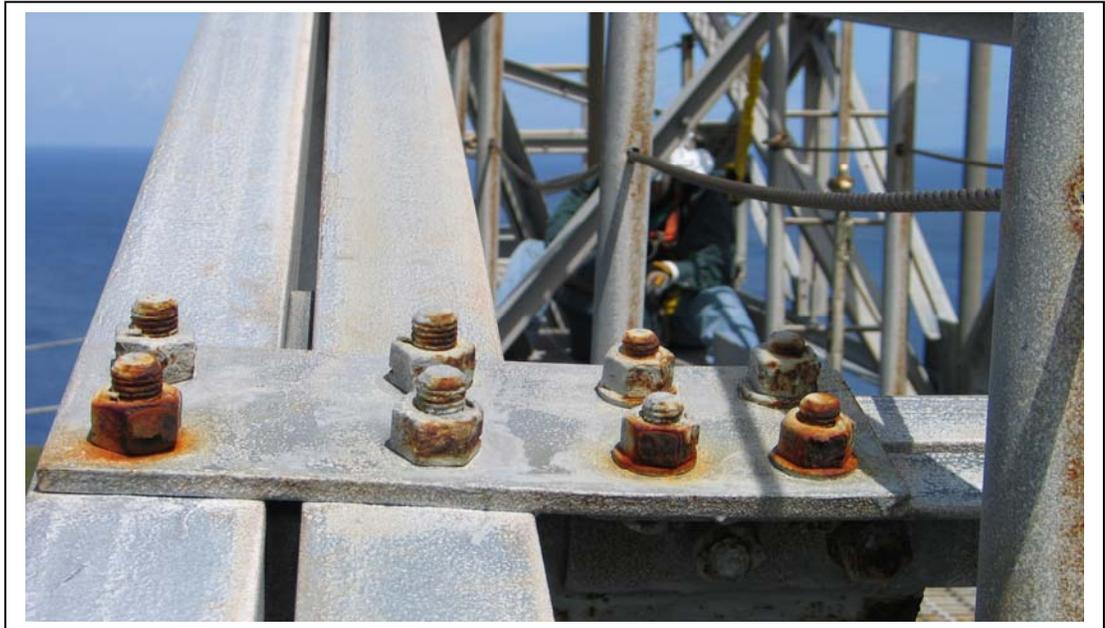
Photo Nos. T6.12 and T6.13 show the condition of the top level outrigger at the 305-ft elevation.

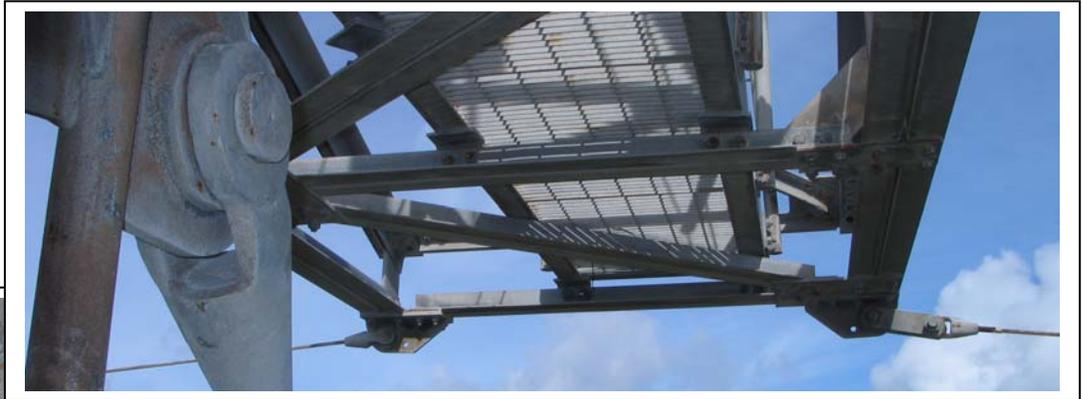
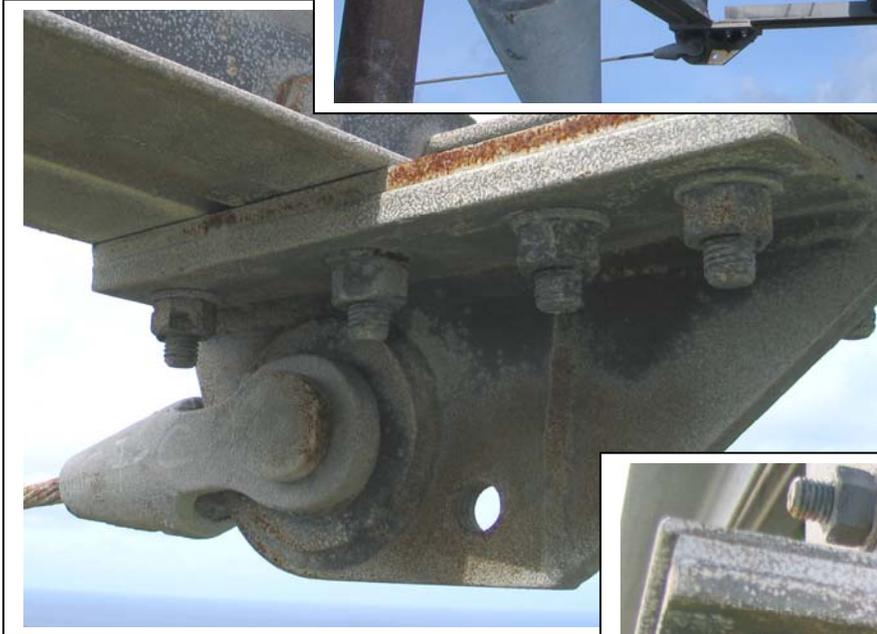
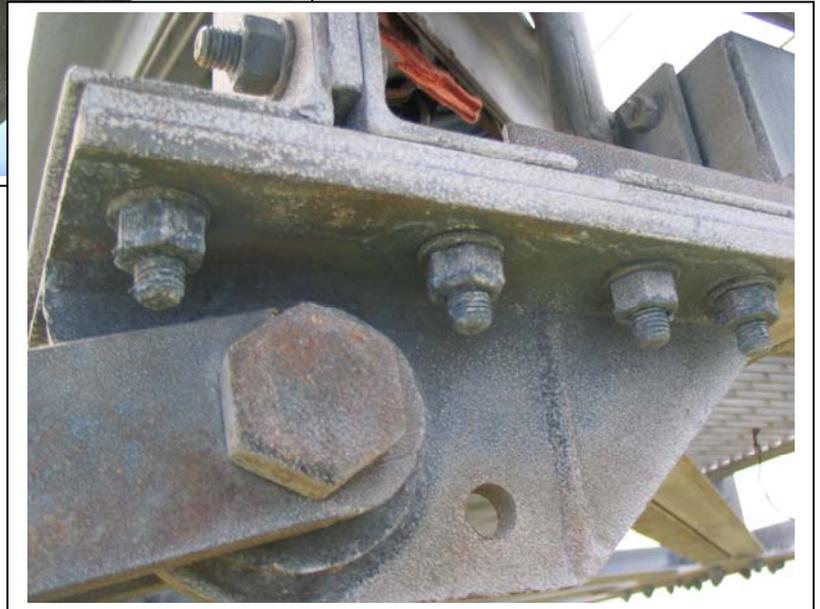
Photo Nos. T7.2, T7.3 and T7.4 show two catenary connection plates at the west side of the outrigger.

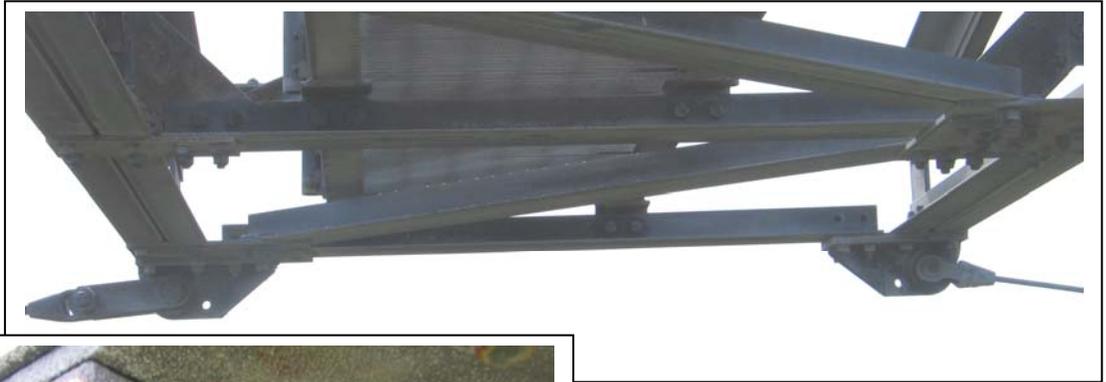
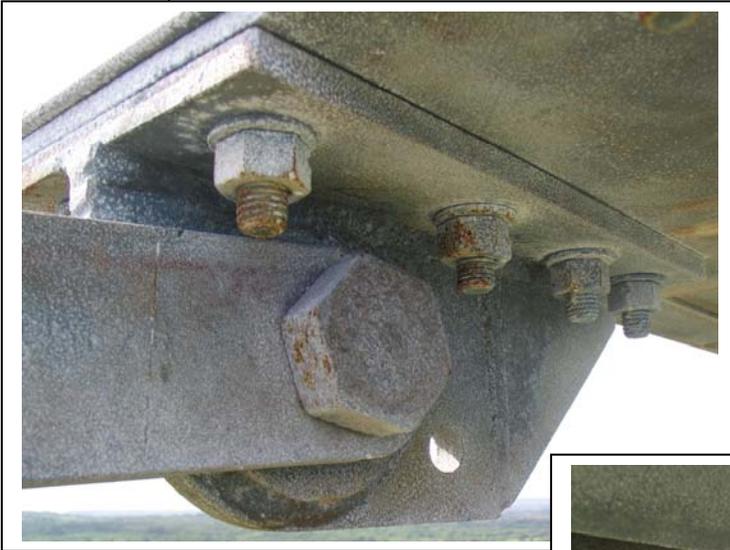
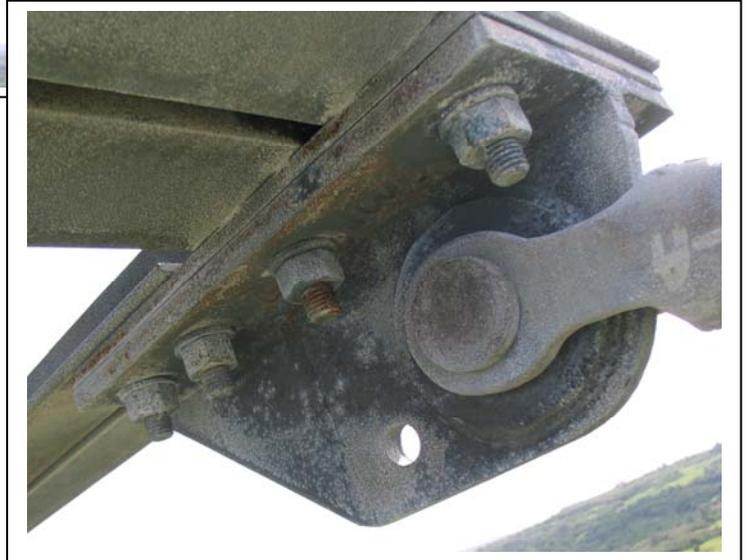
Photo Nos. T7.4, T7.5 and T7.7 show two catenary connection plates at the east side of the outrigger.

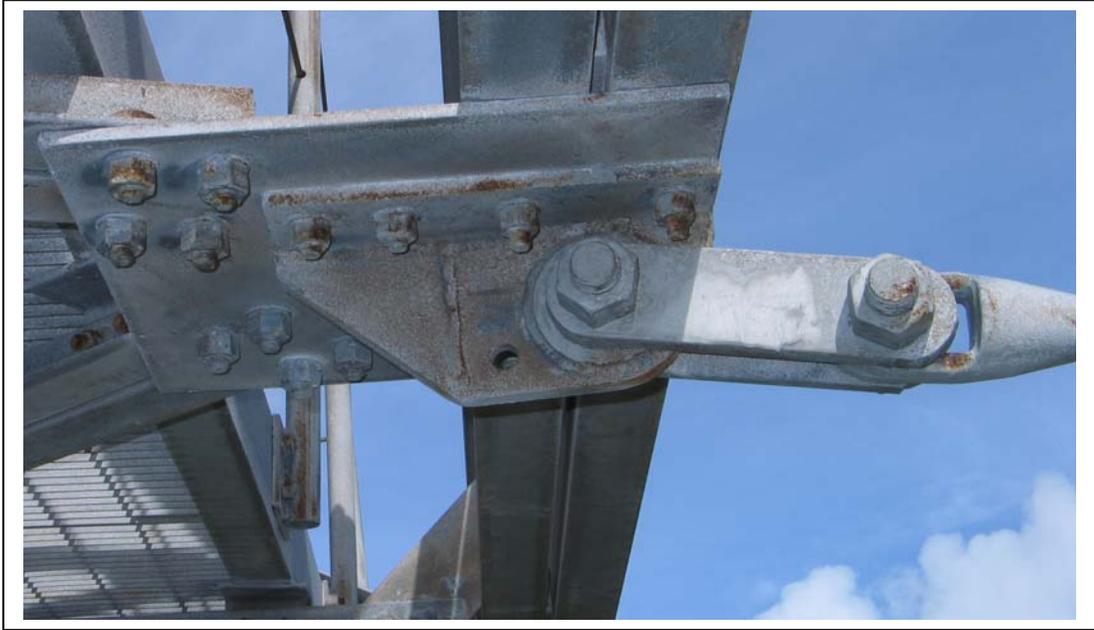
Photo Nos. T7.8 and T7.9 show two catenary connection plates at the middle of the outrigger.

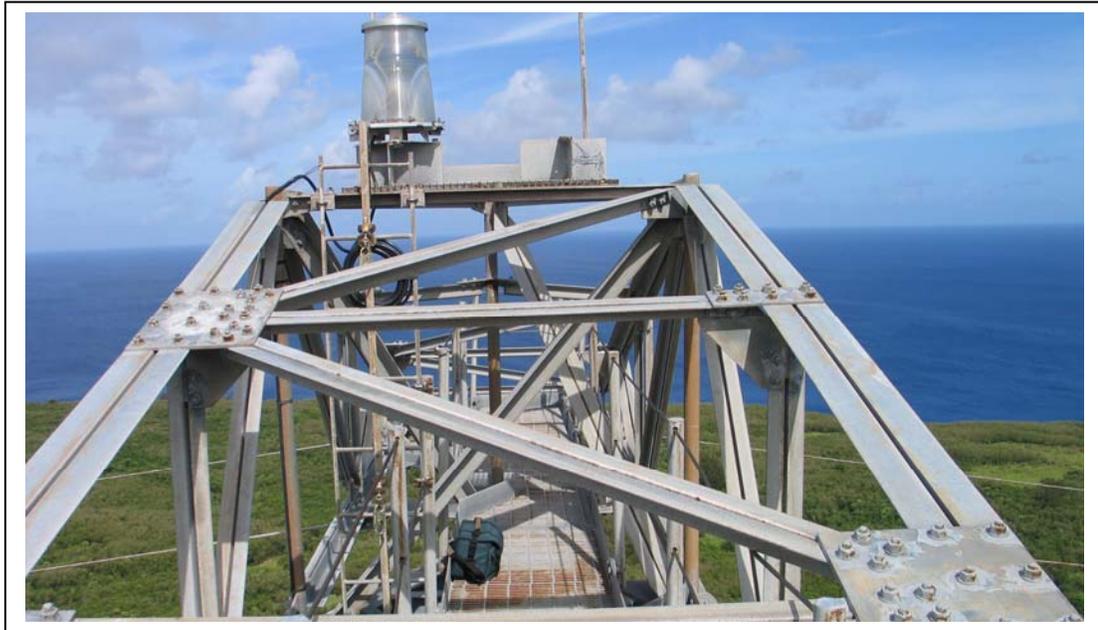
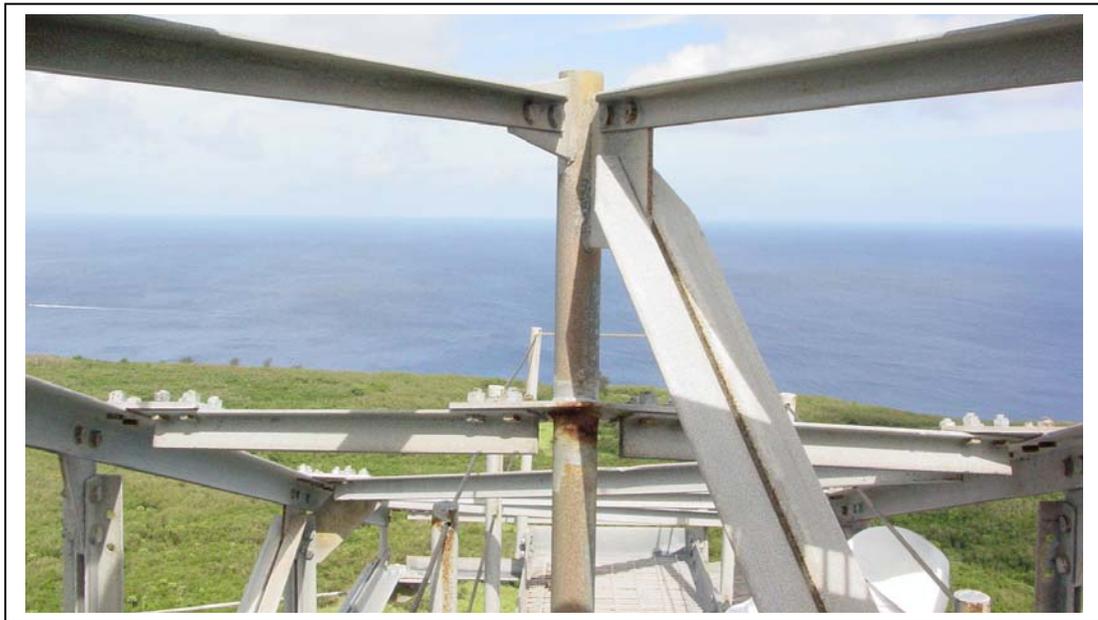
Photo Nos. T7.10 and T7.11 show the condition of the top level outrigger at the 305-ft elevation.

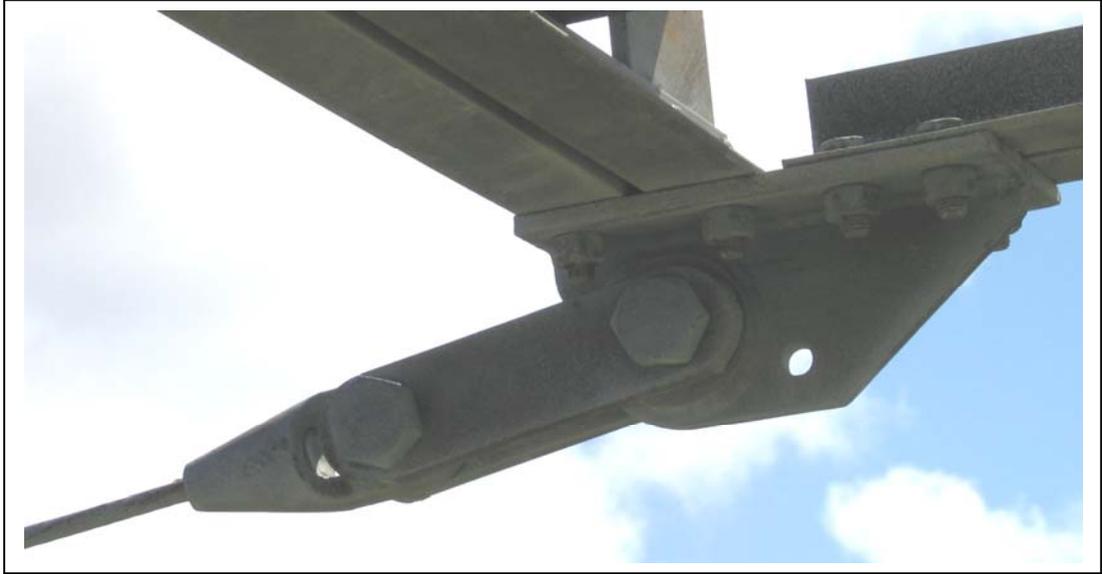
Photo No. T8.2

Photo No.T8.2 is a view of the catenary connection plate at the west side of the lower level outrigger.

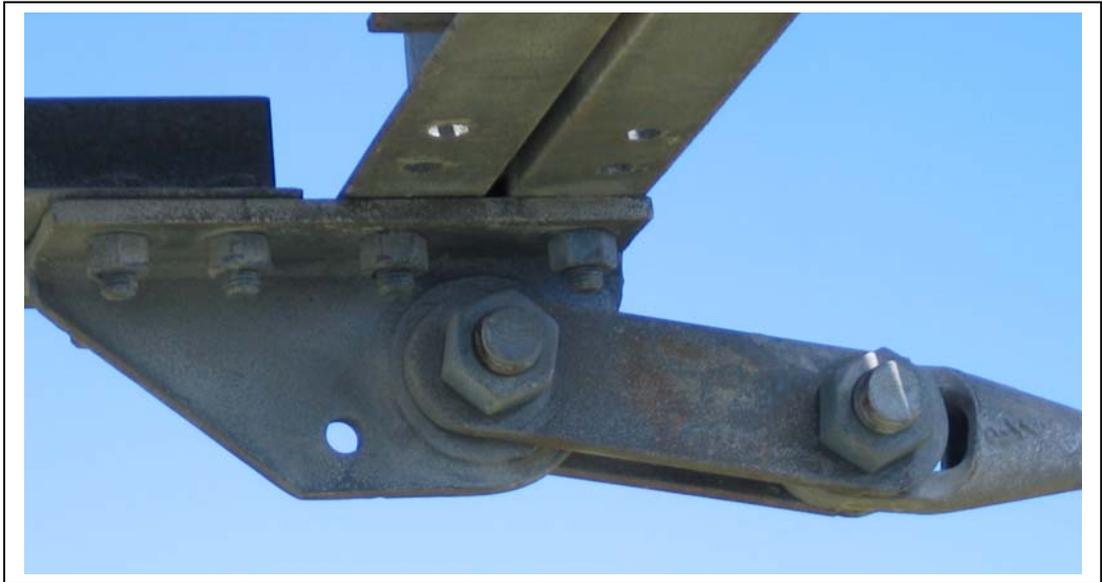
Photo No. T8.3

Photo No.T8.3 is a view of the catenary connection plate at the east side of the lower level outrigger.

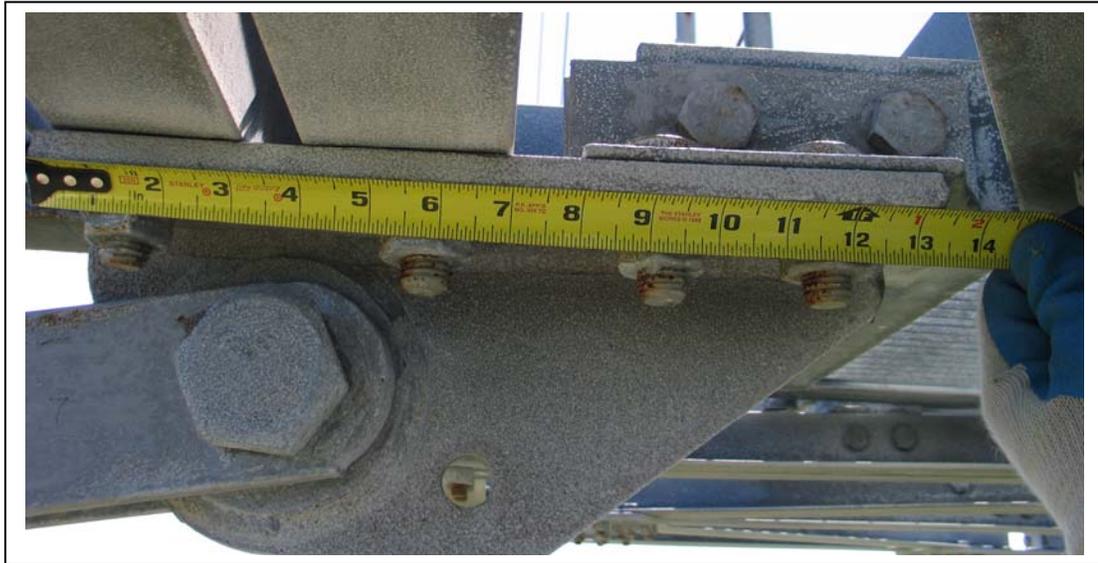
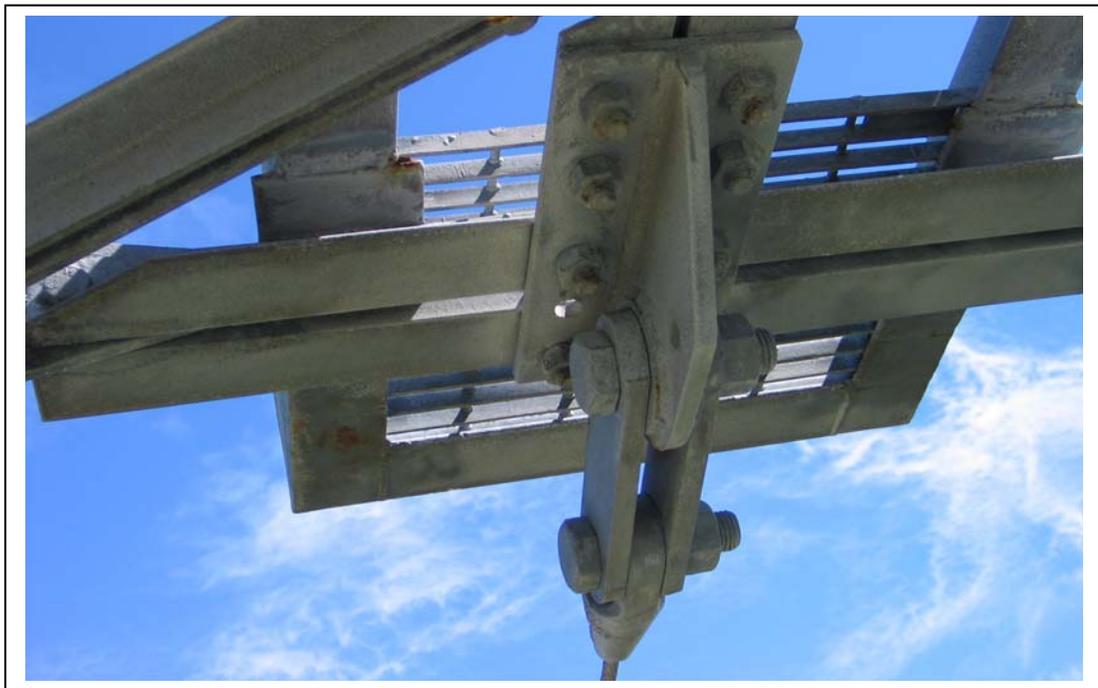
Photo Nos. T8.4 and T8.5 show the catenary connection plate at the middle of the lower level outrigger.

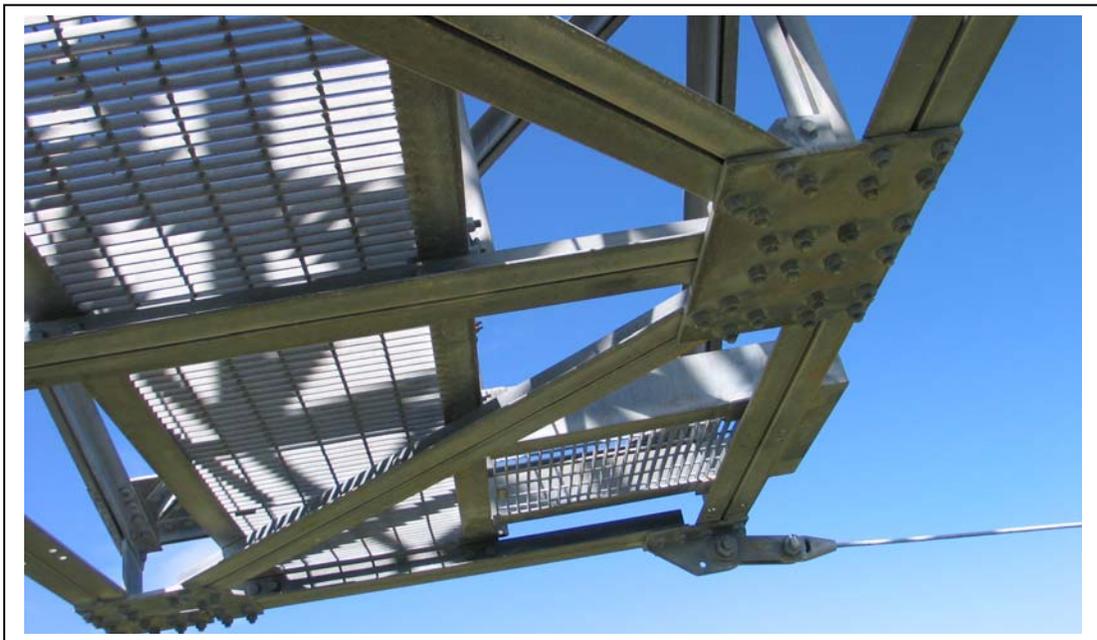
Photo Nos. T8.6 and T8.7 show the lower level outrigger at the 167.5-ft elevation.

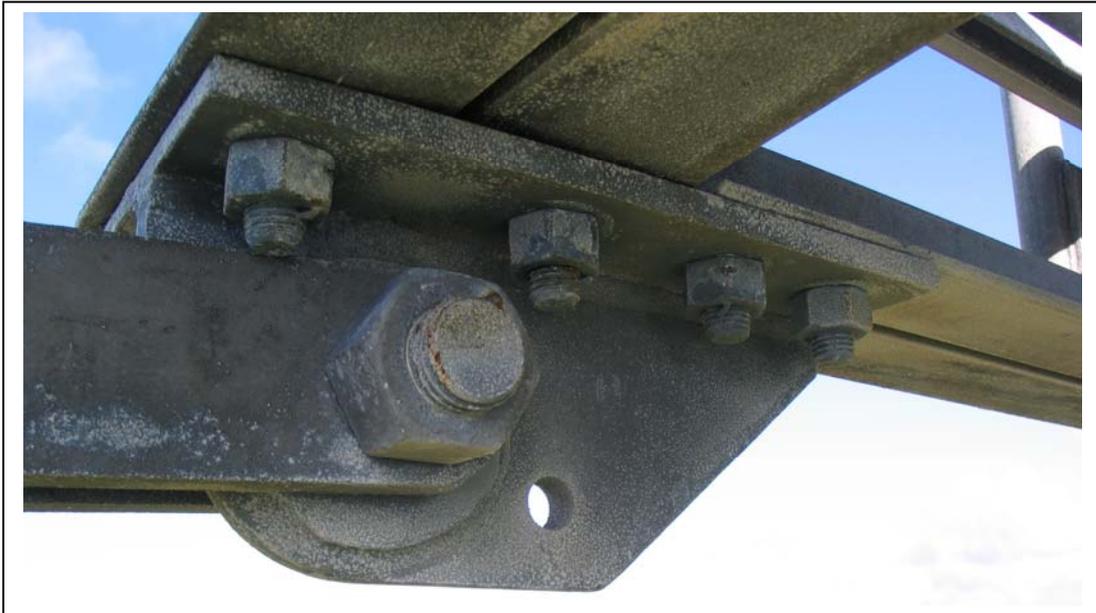
Photo No.T8.8 is a view of the catenary connection plate at the west side of the top level outrigger. Photo No.T8.9 is a view of the catenary connection plate at the east side of the top level outrigger.

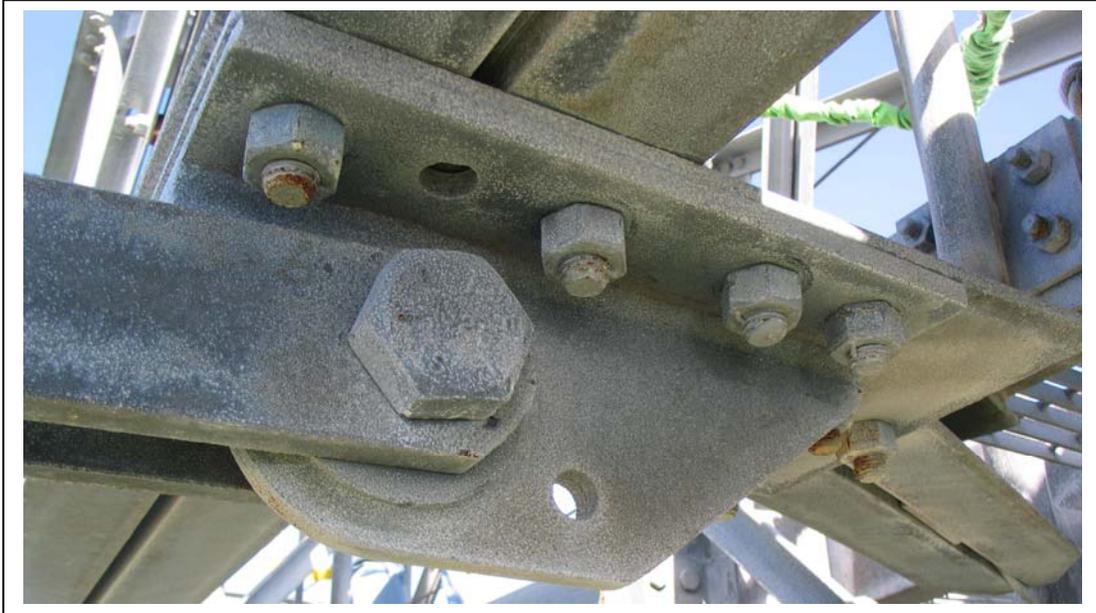
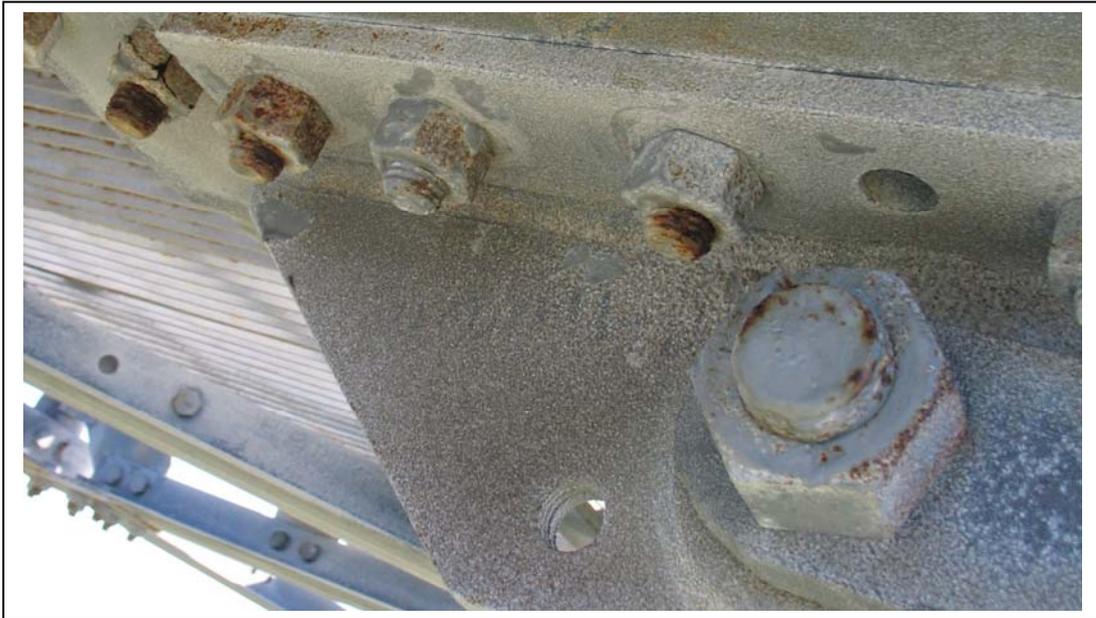
Photo Nos. T8.10 and T8.11 show the catenary connection plate at the middle of the top level outrigger.

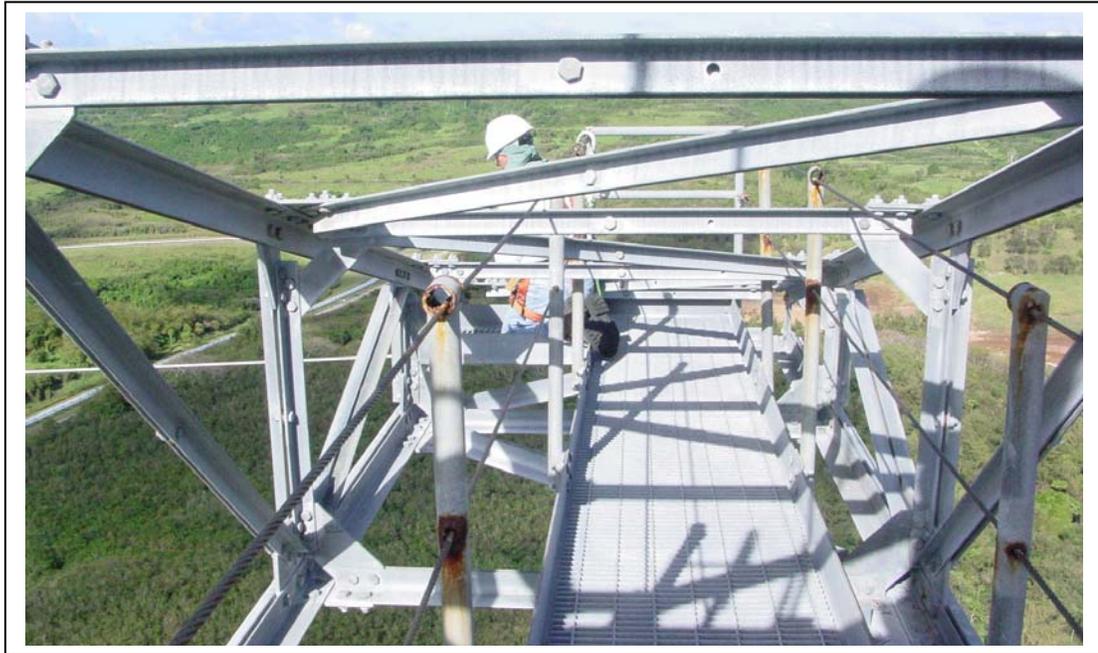
Photo Nos. T8.12 and T8.13 show the condition of the top level outrigger at the 291.5-ft elevation.

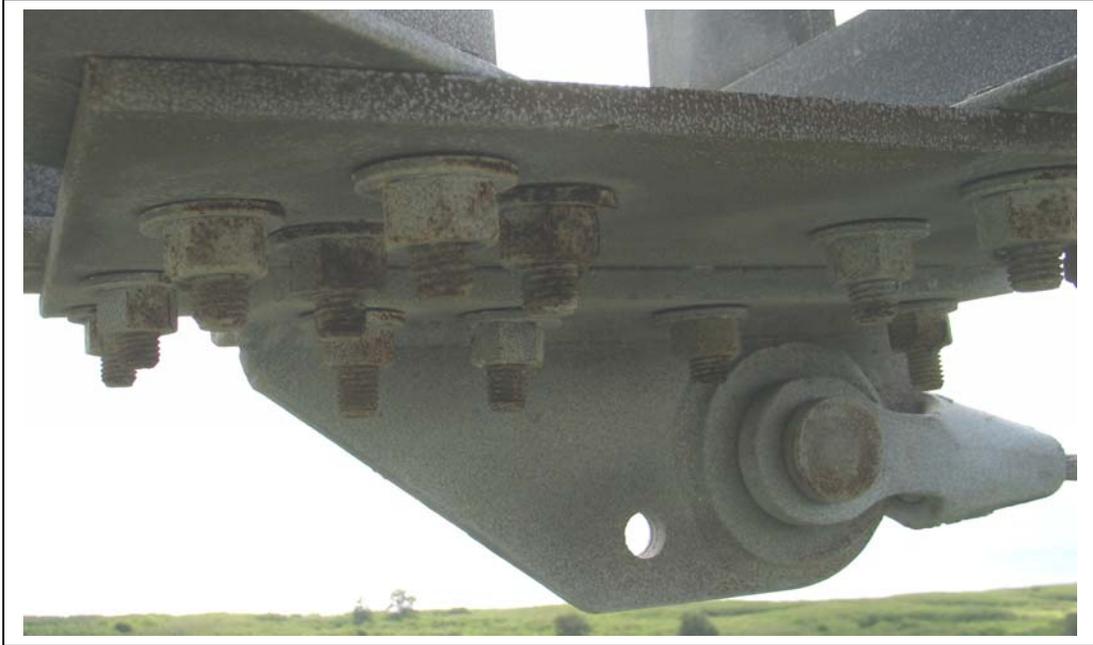
Photo No. T9.2

Photo No.T9.2 is a view of the catenary connection plate at the west side of the outrigger.
Photo No.T9.3 is a view of the catenary connection plate at the east side of the outrigger.

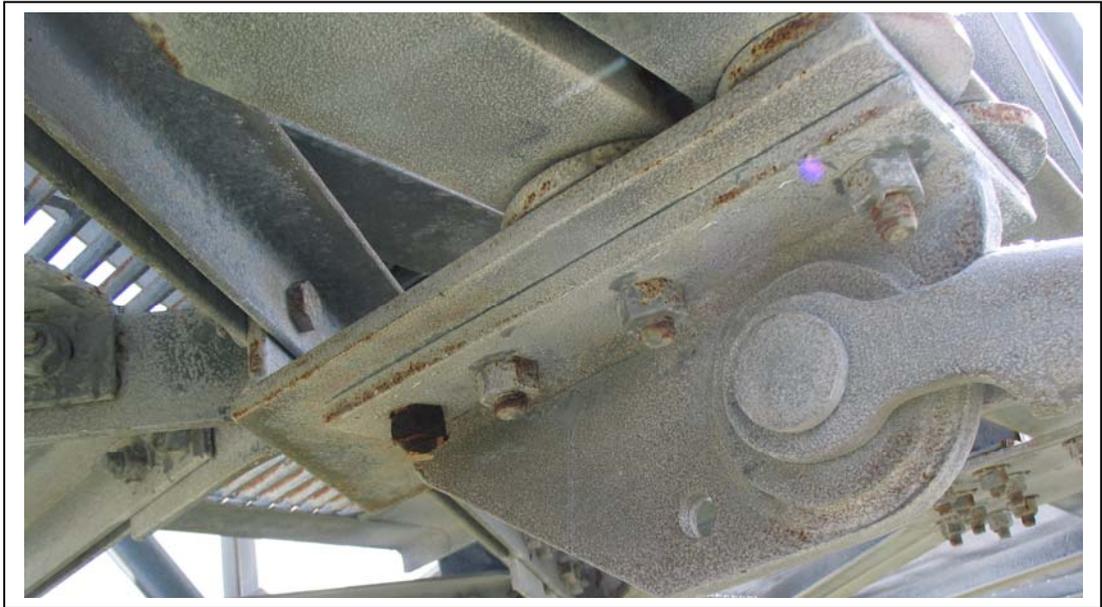
Photo No. T9.4

Photo Nos. T9.4 and T9.5 show the catenary connection plate at the middle of the outrigger.

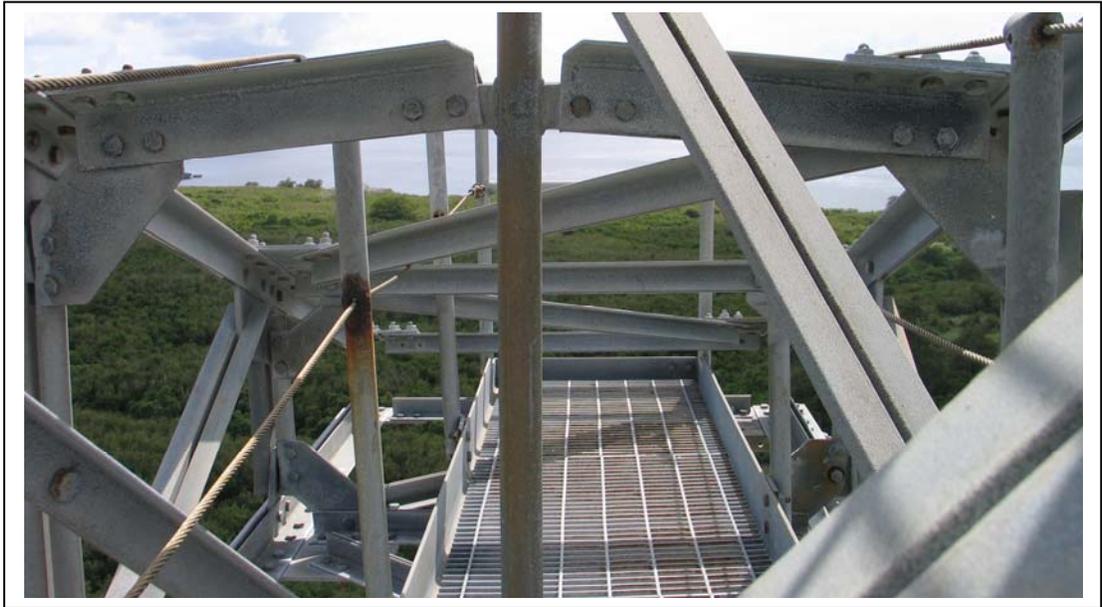
Photo No. T9.6

Photo Nos. T9.6 and T9.7 show the condition of the outrigger at the top of the tower.
